Jewel Mill Area Visited 24th April 2020

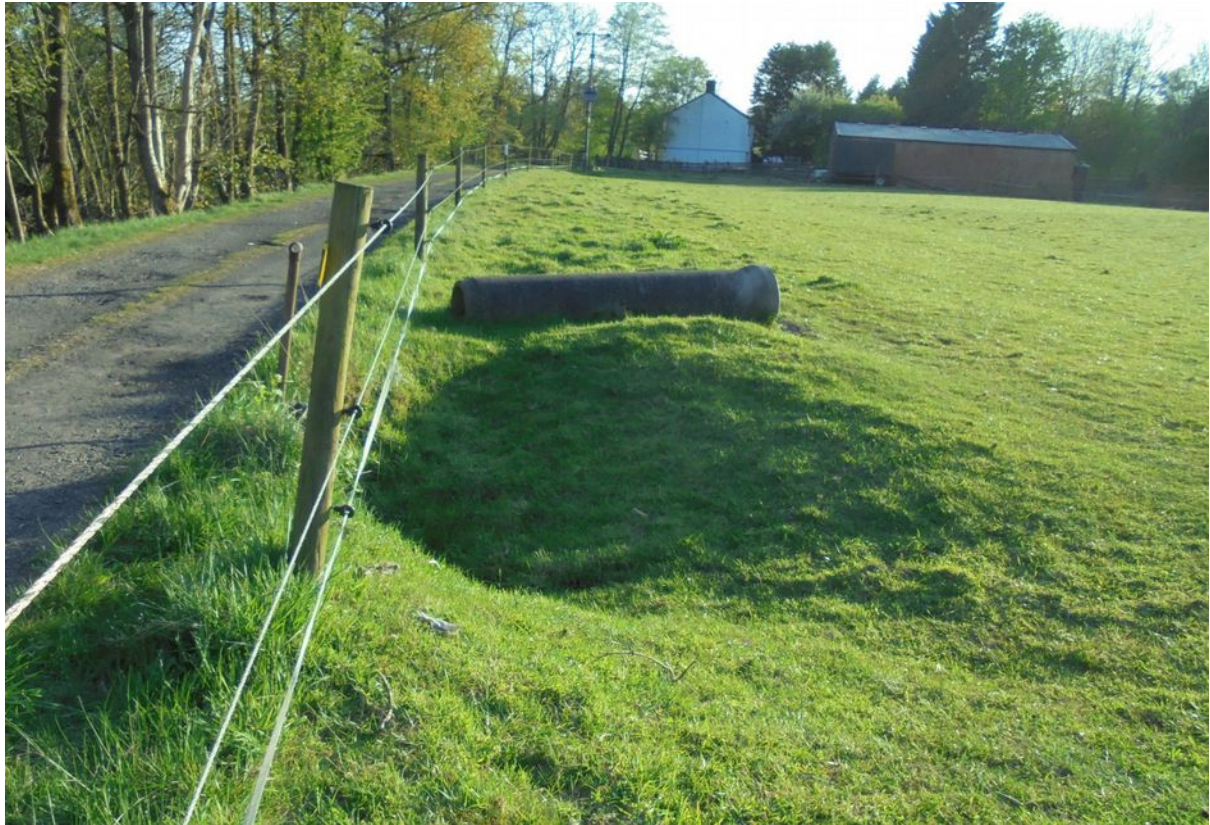
The end of the overflow can still be seen as a depression adjacent to the track under which it passes to the river. There is a section of fireclay pipe lying in the field here, which may have formed part of the overflow, under the track.

The photograph shows where the overflow used to exit the field. This is the view looking south-east; to the left of the track can be seen a row of trees – the river is immediately below them; the buildings in the distance are on the site of the factory.

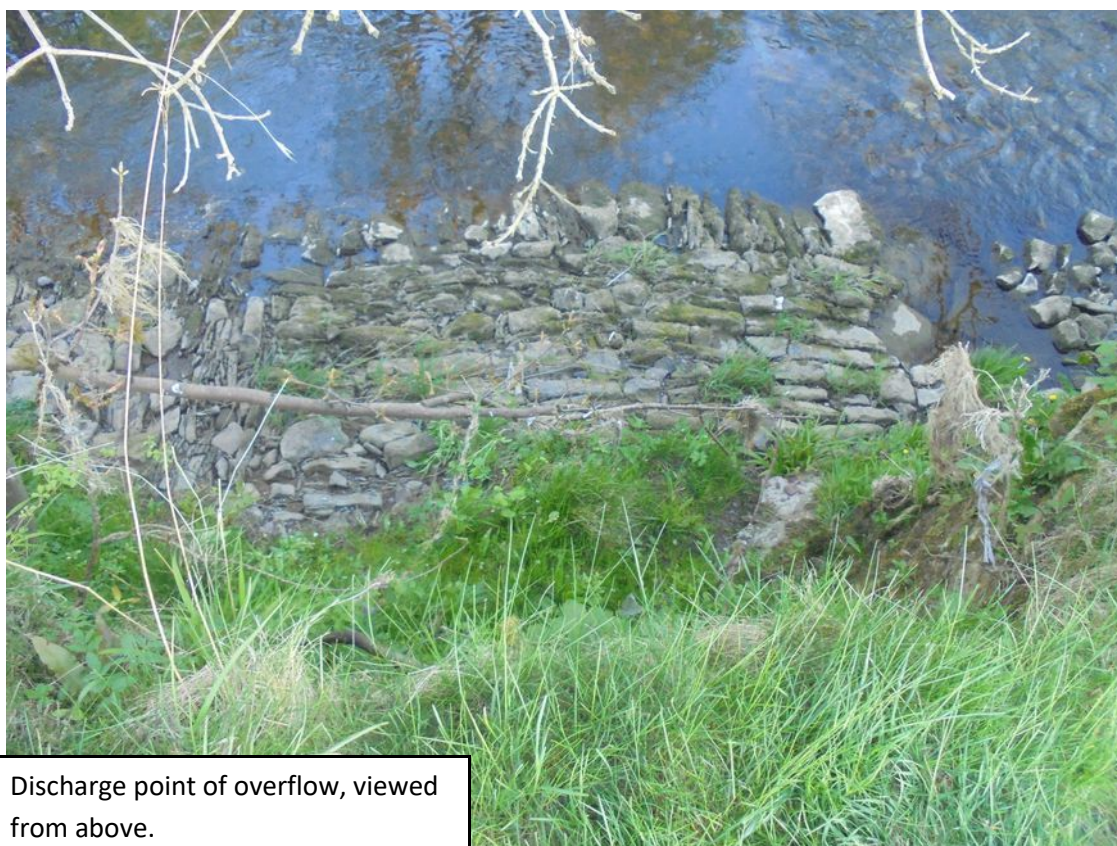
Looking from directly above, there is an area paved with stones extending into the river. (The photographs were taken after a period of dry weather so it is possible that this would be under water normally.)

Discharge point of overflow, viewed from above.

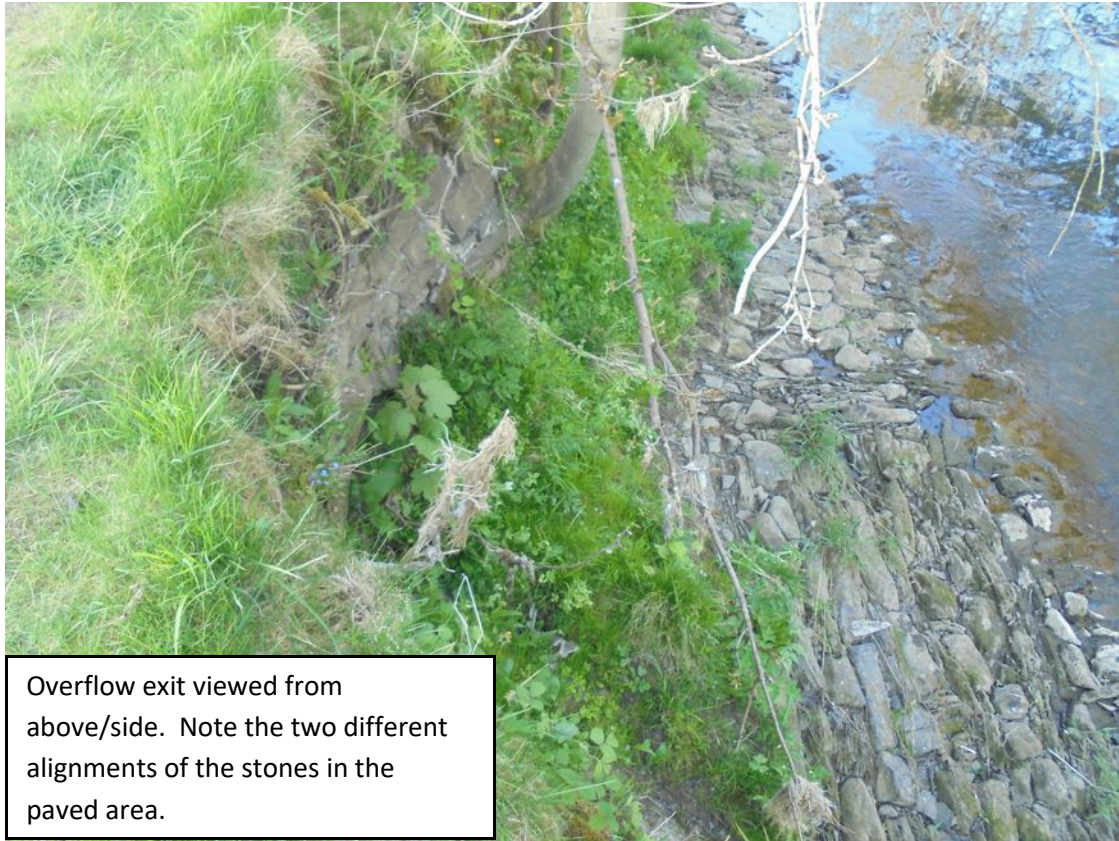
Overflow exit viewed from above/side. Note the two different alignments of the stones in the paved area.

The stones underneath the overflow are aligned longways with the river flow. Either side of this area is an extensive strip of smaller stones aligned longways at right angles to the river flow.

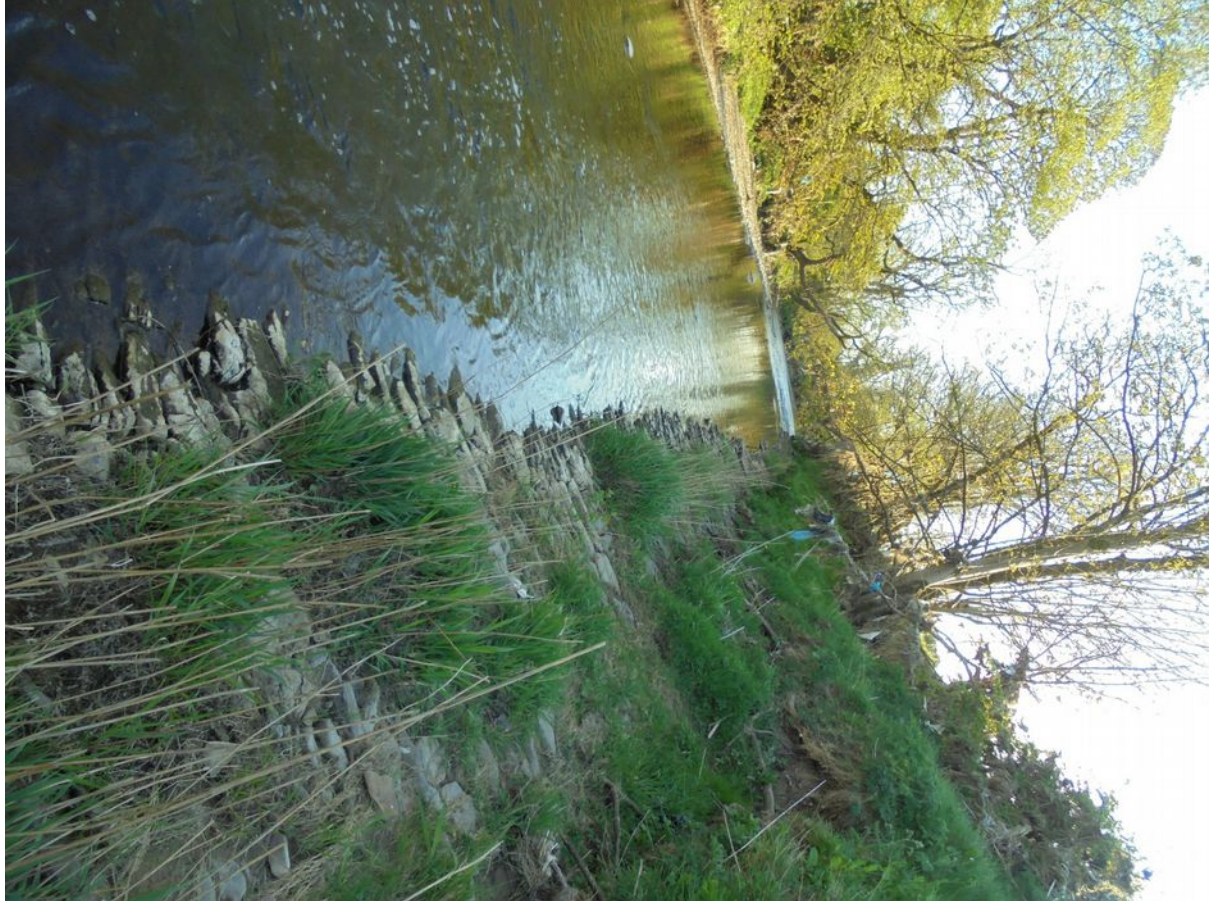
The paved area is quite extensive, extending approximately 30m upstream and 10 m downstream of the overflow and about 2m wide including the submerged part.

Viewing from upstream of the overflow, showing paved edge.

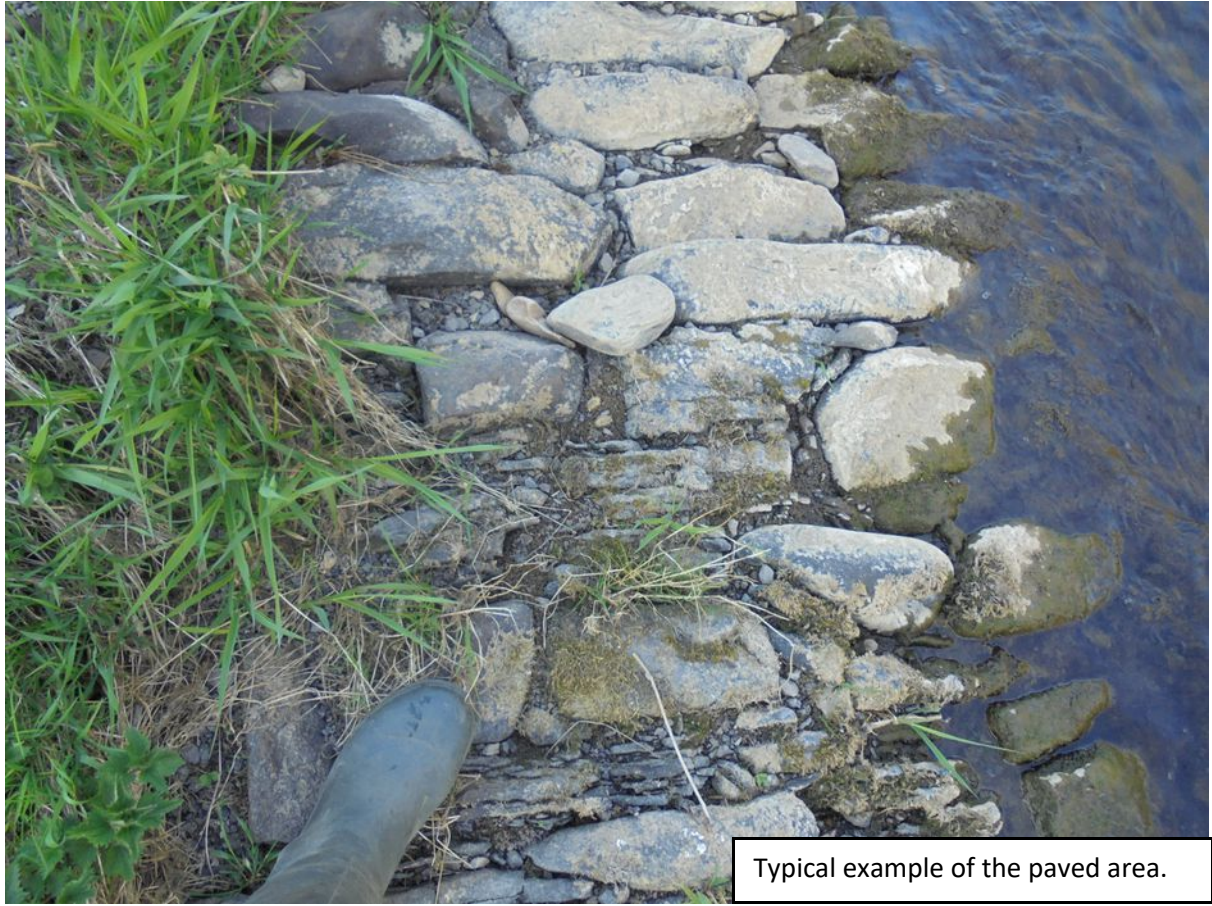
Typical example of the paved area.

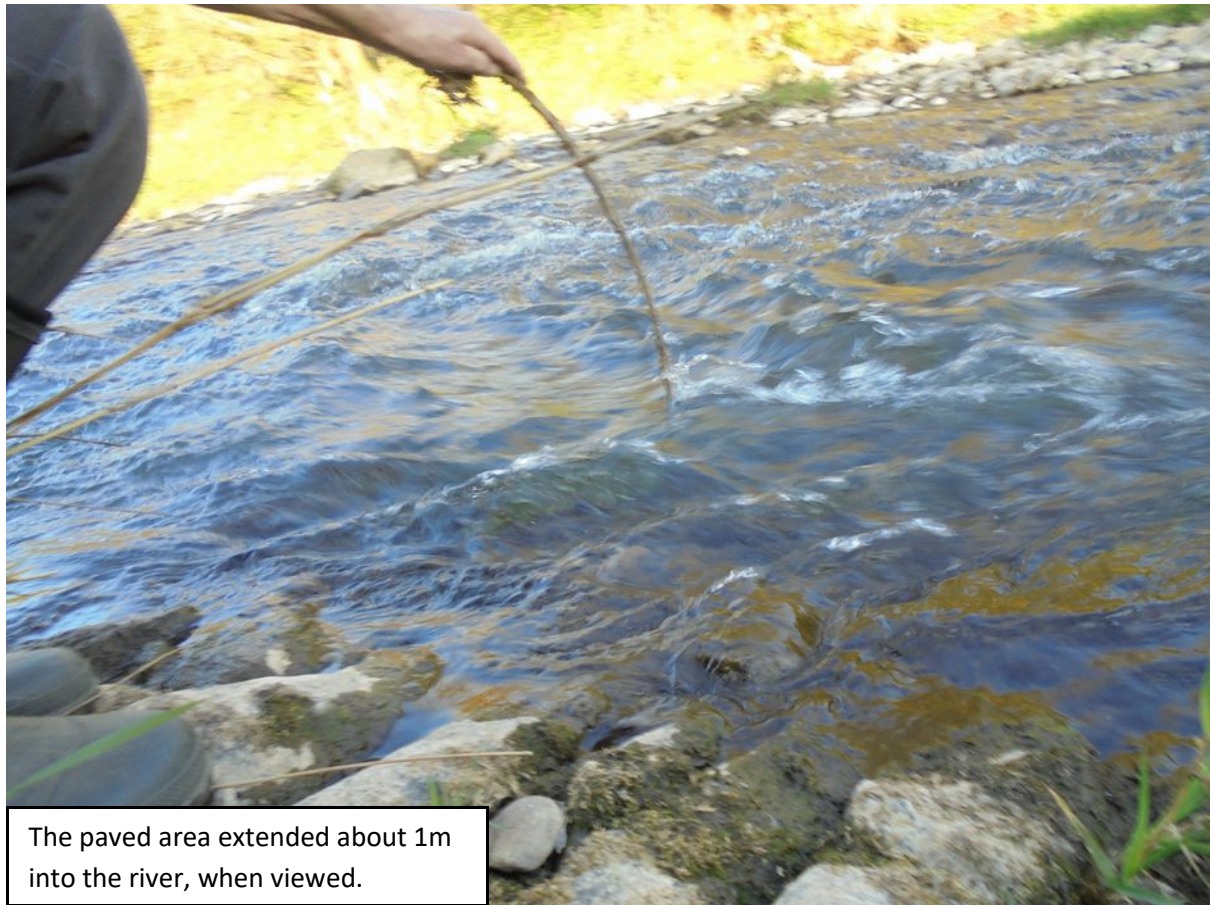
The paved area extended about 1m into the river, when viewed.

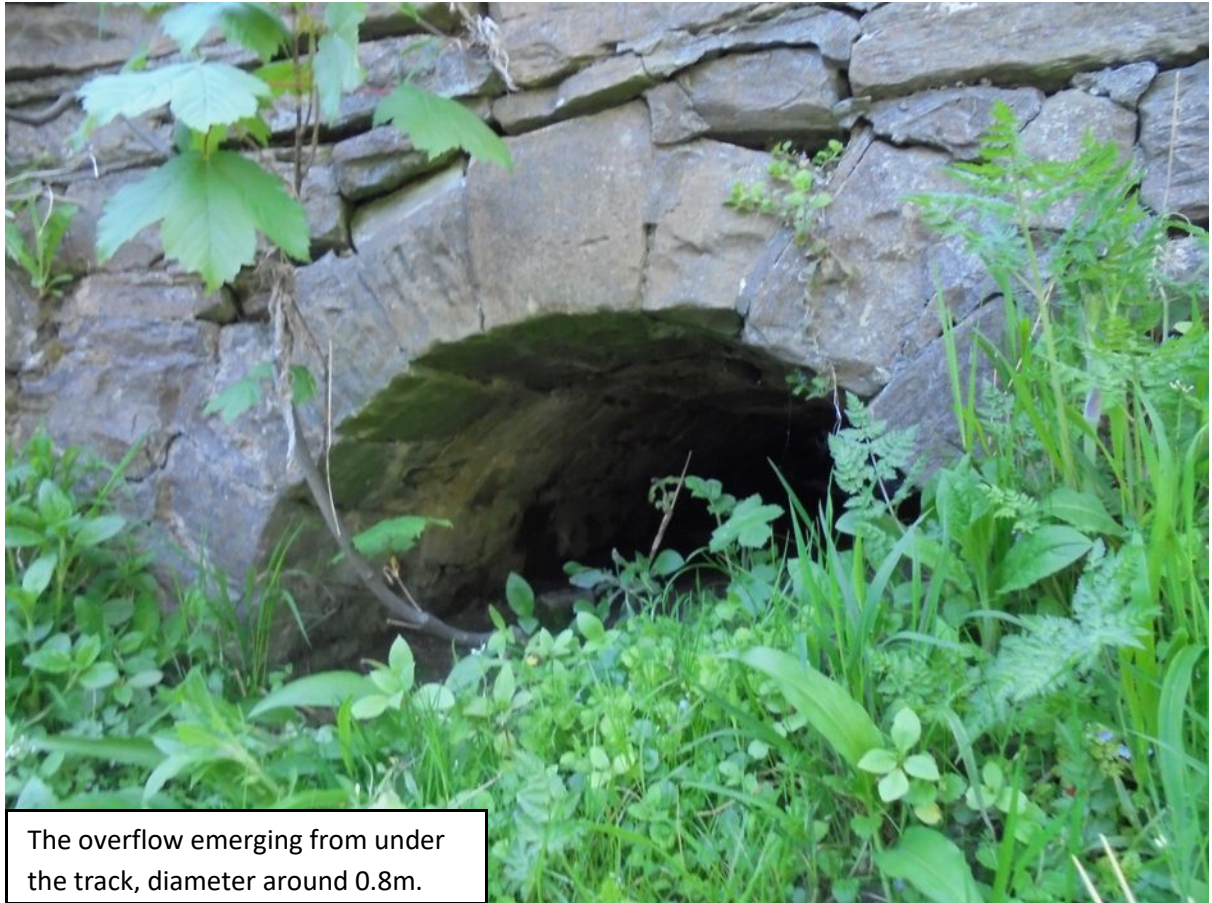
The overflow emerging from under the track, diameter around 0.8m.

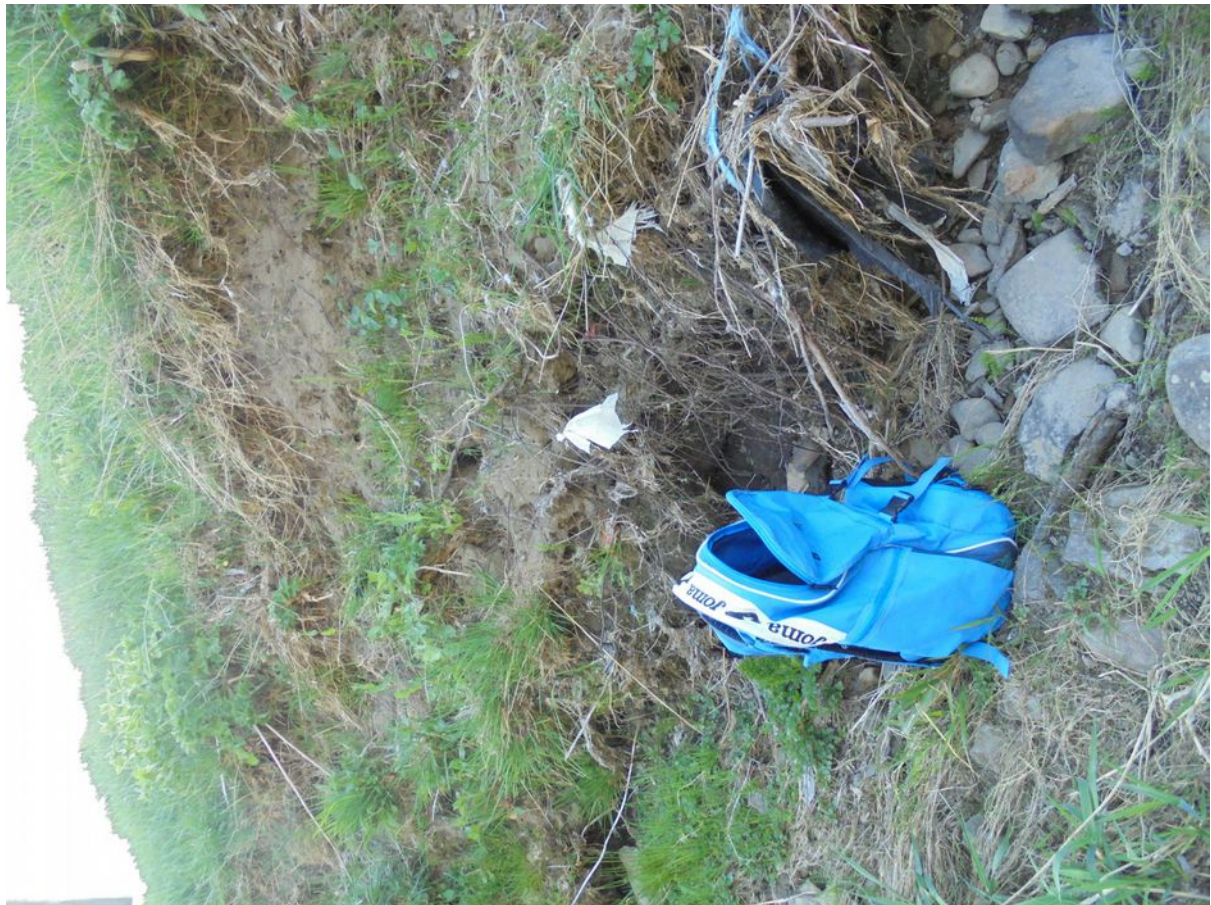
The paved area may have been an attempt to prevent erosion. The banks are very sandy in this area and easily eroded.

A typical section of unprotected bank c 3m high and almost vertical.

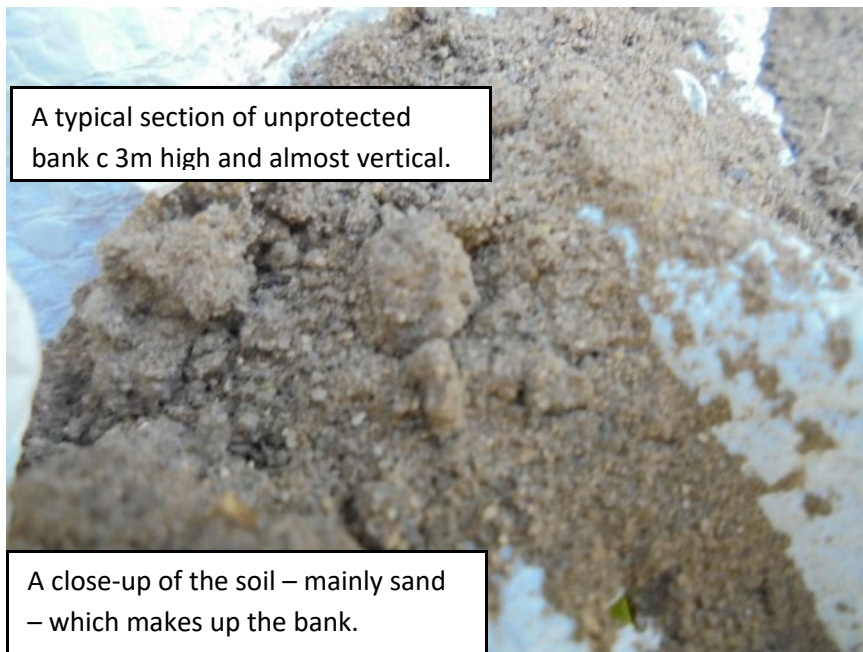
A close-up of the soil – mainly sand – which makes up the bank.

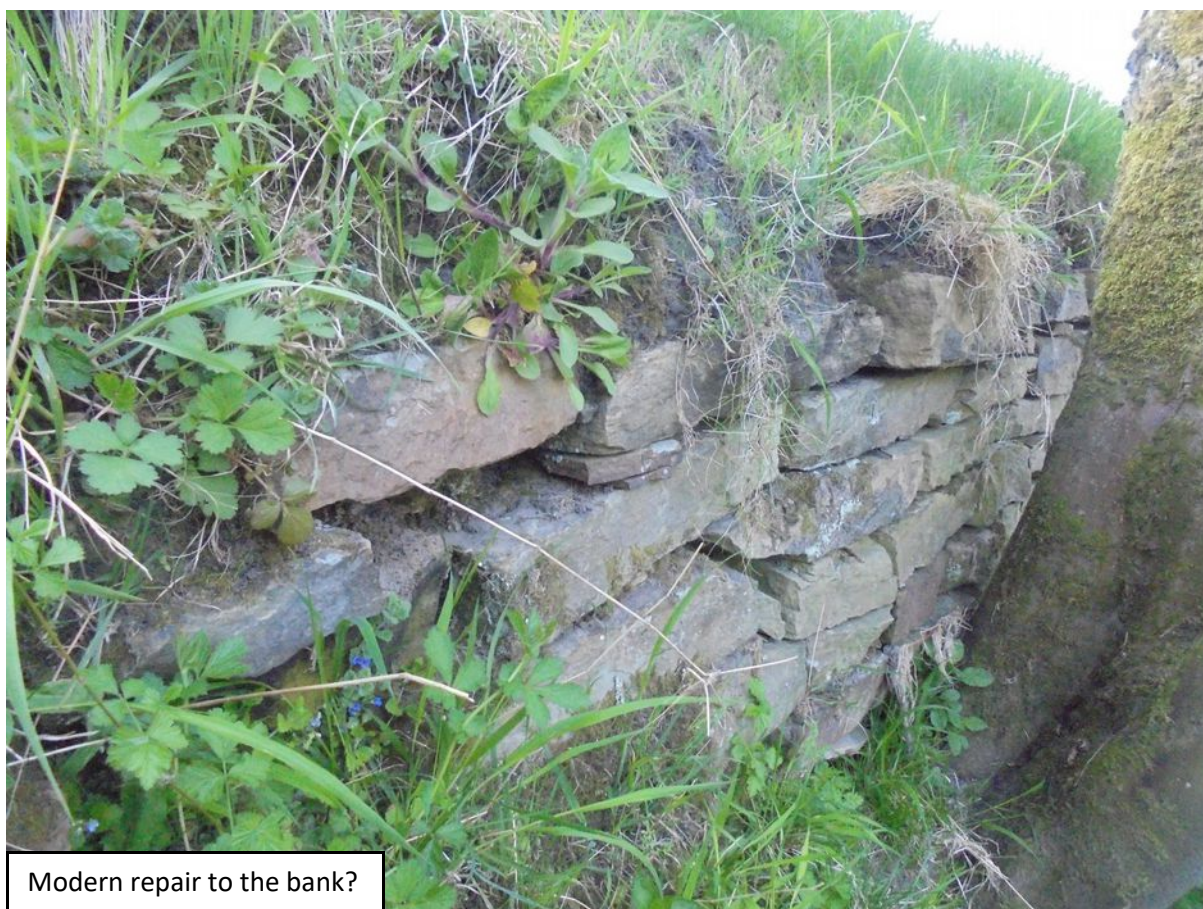
About 20m downstream from the overflow some large stones were noted in the bank which were heavily overgrown and extended for about 10m; adjacent to these was a section of smaller stones which are probably unrelated and may be a repair to an eroded area.

Modern repair to the bank?

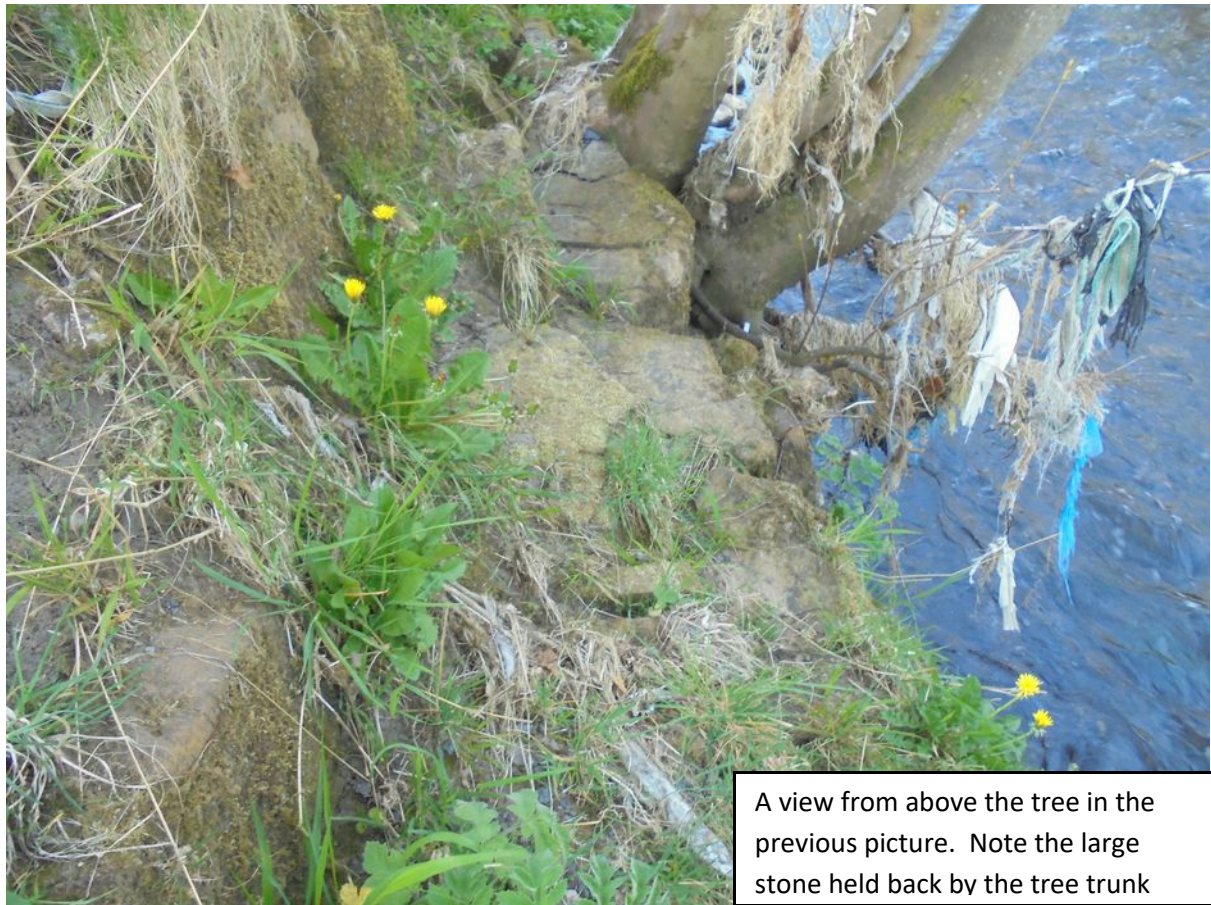
A view from above the tree in the previous picture. Note the large stone held back by the tree trunk

It is not clear what this structure was. It was built with large stones – much larger than stones used elsewhere to repair damage (see photograph above). It is big enough to be part of a bridge, but no corresponding structure could be seen across the stream (although it could be concealed in the undergrowth). It might be a predecessor of the overflow described above.

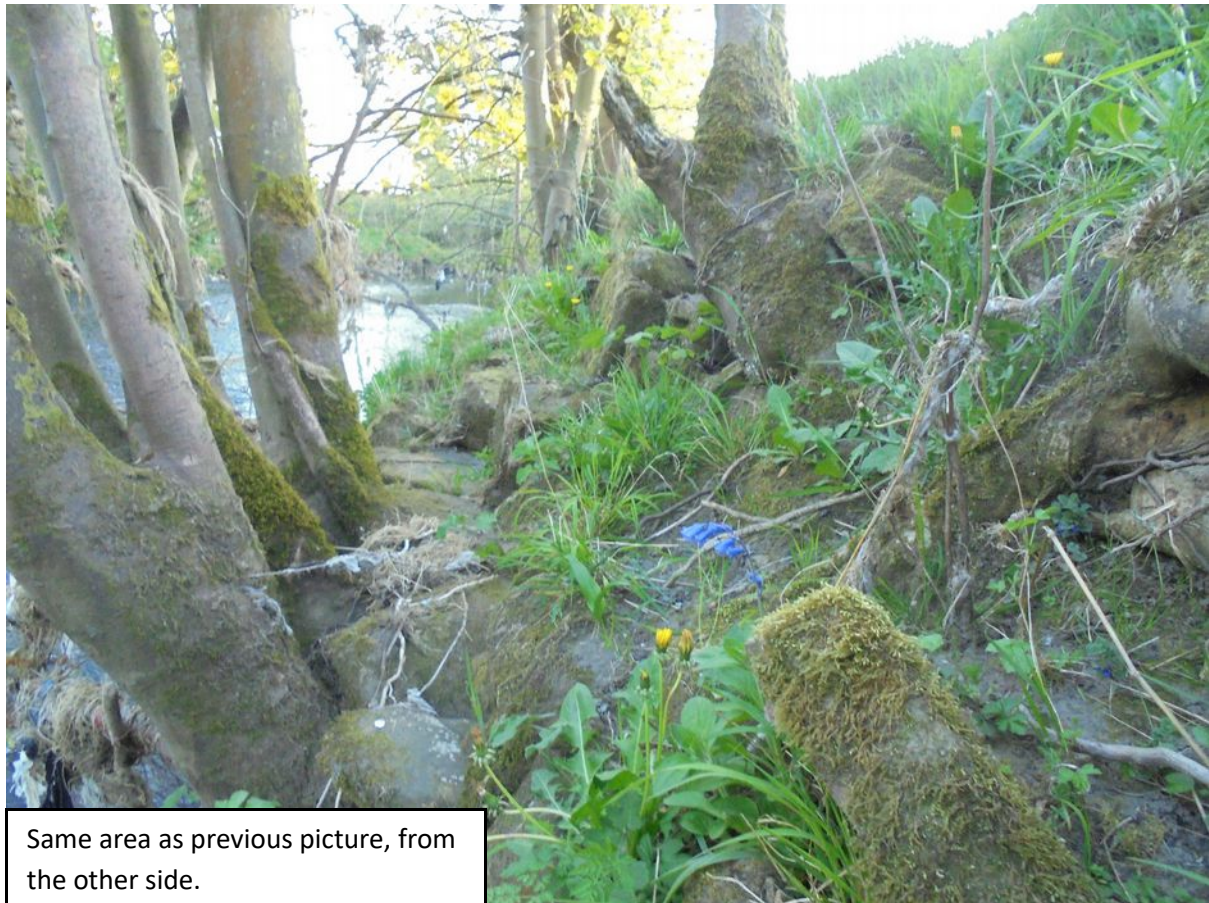
Same area as previous picture, from the other side.

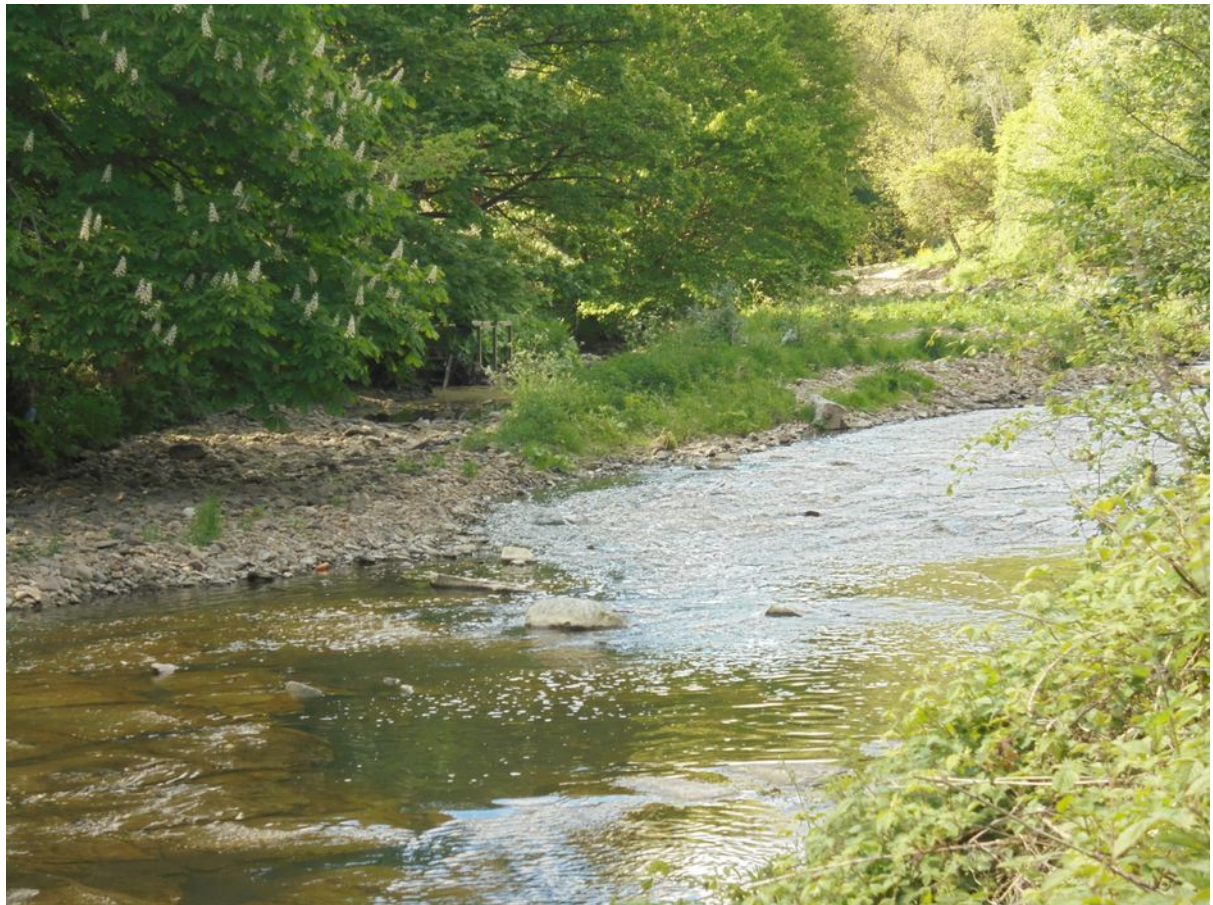
After the full lockdown it was attempted to locate the point where the water was abstracted from Pendle Water. It was not possible to get close, but the photograph shows remains of a stone embankment in the left-hand side of the river – looking upstream from Quaker Bridge.
