PENDLE ARCHAEOLOGY GROUP

Wycoller Landscape project

A Report on a survey of the barn at Bank House, Wycoller, Trawden

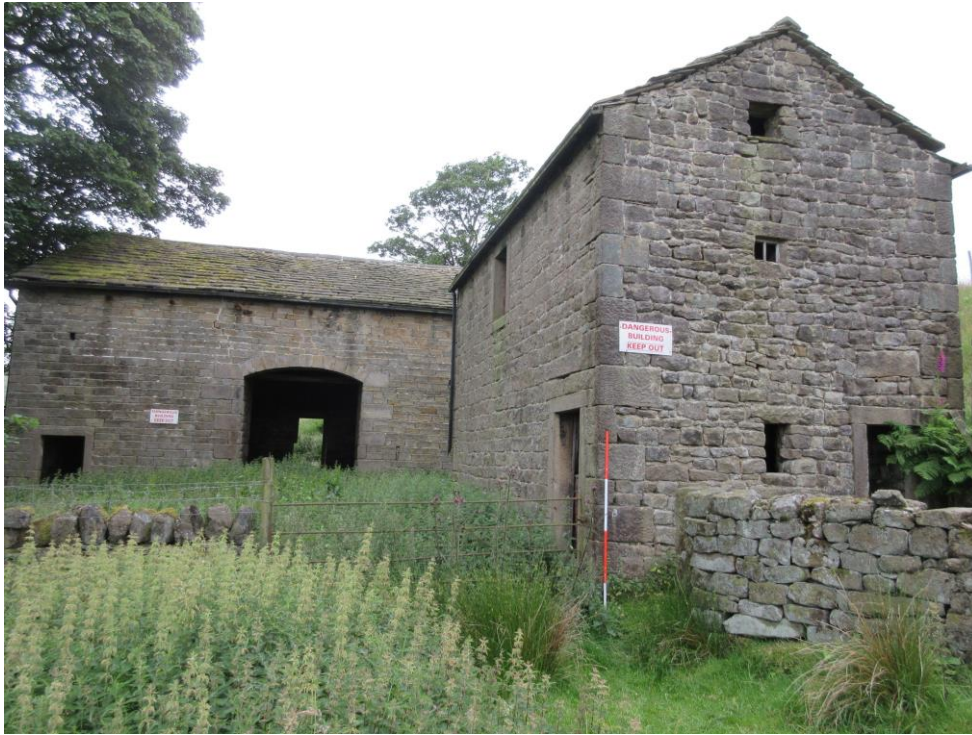
The four external walls are built of coursed watershot stone to a high standard. The inner face of the walling is of random stonework. All masonry is constructed with lime mortar. The external quoins are in dressed stone. The heads and jambs to the doorways are in dressed stone and stone thresholds are formed. Vents are placed at high level in the gable walls.

Pl.1 The barn and outbuilding from the north-west

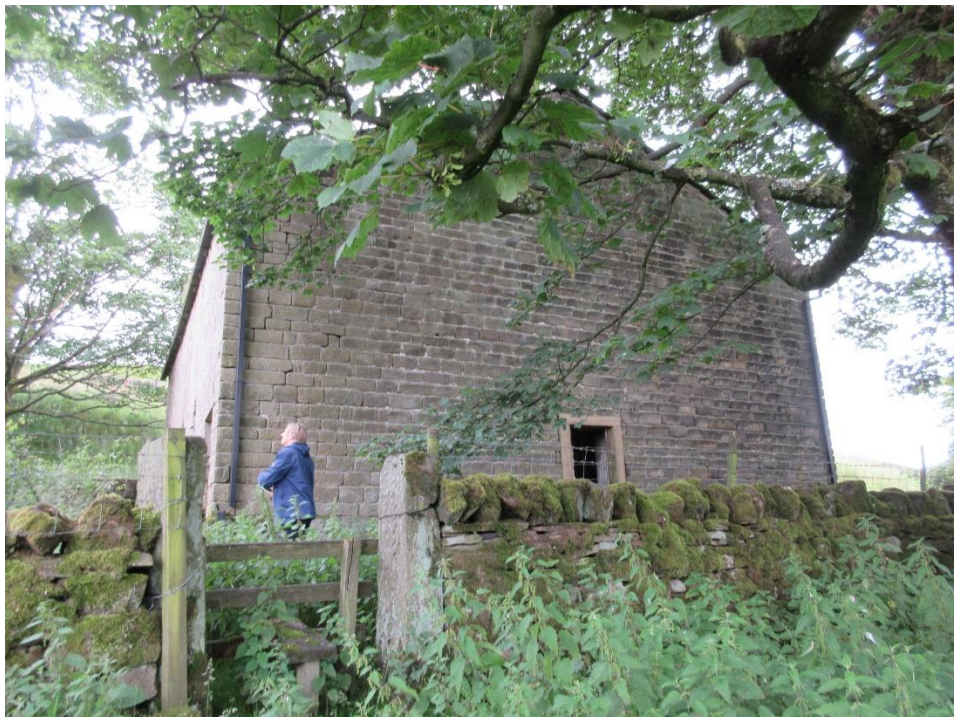
The masonry to the north-east gable walls is stepped twice at its lower courses. It was not possible to see if the south-west wall was constructed in a similar manner.

Pl. 2 The north-east gable wall

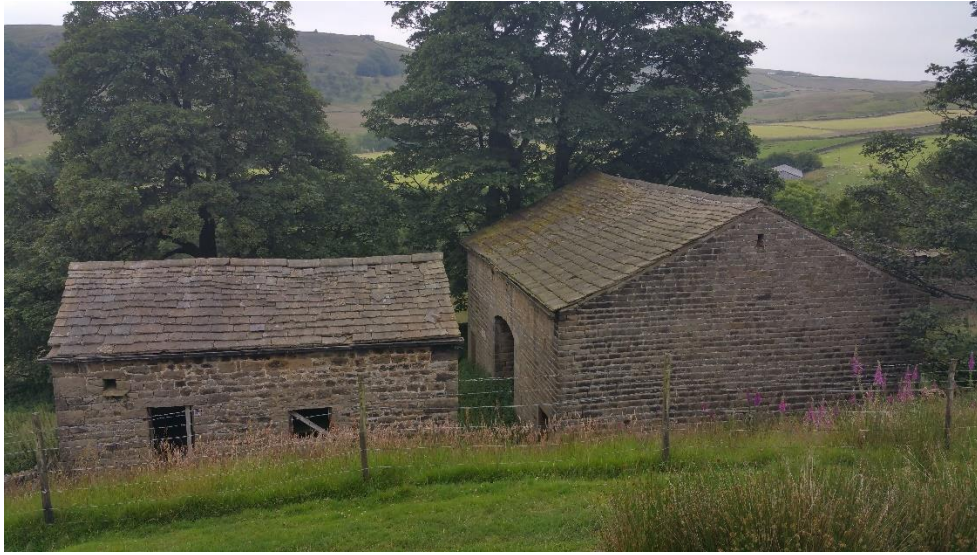
Pl. 3 The barn and outbuilding from the south-west

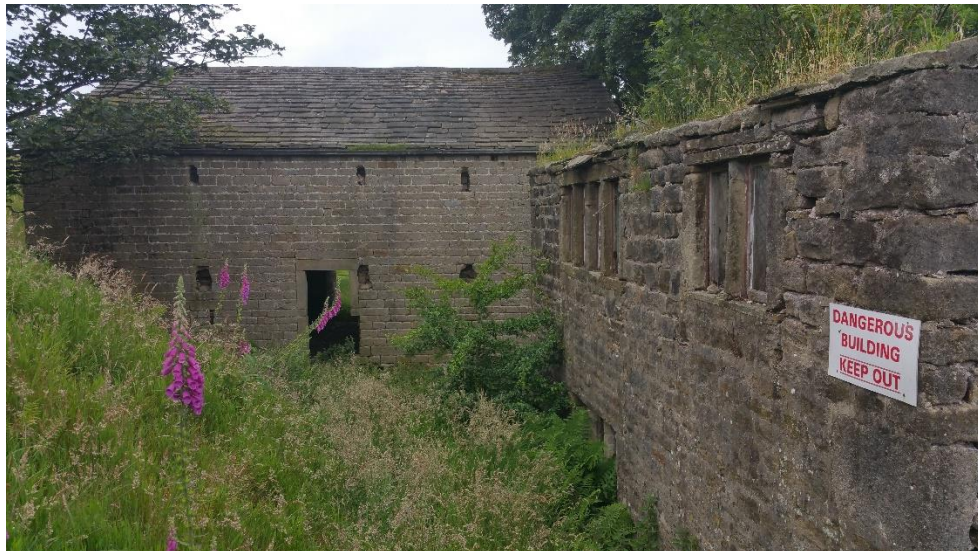
Other vents are placed in the side wall and gable walls. Evidence of recent damage has occurred to the south-east wall in six regular places where attempts have been used to remove masonry, probably surrounding the vents.

Pl. 4 The barn and cottage from the south-east

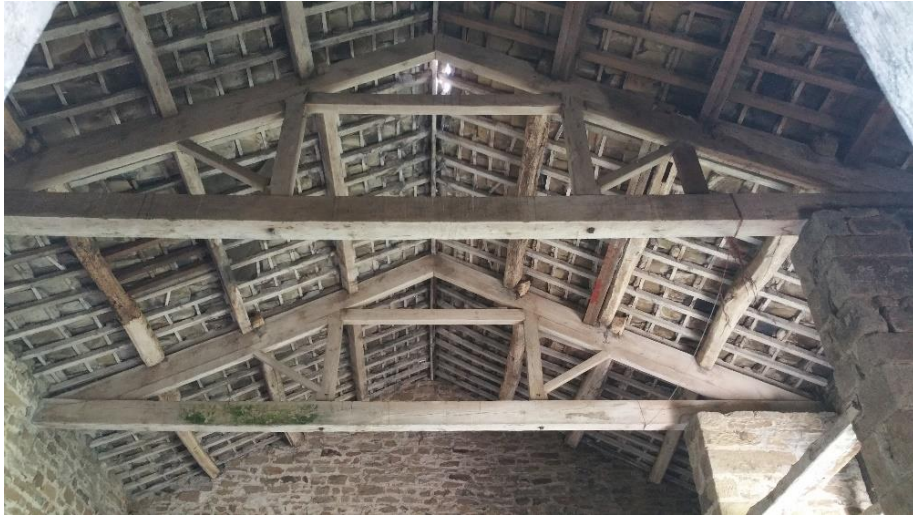
The roof is constructed of grey stone slates with a stone ridge set on sawn spars and purlins bearing on two equally spaced queen post trusses. Many of the purlins appear to have been reused, especially to the two south-west bays along with some rectangular sawn members. The trusses are of oak and made up of timbers of a substantial size. These timbers would not have been available locally and this would have required a considerable amount of effort in transporting them to site. Timber gutters are fixed at eaves level supported on curved wrought iron brackets to both elevations.

Pl. 5 The roof structure

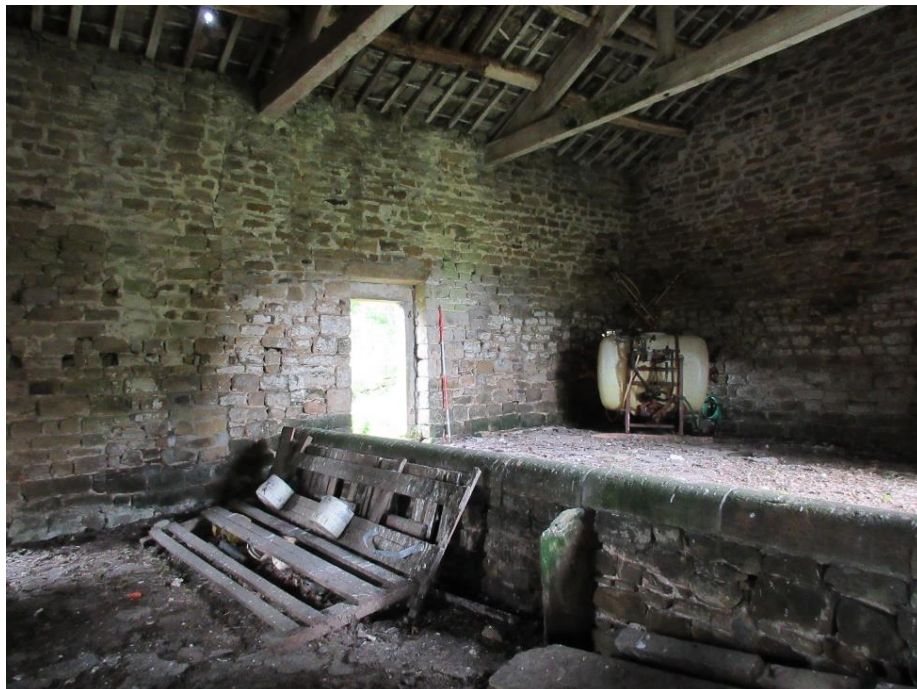
Cattle stalls were set out in the two outer bays with entrances set in the north-west elevation only (pl. 6 and 7). Unusually, a change in level of some 550mm occurred between the north

east bay and the two bays to the south west. Three risers have been formed adjacent to the south-east wall at the change in level. A dwarf wall with a rounded stone capping was built on the floor to the central bay at this point. A slot is cut in the wall adjacent to the barn doors. Hay lofts were formed over the cattle stalls to both end bays.

Pl.6 The interior showing cattle stalls and change in floor level
looking towards the south-east internal wall

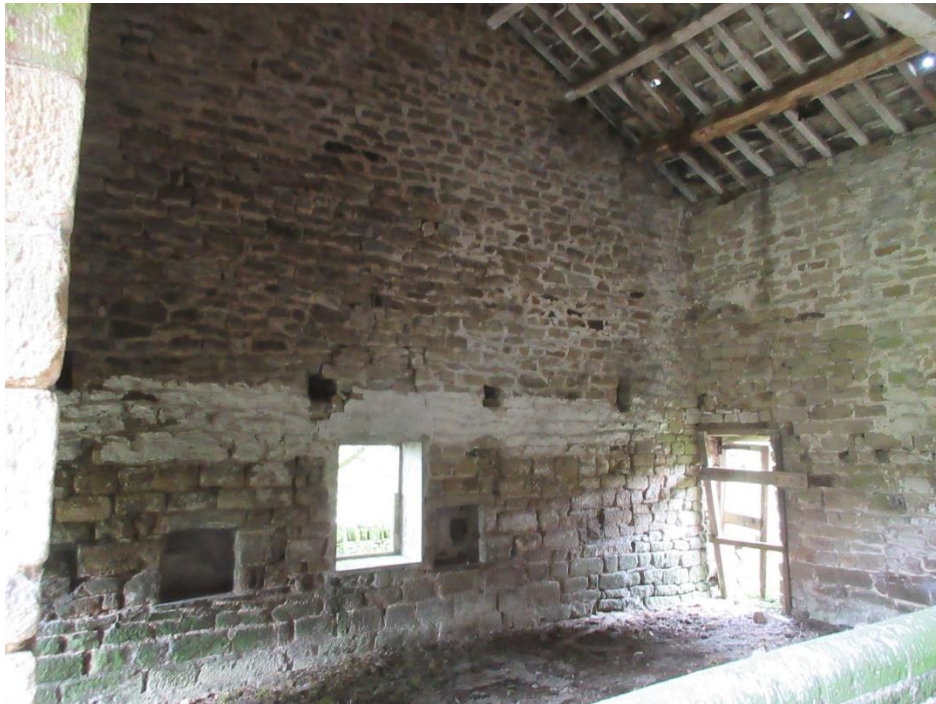
Two recesses are formed in the north east gable wall either side of a window, together with one in the south-west gable wall. These could have provided a shelf on which to place a lantern.

Pl. 7 The interior of the north-east gable wall, showing bearings for the hayloft over the cattle stalls and wall recesses

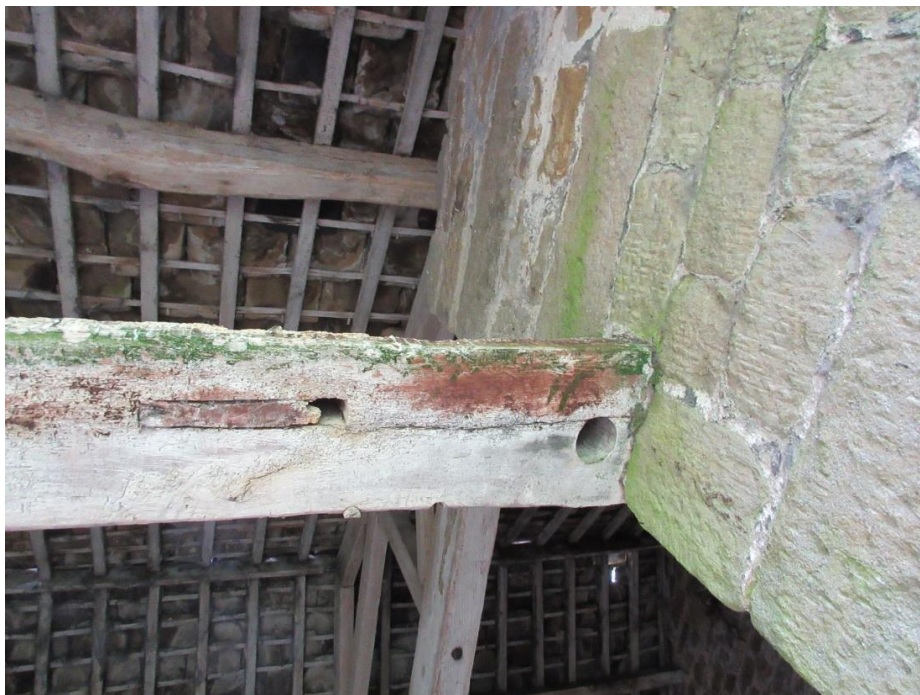
An oak beam is positioned over the barn doors with pivot holes evident to each leaf (Pl.8).

Pl. 8 Beam over barn doors showing socket for pivot

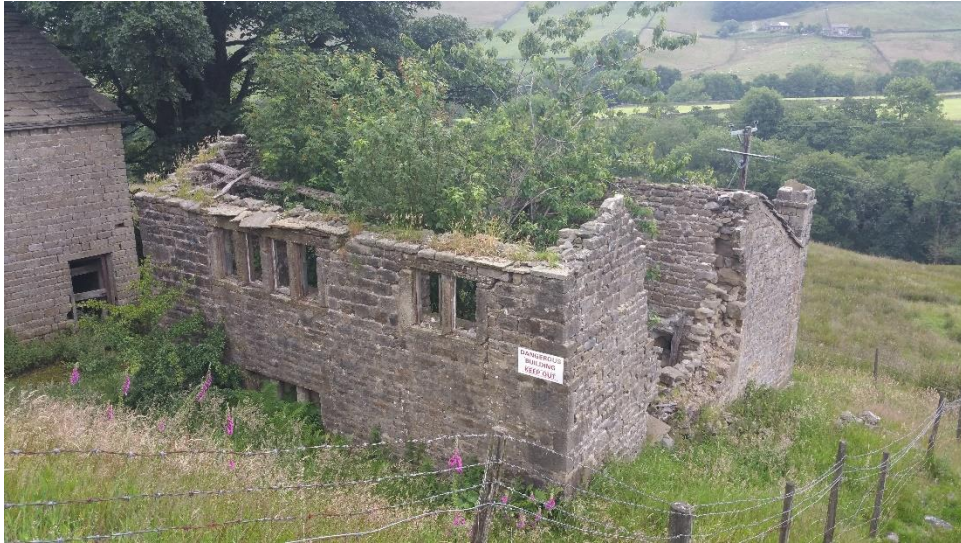
The buildings are set on a platform cut into the hillside with access to the first floor poultry house entered at ground level. Access to the barn is restricted to the north-west and there is limited space at the rear. The cottage is sited close to the rear wall and is not attached as shown on some OS maps (Pl.9).

Pl. 9 The cottage to the east of the barn. Note that there is a gap of several metres between the buildings

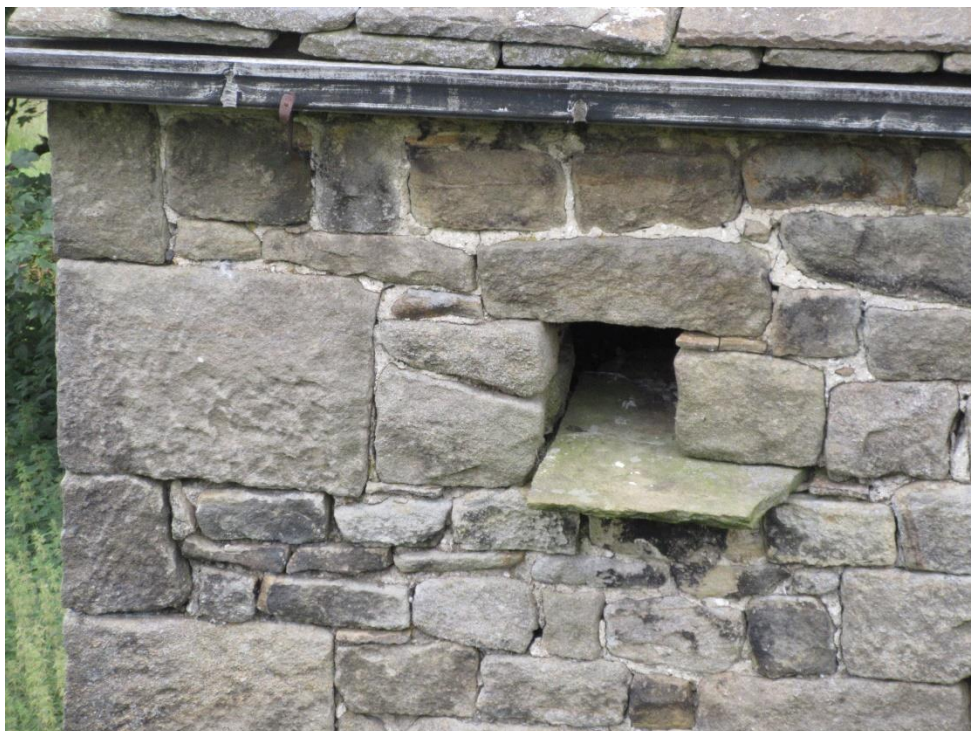
Pl.10 Detail of the entry to the pigeon loft to the outbuilding

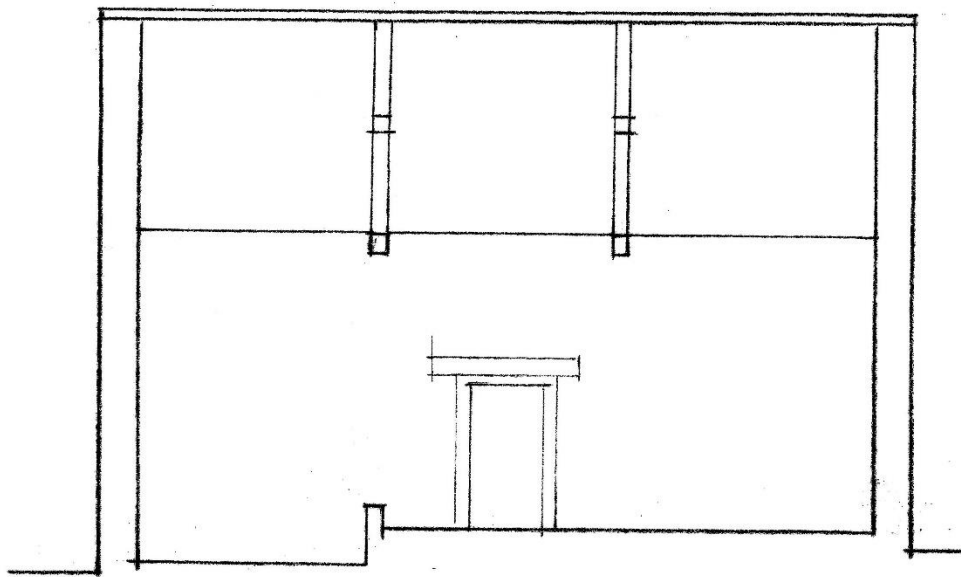
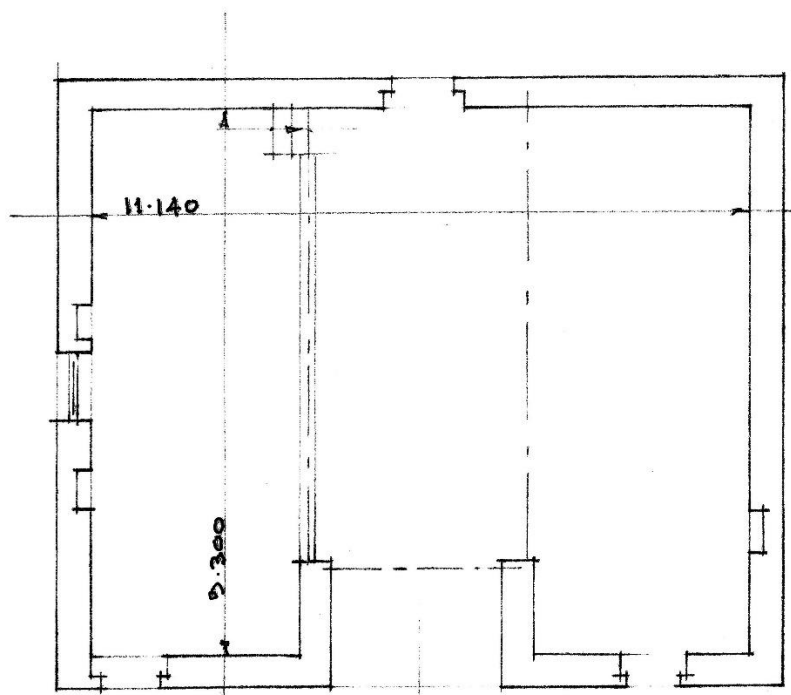
Fig. 1 Plan and section through the barn

The plan of the barn is a true rectangle measuring 11.140m (36.53ft) by 9.300m (30.51ft) internally. A wagon entrance is formed within the width of the central bay with internal flanking walls and inset doors facing north-west. A doorway is placed in the wall opposite to the barn doors
