PENDLE ARCHAEOLOGICAL GROUP

A summary report of two excavations at Burholme near Dunsop Bridge.

Site 1. An excavation of the site of the former chapel

Site 2. The excavation of a probable animal enclosure

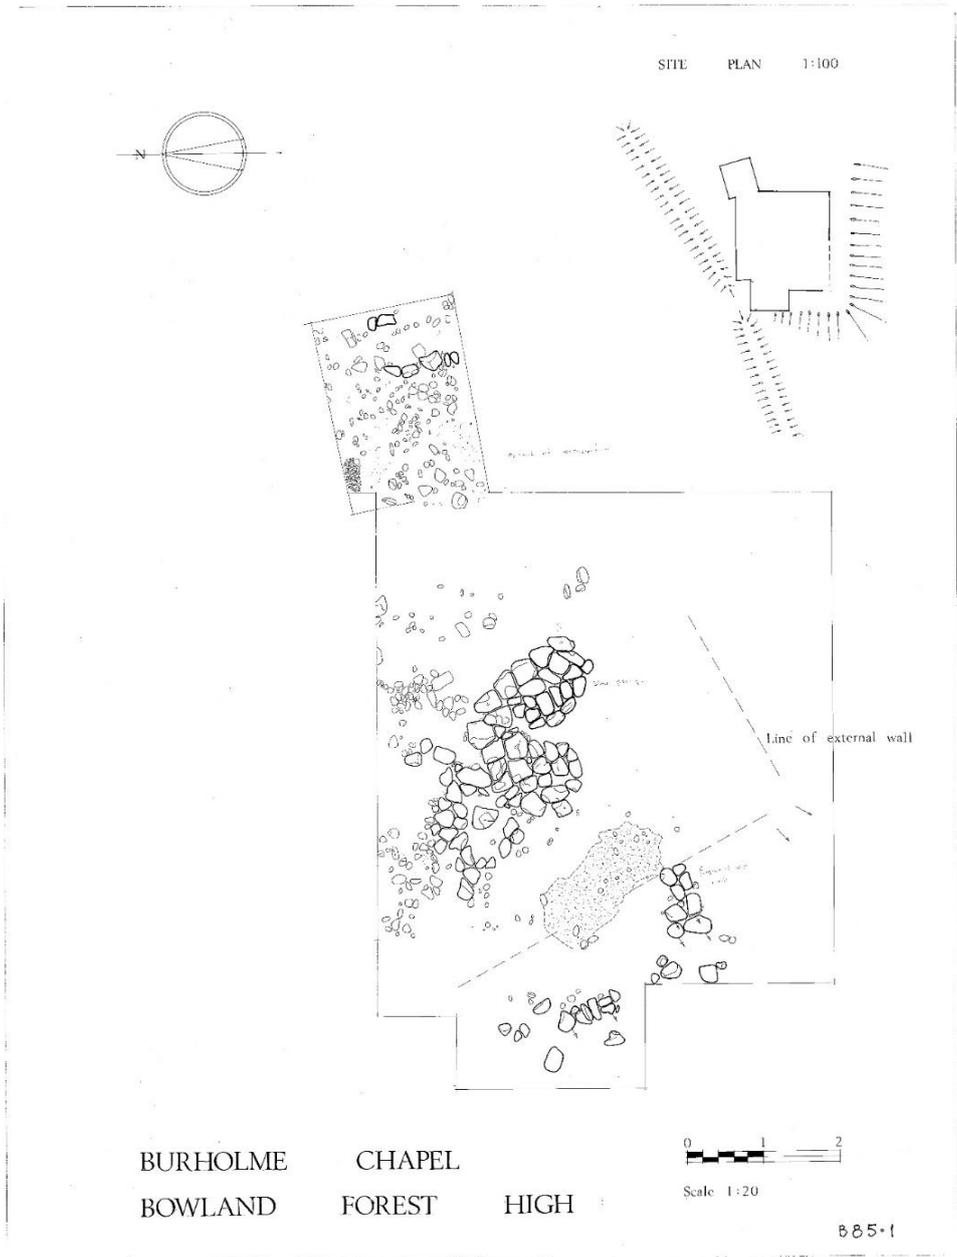
South end of chapel, drawing. B85.1

An excavation took place in September 1985 (dwg. B85.1). The purpose of this excavation was to re-examine and record the site of Burholme Chapel previously excavated by Father White in 1948. No traces of the former excavation were seen. The site is situated at the easternmost end of a spur of land situated between Fielding Clough and the holloway leading from Burholme to Newton. The building was sited on a clearly defined platform to the south of a field boundary. A short distance to the east the spur was supported by a stone wall, at the bottom of which was a stream. There was a level portion of land forming the tip of the platform to the south east. The area to the south is described as `the orchard` and has been for many generations. There are several platforms in this area. A former metalled track ran to the south of the site. This terminated at the building and ran to the west.

The `ghost` of a wall to the west and south was seen when the surface was freshly trowelled. This shadowing only lasted a matter of minutes until the surface dried out and would be seen as the foundation to the wall. The shadowing was lighter to the inside of the building. An extension trench was opened up at the centre of the east side of the site. Traces of stone set in clay were seen which could indicate the foundation of the east wall. The sub floor at this point was made up of clay and small pebbles which contrasted with the sub floor elsewhere. The floor surface at the east of the site was approximately 300mm below present ground level.

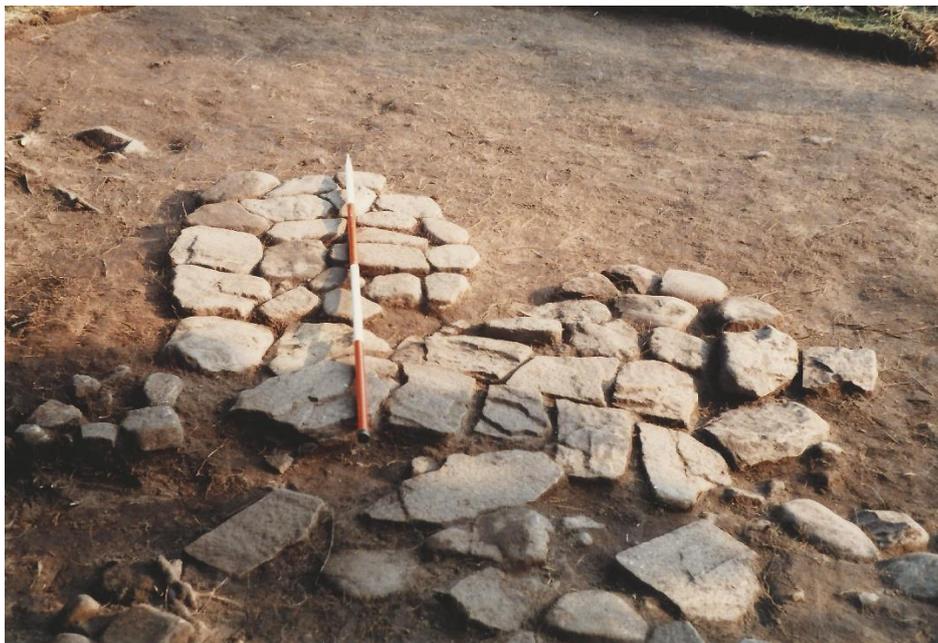
Area of paving to south end of chapel

An area of stone paving set on clay, approximately 2 by 3 metres was seen near the north wall. Many of the paving stones were water worn. The paving had been laid on the axis of the side walls of the building and this was evident in the direction of the joints.

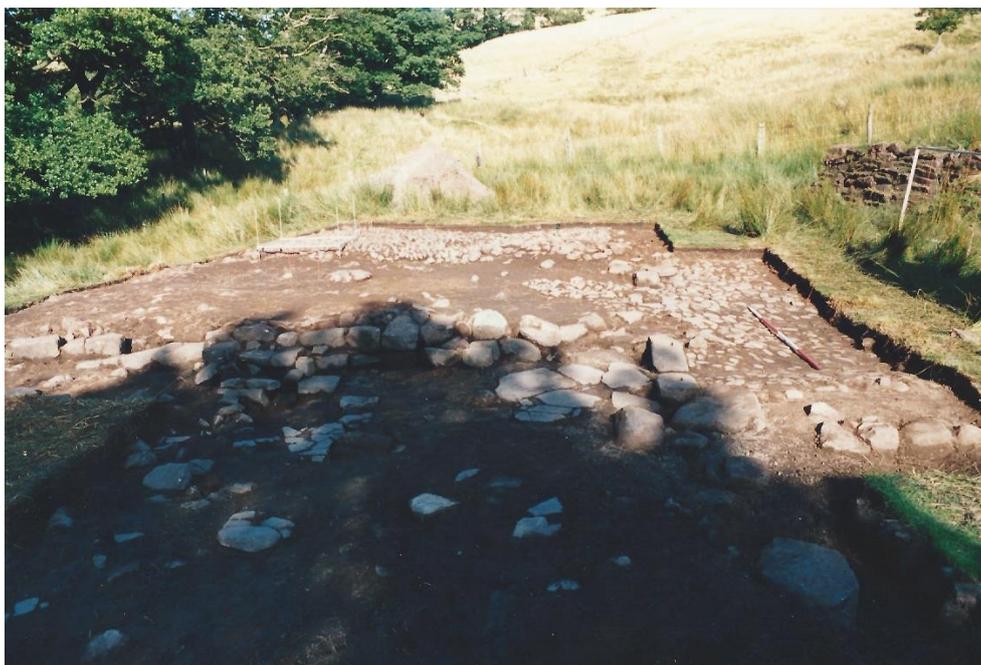
The east end of the chapel and the area beyond

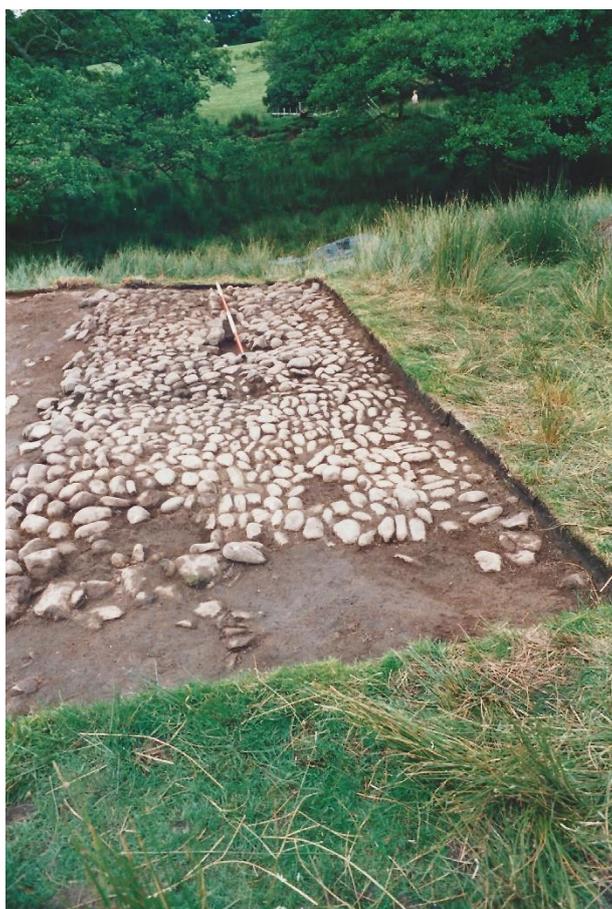
The cobbled area of the barn at the rear of the site

The regular area of cobbles to the east of the site suggests that it related to a former agricultural building with the external walls having been completely robbed out. There was no obvious evidence of any external walling.

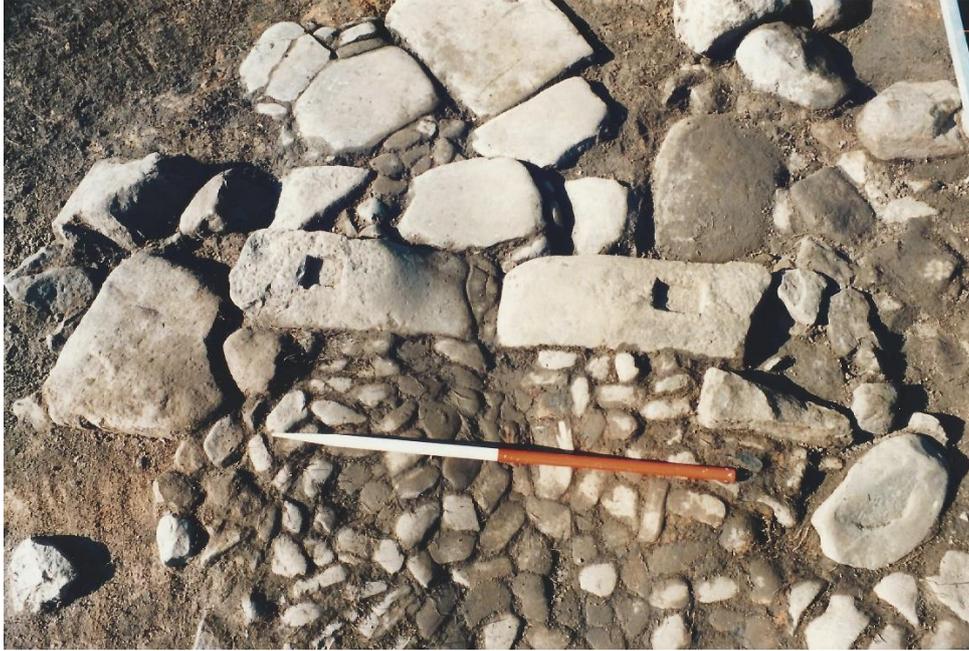
The threshold to the doorway at the south-east corner from the outside

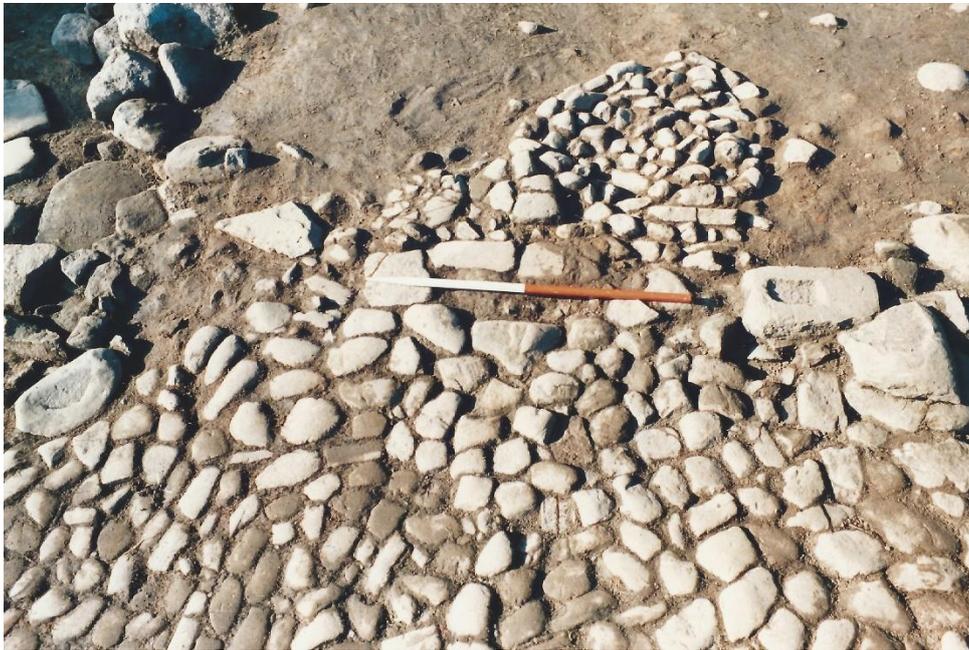
Cobbles to north of east wall on the line of the south wall

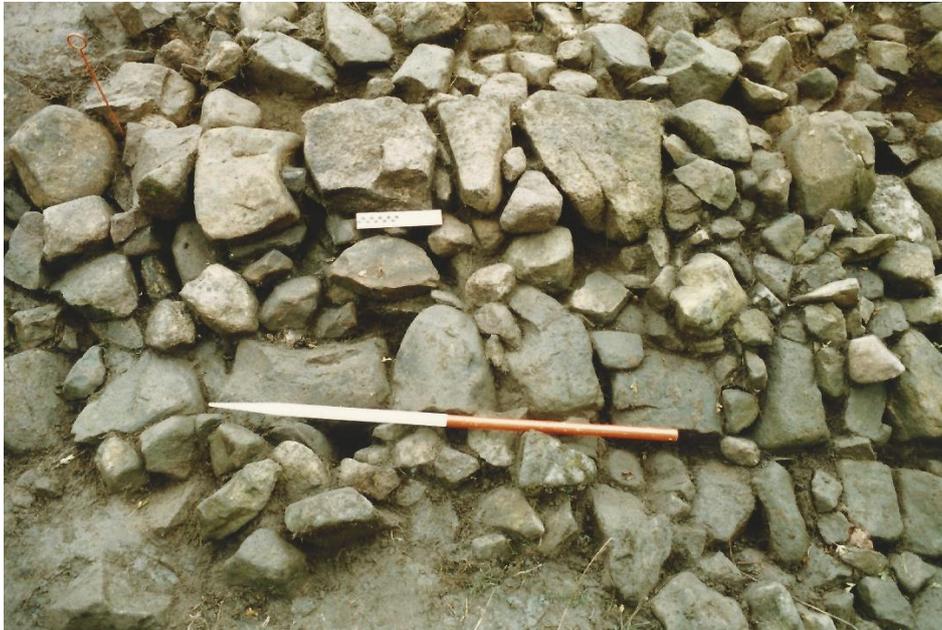
Detail of the walling

The form of the enclosure being a sub-decagon is unusual as is the high quality of the masonry. This could have been mortared due to the presence of mortar on site. The character of the masonry is similar to that of the adjacent chapel, which suggests that they could be contemporary.
