PENDLE ARCHAEOLOGICAL GROUP

Notes on a probable

Roman Road from Barnoldswick to Long Preston

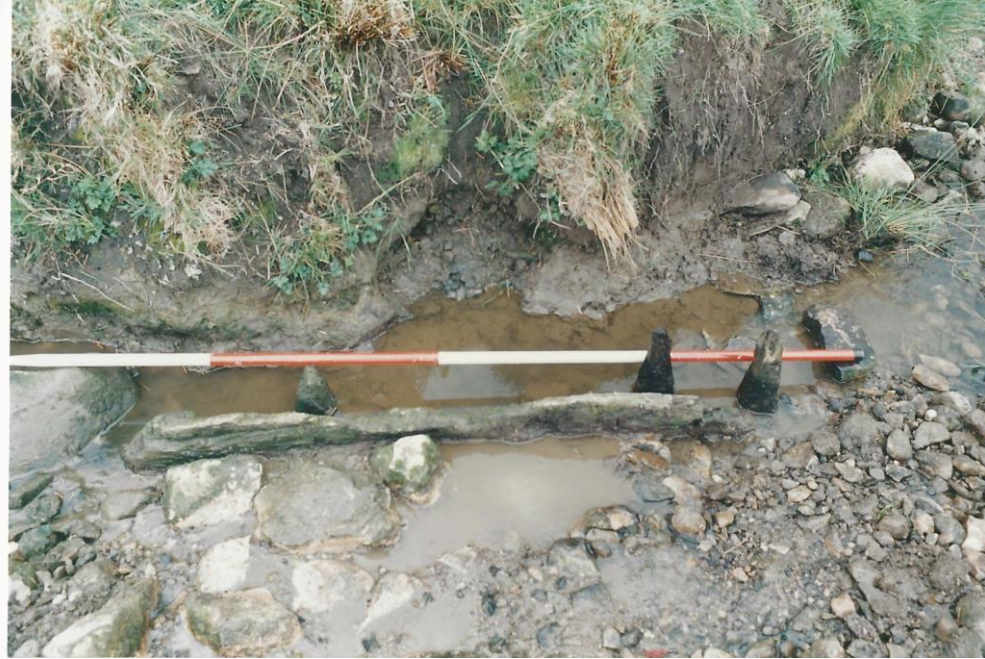
Timberwork in the stream bed at Horton Beck.

Following flooding in the winter of 1989, a portion of the bank to the beck was brought down to expose three stunted posts driven into a stream bed and a plank resting alongside. It was thought that these timbers could possibly form a simple bridge abutment for the stream as they were on the alignment of the road. Samples of a post and a portion of the plank were sent to Sheffield University for dendro-chronological dating, but unfortunately no result could be obtained due to the minimum number of rings not being present; the timbers were identified as ash. It is possible when facing south, to make out a possible outline of the road in the exposed bank of the beck. However, such evidence should be treated with a certain amount of caution as subsequent deposits of alluvial gravel have been laid in such a way as to give the impression of a road surface. During excavation some 10 metres to the south of the beck possible evidence of the road was seen.

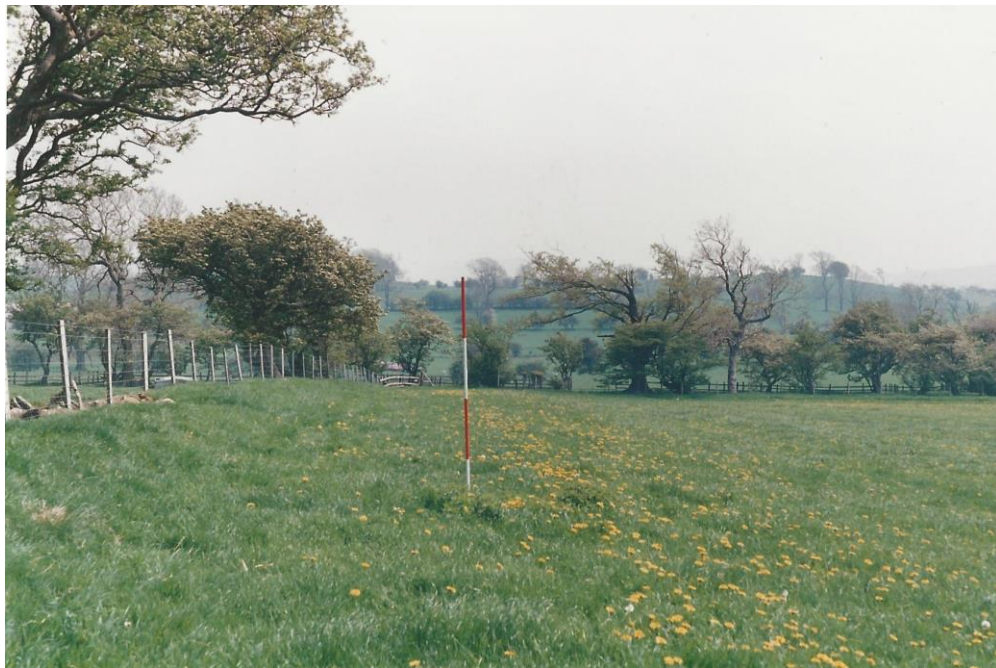
The road to the north of Horton Beck looking south, note how the flowers stop short of the edge of the road.

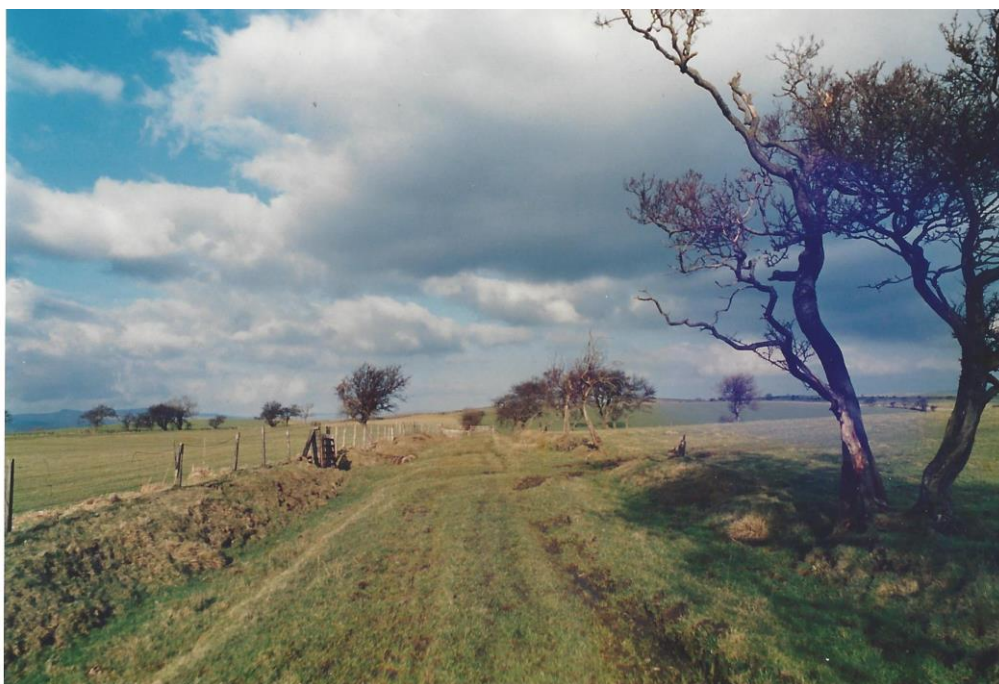
The road by Section 2 near Varley Field by Stoop Hill.

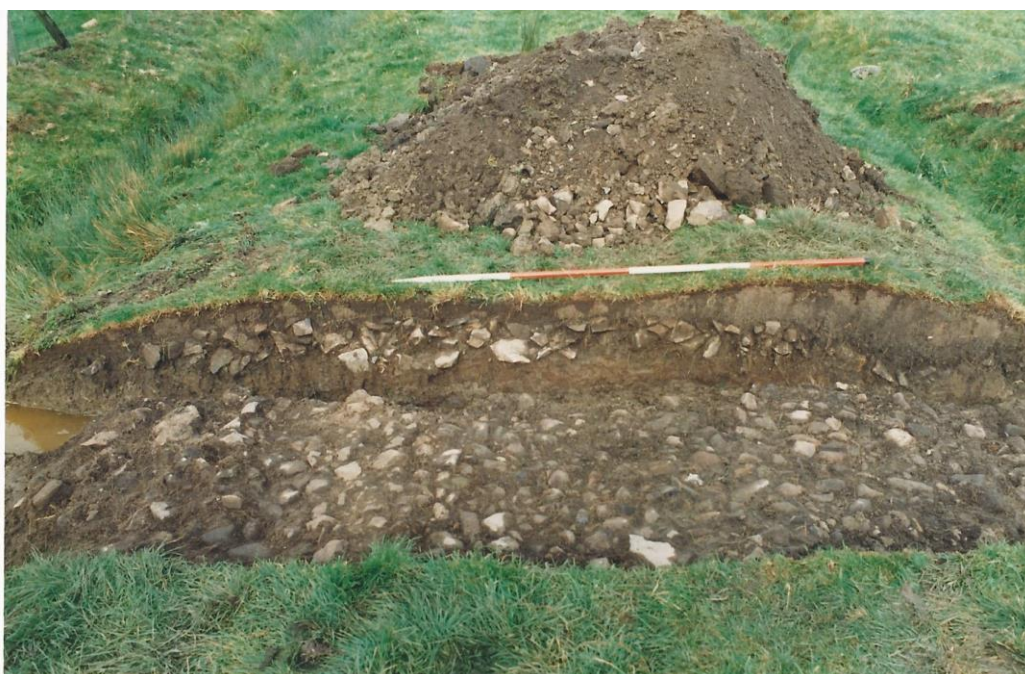
Section 2. Note the degree of camber.

This section was cut on a well-defined section of the road with the agger being very prominent. The construction of the road bed is of irregular limestone pieces and sandstone pebbles some 200 mm thick and on dense brown clay. From the make up of the road it would appear to have been extended to each side, the original width was approximately 3.800 m. There was no evidence seen of the original ditches, the present ones being of recent date. A dark blue melon bead was found in the road surface.

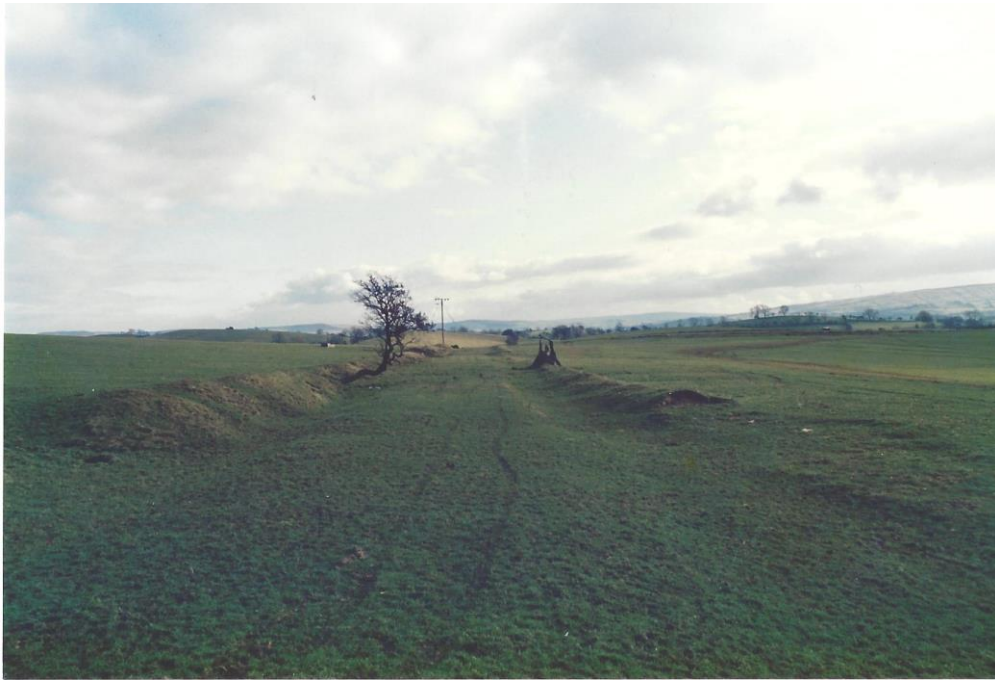
Road to the north of Varley Field.

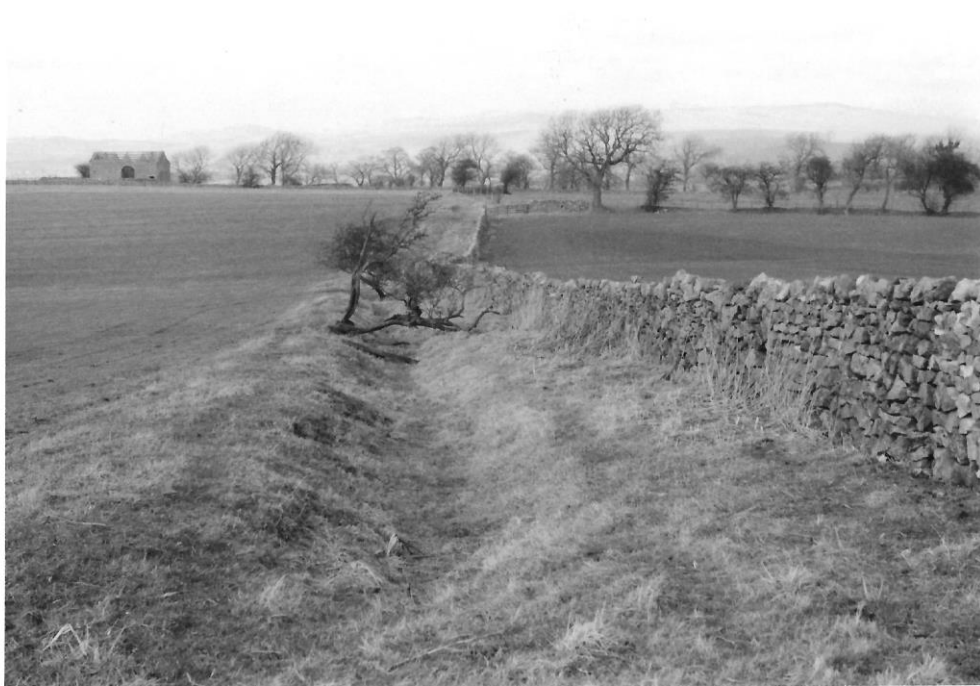
The road to the east of Nappa looking to the north.

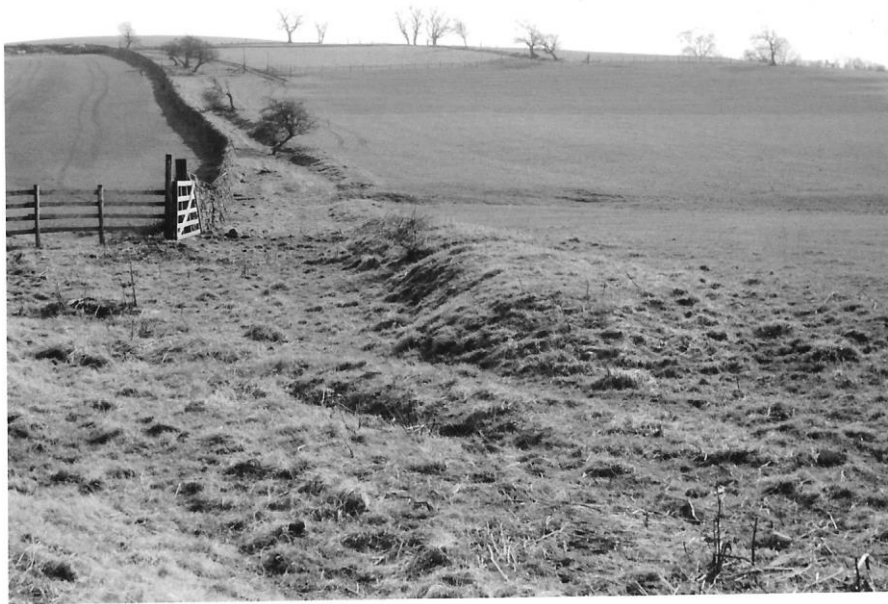
The road to the east of Nappa looking to the south

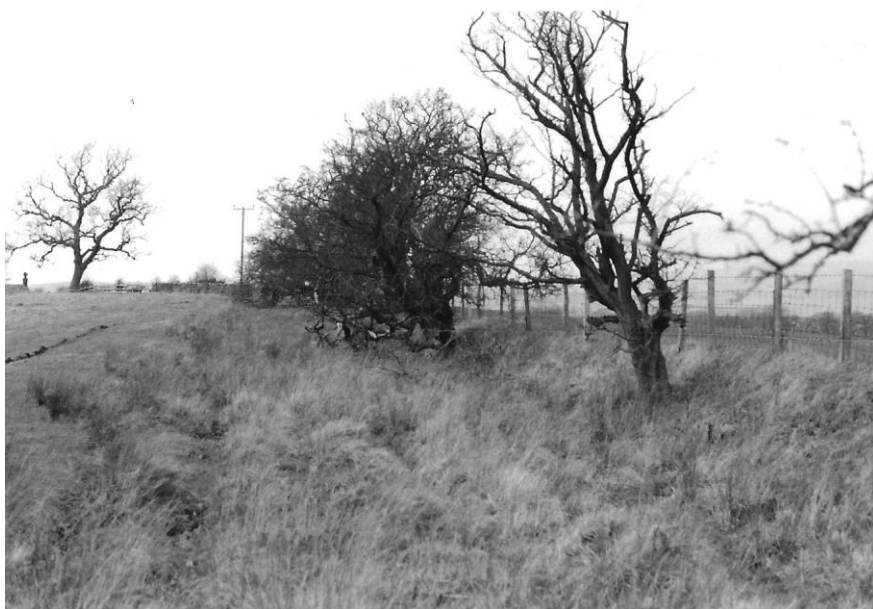
The road at Goosemire Height.

The section between Swinden and Goosemire Height is well defined with an agger and is sunk approximately 300 mm below the surrounding ground with a parallel bank to each side. This is described by Gregory¹ who thought that there was a 'Roman camp' at Swinden. It is significant that this section of the road is built off an outcrop of limestone, which had been levelled to take the road base,
