Wycoller Country Park Landscape Project

A Report on a Survey of Bracken Hill Barn, Wycoller

A Report on a survey of the Barn at Bracken Hill, Wycoller

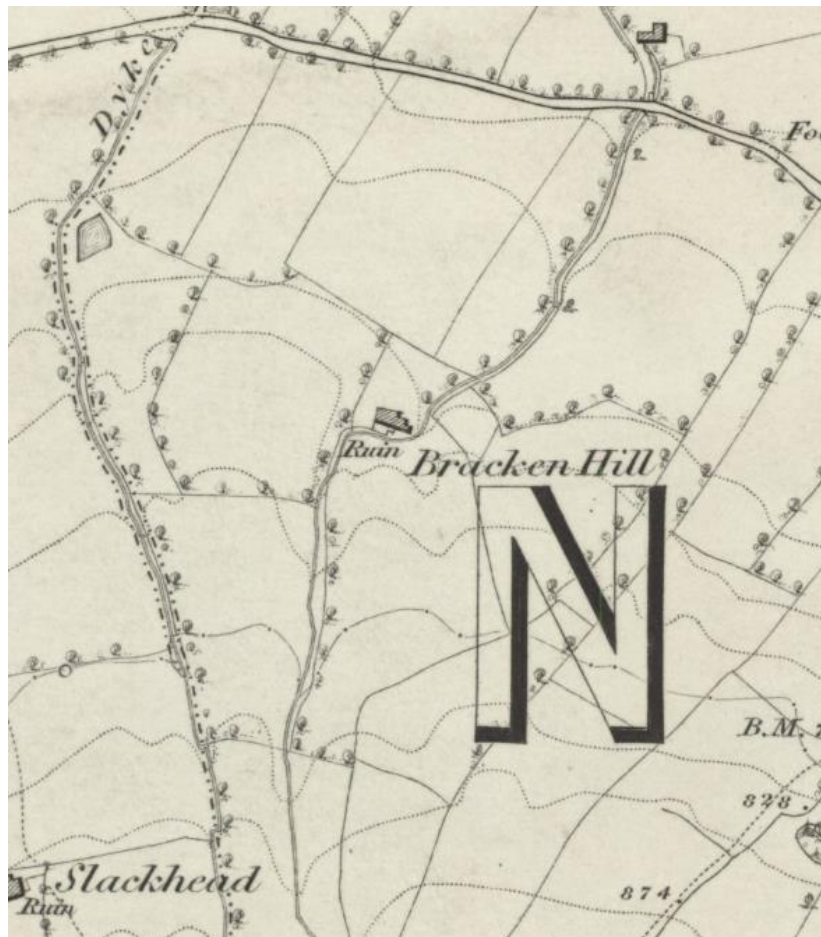
1st edition OS map 1848 (six inches to a mile)

The barn and the attached farmhouse with the primary extension to the east are shown in plan to match the existing. There is also a small extension built on to the eastern wall of the farmhouse which is probably a cottage. The projecting barn doors are not shown

The building is described as 'ruin'. There appears to be a narrow enclosure wall to the south elevation of the barn, which may have been a lean-to shorn of its roof. No access roads, tracks or footpaths are shown relating to the building. Trees are shown to field boundaries. As the building is shown without a reference to it being a ruin on subsequent OS maps, the implication is that substantial repairs would have been carried out sometime after 1848. However, importantly it shows that the building was unoccupied almost certainly due to the drift of people to the nearby towns at the onset of the Industrial Revolution.

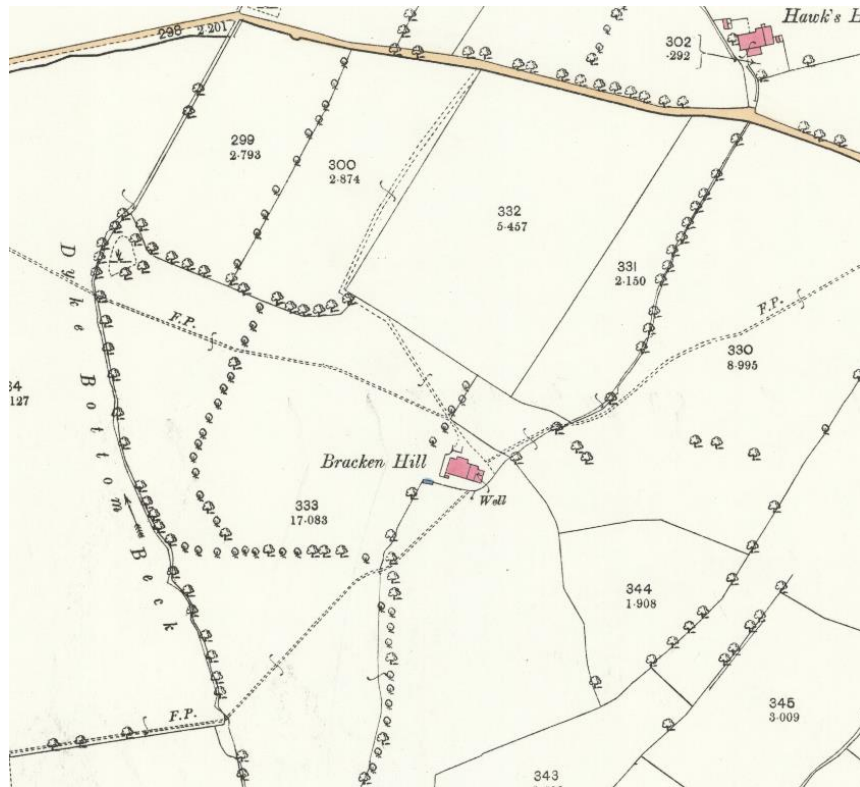
OS map 1893, scale 1:2500

This map shows the same outline to a larger scale but the small extension to the east of the farmhouse has been squared off to form an extension to the farmhouse around the cottage. Surviving windows to the building suggest that the farmhouse was used partly for wool or worsted weaving. The small cottage was probably for a farm worker. Some pigsties are shown by the entrance into the farmyard. The projecting barn doors are indicated. A well is indicated within the farmhouse/cottage. Trees are shown in the field boundaries around the farm. An access road is shown from the unclassified road into the village and three footpaths are indicated running up to the building.

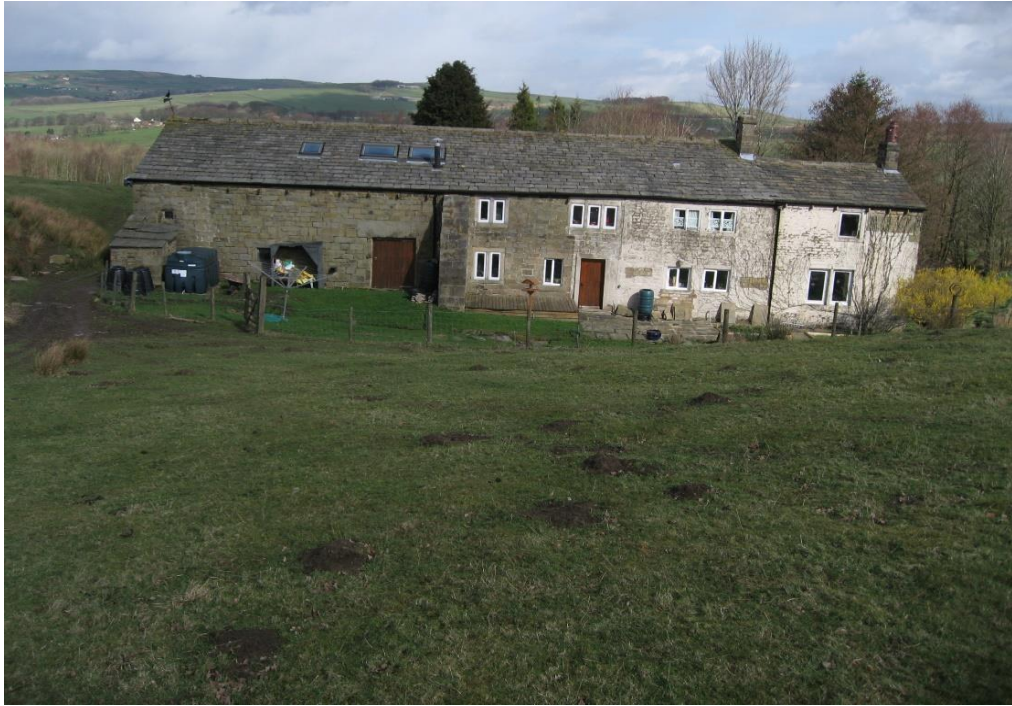
Pl. 1 South Elevation showing farmhouse and former cottage to the right..

The barn is of five bays and is built of coursed, squared stonework with a roof of grey slate sat on purlins and king post trusses (pl. 1 and 2). At a later date a farmhouse with a first floor three light south facing window was inserted into the eastern bay of the barn. This adjoined an eastern extension, which also contained a small cottage on the south elevation. It is not known if the extension and the accommodation in the barn formed one or two dwellings. This is shown on the 1848 six inch OS map and is detailed on the 1893 1:2500 OS map. The roof to the barn was almost certainly raised at this time. A second phase involved a further extension to the east and the reorganisation of the dwellings into one farmhouse, this is detailed on the 1912 1:2500 OS map. In recent times the farmhouse has been extended into the barn to occupy the eastern two bays. At present the building and farmhouse are not used for agricultural purposes.

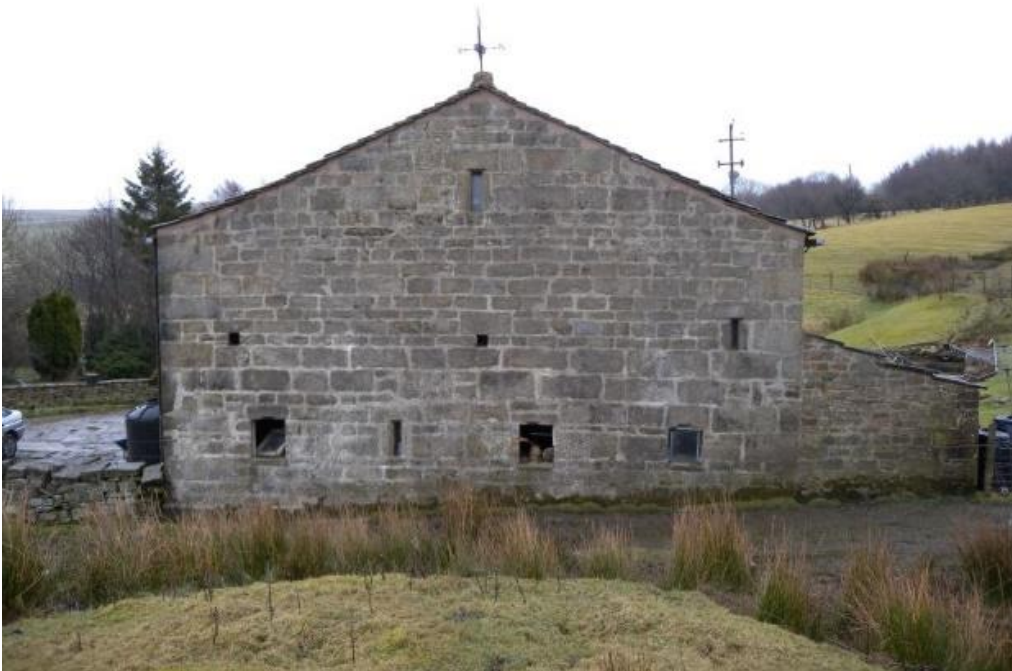
Pl. 2 West elevation, note differing depths of stone courses.

The external walls to the barn were built of high-quality squared, coursed masonry of differing depths. Several courses in the lower half of the west gable wall and at high level are exceptionally deep. The facing stones were dressed to an even face and some tooling was visible; this is clearly visible to the western section of the south wall. Large quoins with a picked finish are built into the external angles. The internal face of the wall was similarly finished. The inner and outer leafs of stonework do not appear to have been tied

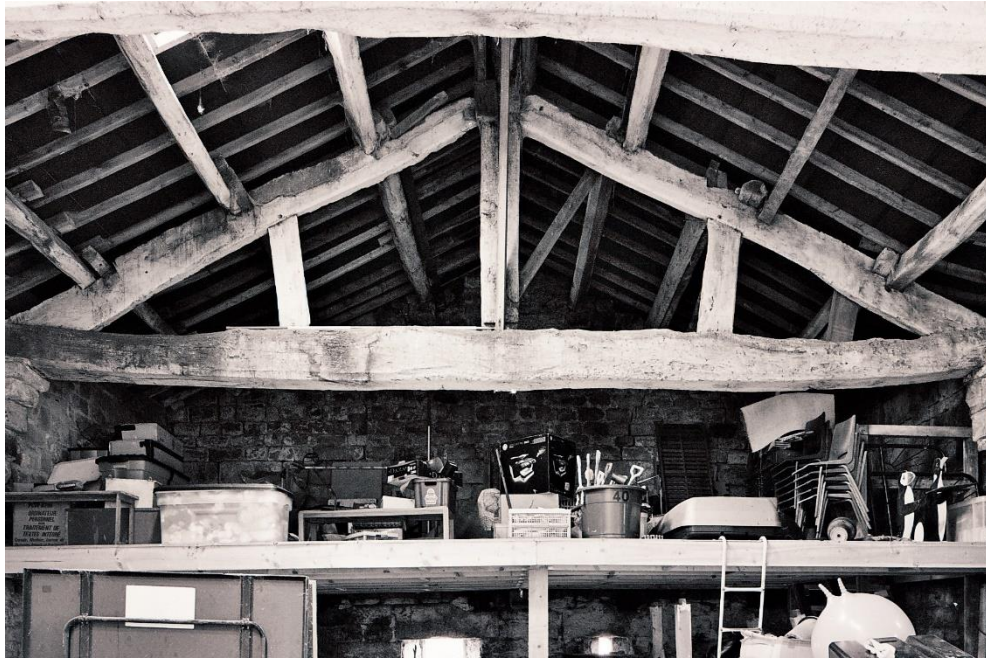
Pl. 3 Detail of roof truss

The roof over the barn and adjacent farmhouse is continuous and covered in grey slate with stone ridges. The bases of two much eroded finials are positioned over the two gable walls to the barn. The spars are underdrawn so their size and description is unknown. These bear on three purlins set on each side of the principal rafter of a truss. Four trusses are placed within the barn constructed to a pitch of approximately 35 degrees. The two oak trusses to the extant barn are king post in form with two raked angle struts set to either side of the central post (pl. 3). The tie beam is chamfered on its lower edge with the king

post and braces chamfered on all edges complete with stop ends. The truss members are substantial with the tie averaging 485mm by 280mm and the king post 185mm by 123mm. The king post and braces are tenoned into the tie beam. The trusses are marked in many instances with carpenter's assembly marks, i.e. the westernmost truss is identified as IIII with the number identified numerically. Some of the timbers are suffering from an attack of woodworm and their surface appears to have been lime washed. The two trusses in the extant barn, with one exception, bear on corbels formed out of diminishing stepped courses of stone. The bearing of the truss closest to the north barn door rests on a timber block (possibly part of an earlier truss) set on a well-formed corbel. The two trusses to the east (within the portion of the house extended into the barn) are of oak. These are of a later date and do not have chamfered edges.

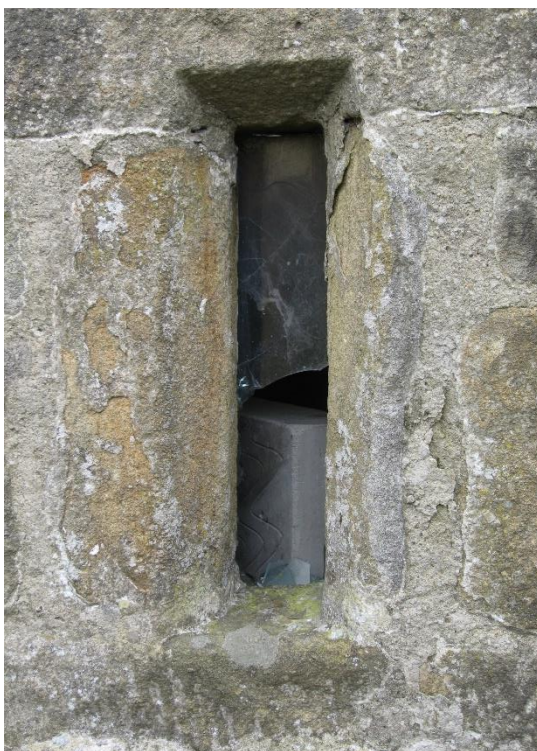
Pl. 5 Detail of vent to west elevation

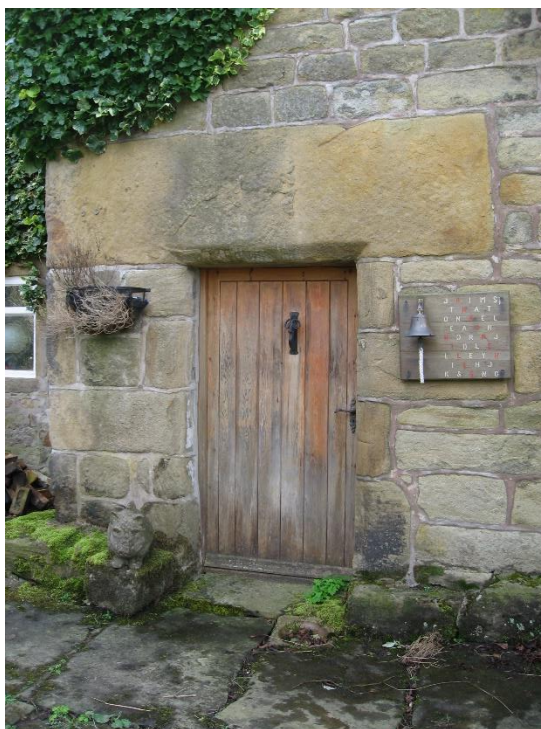
Pl. 6 Detail of side door to north elevation, note the size of the lintel

Doors with large monolithic stone lintels and chamfered heads and jambs gave access to the cattle stalls at the east and west ends of the north elevation. The lintels to the easternmost and westernmost doors on the north elevation formed a quoin to the corners of the barn (pl. 6). Two lintels are set over these and other openings bearing on the inner and outer leaves of masonry. An exceptionally large lintel is set over the south doorway into the barn (pl. 4), this doorway appears to have been widened. On the north elevation these openings flank a central projecting wagon door with projecting wing walls of 1.780 m to each side. The hanging stile to the wagon door at present is mounted on a pivot block at its foot and retained at its head. Corbel blocks are present to each side of the opening on which a course of masonry has been set so raising the height of the opening together with the roof. A single vent at high level in the north wall opens into the loft. Four vents were formed in the western gable wall at low level to the cattle stalls (pl. 5). One of these remains extant and is finely made being 590mm high and 220mm wide externally with splayed jambs and head and measuring 520mm and 110mm internally. The vent opening splays into the barn to a width of 650mm. The remaining three have been enlarged. Two small square vents and one larger rectangular one are formed in the gable wall at hayloft height. A larger vent, with internal splays, is formed on the line of the ridge at high level.

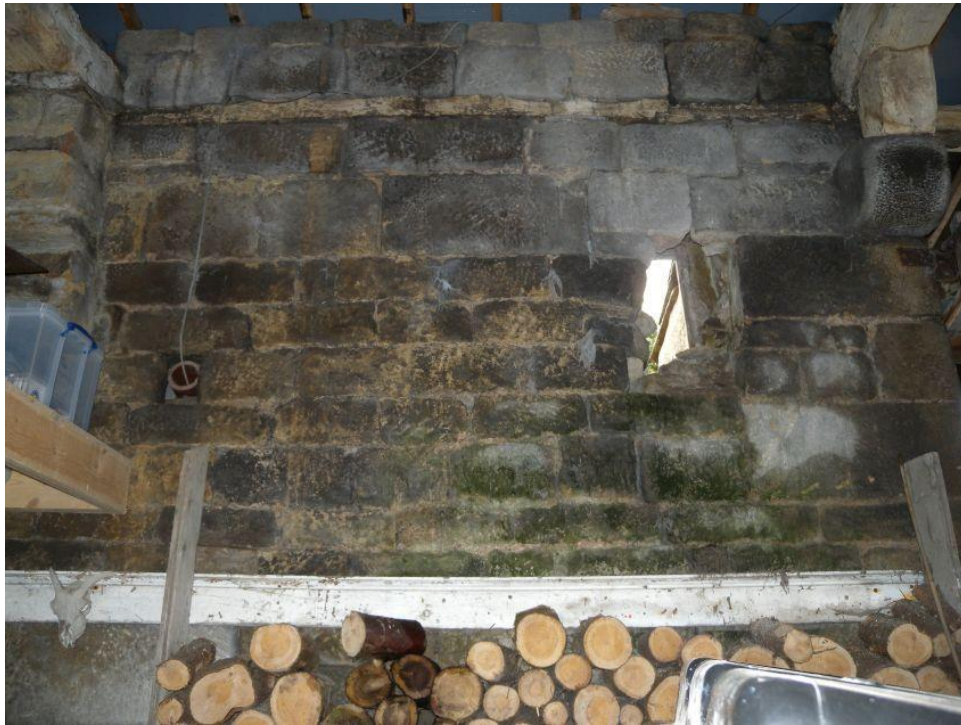
Pl. 7 North internal wall showing wall plate and projecting corbels.

From the evidence of the raising of the external walls it is almost certain that the original form of the trusses differed from those now extant (see appendix). The insertion of the present trusses would have involved the raising of the external walls by approximately 450 mm in order to accommodate the present arrangement of roof timbers. This is supported by evidence to the interior of the north wall where a wall plate can be seen positioned two courses below eaves level (pl. 7).

It would appear that when the roof was replaced with the present arrangement, the roof trusses were placed on the top of the existing walls (pl. 7). The external walls were then raised to cover the ends of the truss where they rested on the wall and to allow the spars to bear on the top of the external wall. These raised sections of walling can clearly be seen internally and externally at both barns. The primary roof form would appear not to have incorporated a tie beam placed at the bottom of the principal rafters with these rafters bearing on a shaped bottom member bearing on the corbels. This member could have been adjusted in height to take up any variation in levels. A tie would then have been placed at around first purlin height with a possible additional set tie higher up.

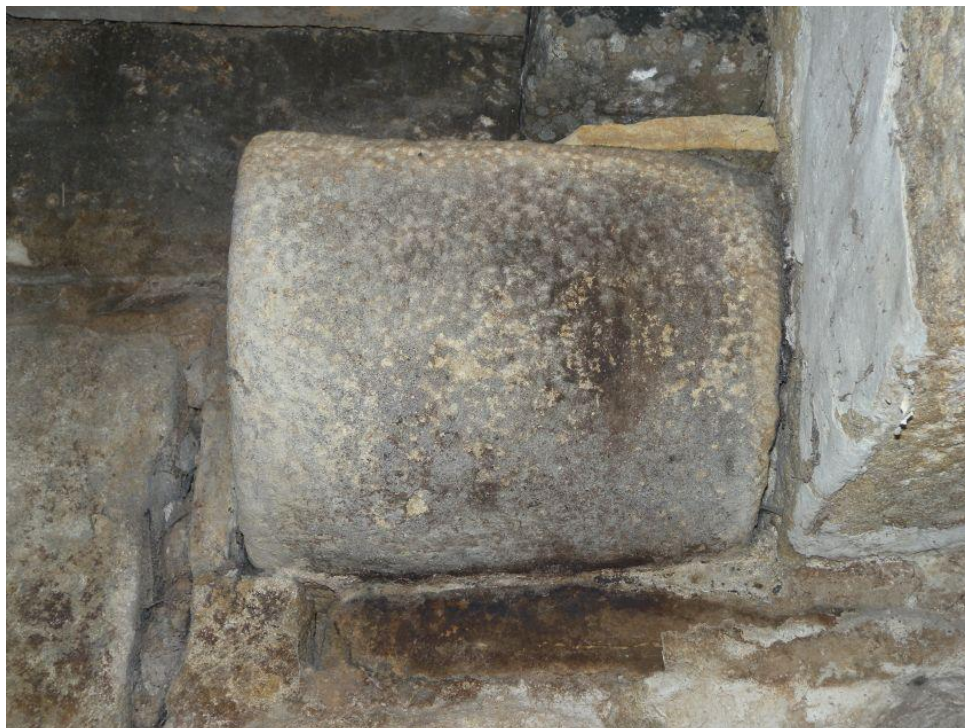
Pl. 8 Corbel detail showing picked finish

Unusually the external walls of the building are constructed in coursed squared masonry with a roughly dressed face and tooling evident in certain areas. The coursing both internally and externally is of random depth which averages 200mm in depth. However, several courses to the west elevation are built of large squared masonry some 360mm in depth. This quality and size of masonry is unusual and is matched by similar stonework at Parson Lee barn where it can be seen at high level on the south elevation. The size of the lintels to the door openings is very large being much larger than required to span the opening; that of the external lintel to the door to the centre bay in the south elevation is 650mm deep by 2 630mm long by 300mm wide. The weight of these is considerable with the estimated weight of the lintel to span the latter being in excess of a ton. Such a size of lintel would require the use of a hoist of some form to place it in position. The high quality, consistency and finish of the corbels suggests that these are reused from another building (pl. 8).

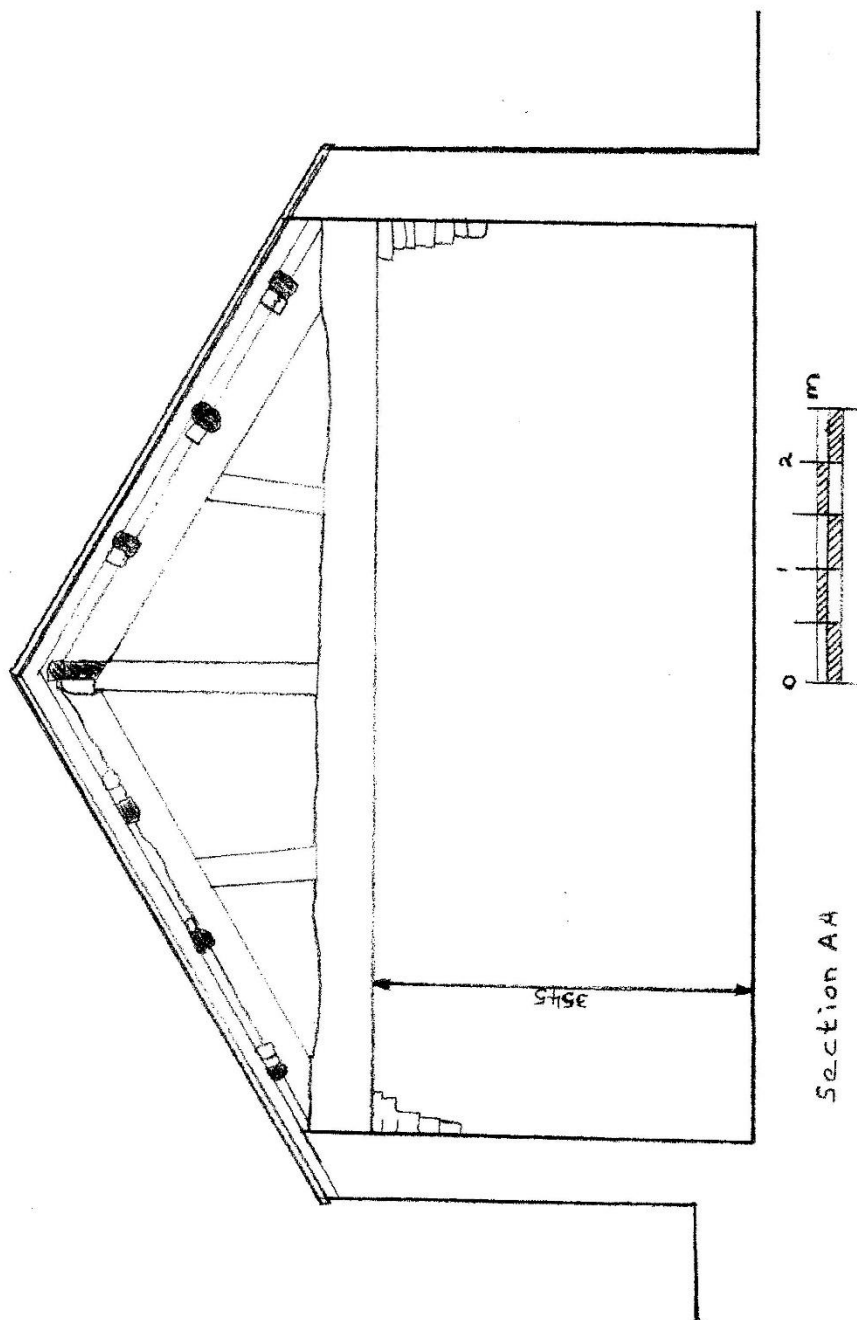
Fig. 2

Bracken Hill Barn Wycoller Scale 1:50

The Roof (Fig. 2)
