Wycoller Landscape Project

A Report on a survey of the barn at Copy House Farm Wycoller

A Report on the Barn at Copy House, Wycoller

- Record no. – AB.03
- Location – Copy House Barn, Wycoller
- NGR – 9330 3890
- Altitude – 230m
- Orientation of barn doors – flush wagon entrance faces north
- Listing – unlisted
- Date of Survey – 20th April 2013

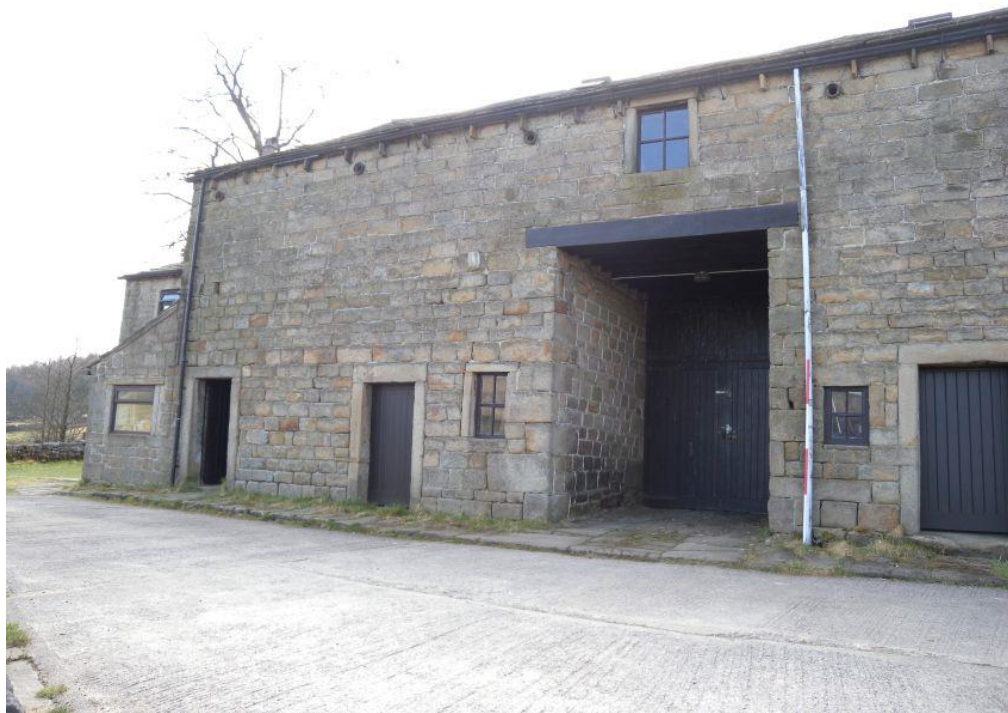
Pl. 1 North elevation (eastern Section)

The north facing wall is 520mm thick and is built of watershot masonry. A clear break in the phasing of the wall can be seen midway up this elevation. Two doors leading to the shippon are positioned at each end of the elevation with substantial lintels over the openings. Two windows at low level and one central pitching hole (now window) at high level all with square jambs and heads were formed as part of the final phase of construction.

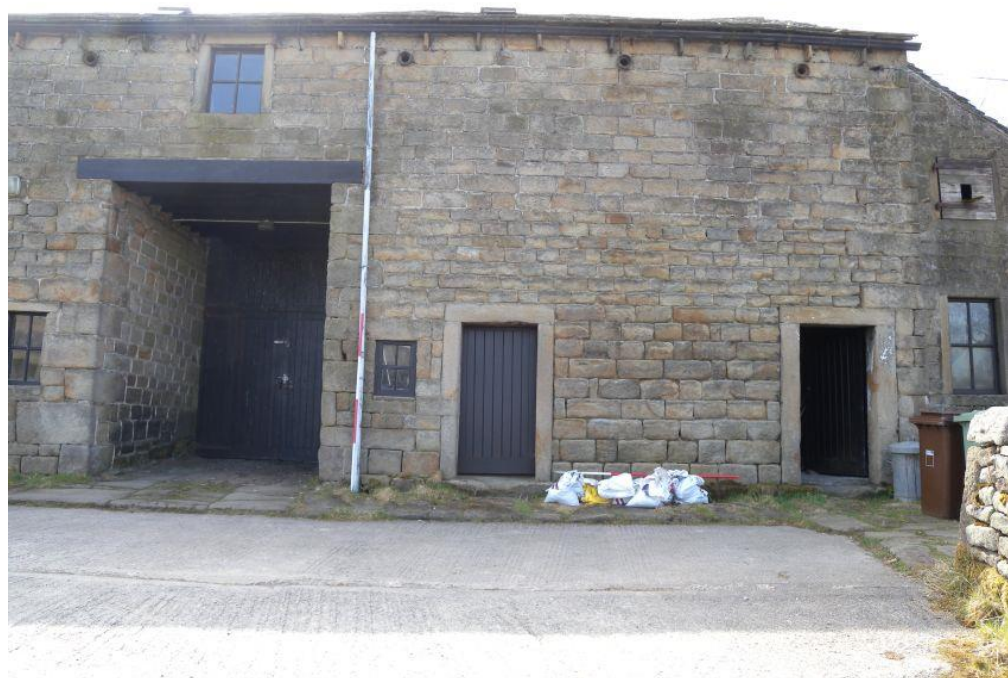
Pl. 2 North elevation (western section) note change of masonry mid-way up the wall

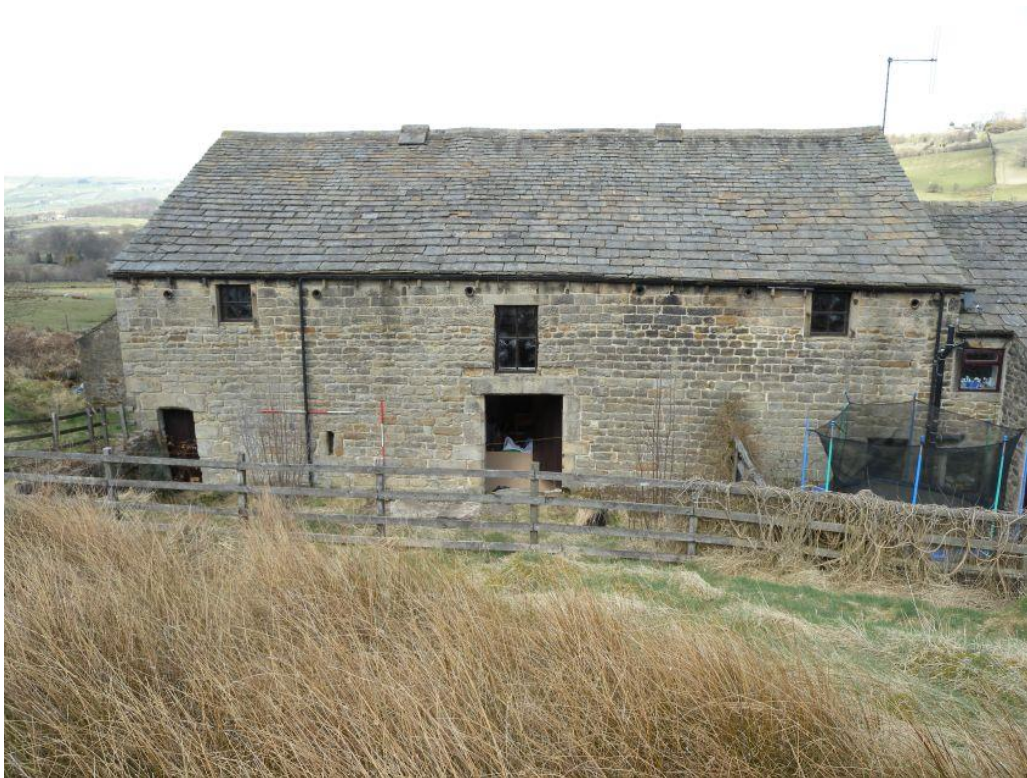
Pl. 3 South elevation

All the external walls were built with an inner and outer leaf of masonry bonded with lime mortar. The south facing wall is of coursed rubble with the top five courses of different masonry reflecting the final phase of development. Doorways are formed at the east and west ends which lead to the shippons with square dressed stone heads and jambs to the east door. The door to the west of the south elevation appears to be of the primary phase having the jambs formed with large stones and a large lintel over with a crudely cut splay formed to the lower outside edge (Pl. 7). A large door has been inserted into the centre of the wall opposite the barn doors (Pl. 6 and Fig. 3). This is clearly later and of re-used masonry. The jambs are finely splayed with non-matching stop-ends. The lintel is non-matching and has a crudely cut splay to its outer edge. The doorway appears to have been increased in width by c. 320mm as can be seen by a change of masonry to the step. This is reflected in the reduced bearing of the lintel at its eastern end. It is likely that the doorway is a modified primary phase threshing doorway, inserted and altered more than once when the barn was extended in the mid-late 19th century. There may have been a timber lintel at one time (suggested in the stonework), perhaps replaced by the current crude stone lintel when the pitching door was inserted immediately above the doorway. Thus, one could postulate three phases for the doorway:

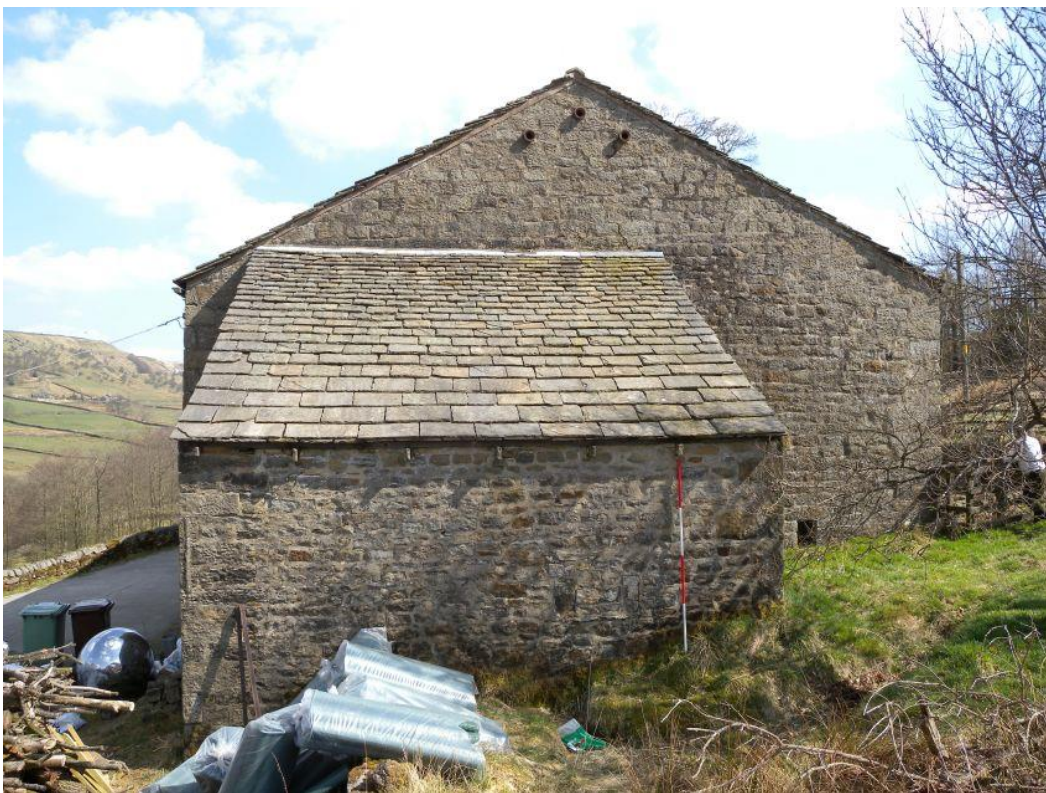
Pl. 4 West elevation

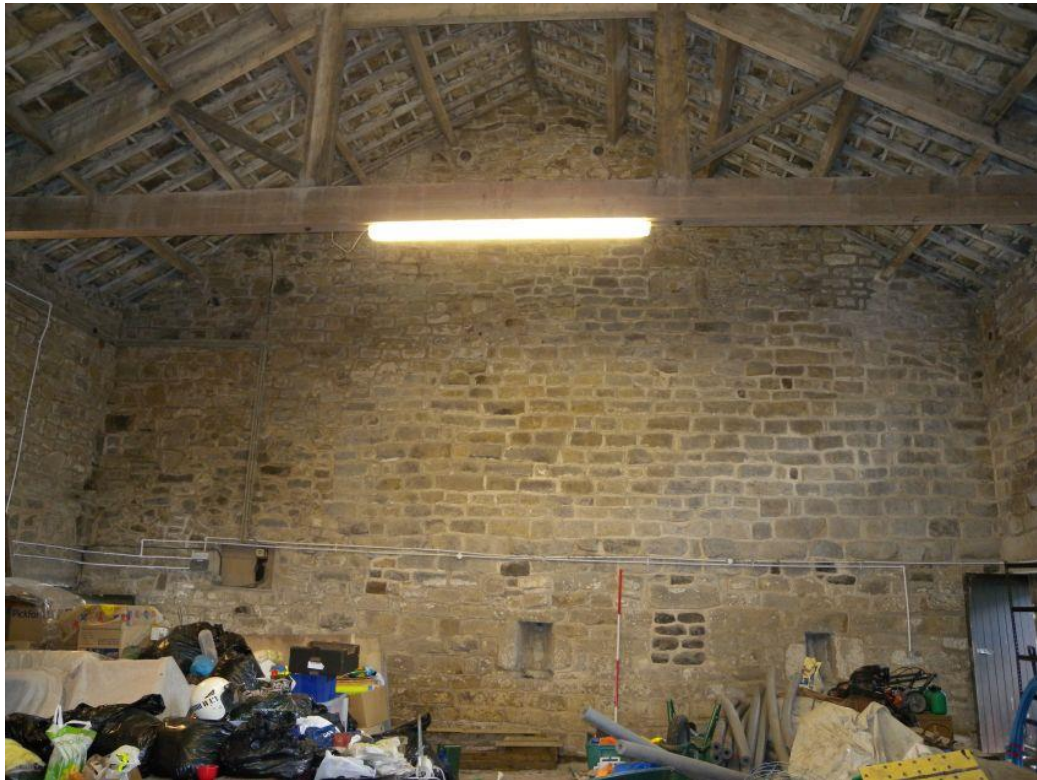
Pl. 5 East internal wall; the outline of the primary barn gable wall can be seen

Substantial alterations were carried out around 1890, which involved the demolition of the north wall and rebuilding it on a line of around 3.500m to the north, i.e. the line of the projecting wagon entrance. At the same time, the roof was raised so as to provide access for larger wagons. The side walls of the projecting wagon entrance were retained. It is probable that this additional space was primarily used for increased milk production, with two doors being provided for access, as farming moved towards the milk economy of the latter part of the nineteenth century; the doorways are too low for horses. At this time the pitched roof would be asymmetrical, the earlier north facing pitch of the roof being followed (Fig. 1). The eaves level of the primary roof was approximately 1.300 m below the present eaves level. A change in the quality of the masonry can be seen on the north external elevation showing the earlier eaves line, which is around half way up the total height of the north wall. The pitch of the roof was slightly steeper than that of the present roof (Pl. 5). Around this time a store was built onto the west gable wall as shown on the first edition maps.

The external leaf of the east gable wall has been rebuilt, probably when the attached farmhouse was extended. Internally this wall shows clear evidence of the primary phase of construction where the later phases can be seen to the north and at high level. Three blocked vents are present at low level made up of large stones to the sides of the openings and a hay door was positioned mid-way up the elevation. The west gable wall

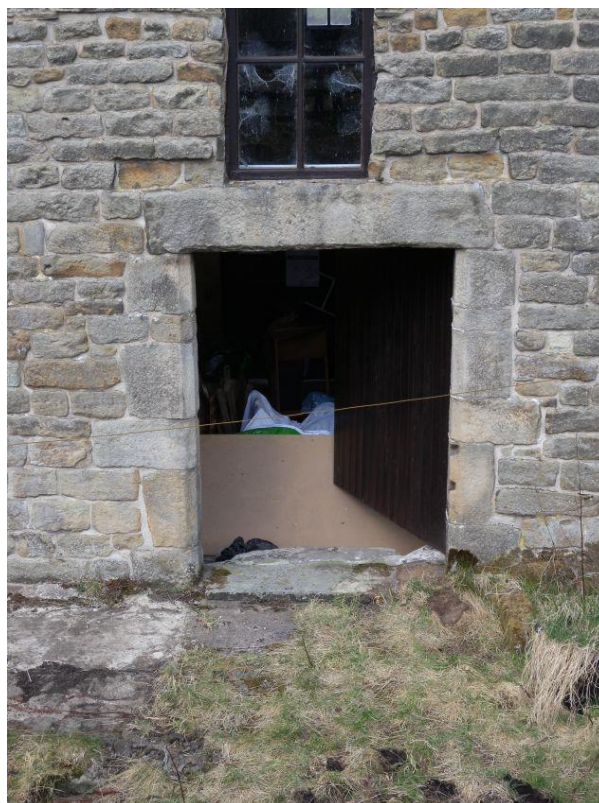
Pl. 6 Large door opening to south elevation

- a primary phase narrow threshing door;
- subsequently widened with a timber lintel;
- this was replaced with a stone lintel when the pitching doorway was added above (i.e. acting as a stone sill for the doorway).

The widening of the primary phase doorway in the centre of the south wall could be seen as a need to accommodate small wagons or equipment from the south. The finely worked jambs represent a 17th century primary phase of good quality. Unfortunately, the lintel over is not of the same level of workmanship.

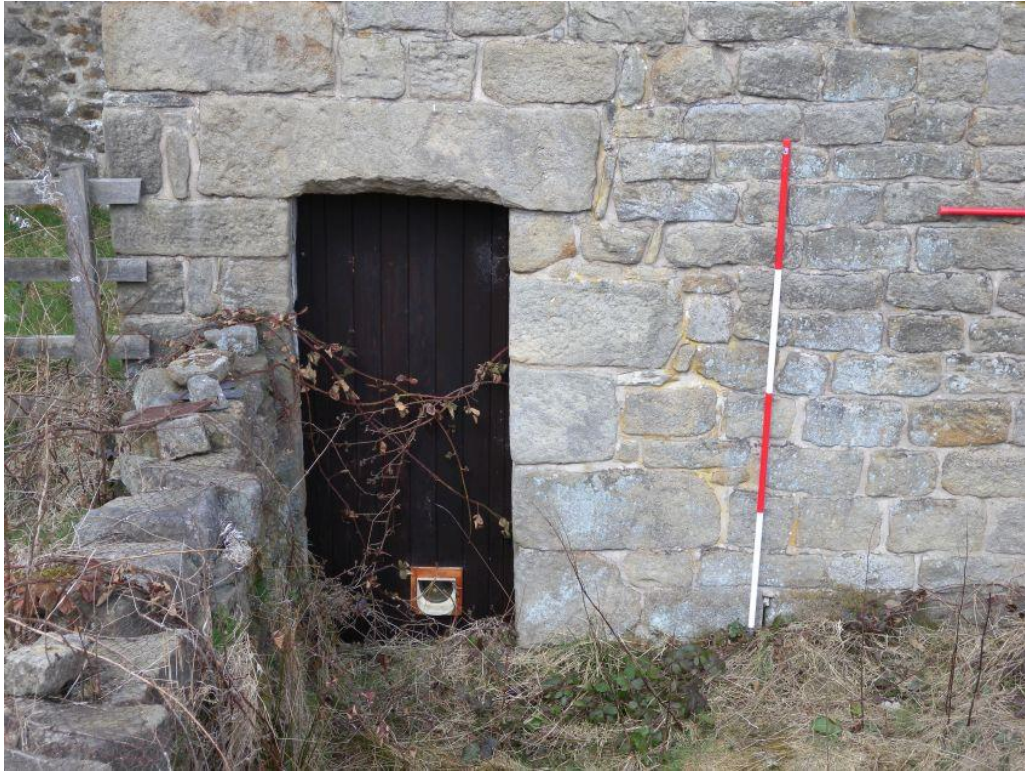
Pl. 7 Small doorway to west of south elevation

Interestingly slots have been cut into the side of the jambs at low level. These have been positioned to prevent animals entering the barn from outside. There is a considerable change in level at the doorway of 510mm. This is accommodated by the insertion of three steps. This change of level is also reflected in the height of the vents above ground level to the west elevation. Two pitching holes (now windows) and the above mentioned pitching door have been formed at high level with square heads and jambs as part of the final phase. The two holes align with the presumed hay stores on balconies above the cattle stalls.

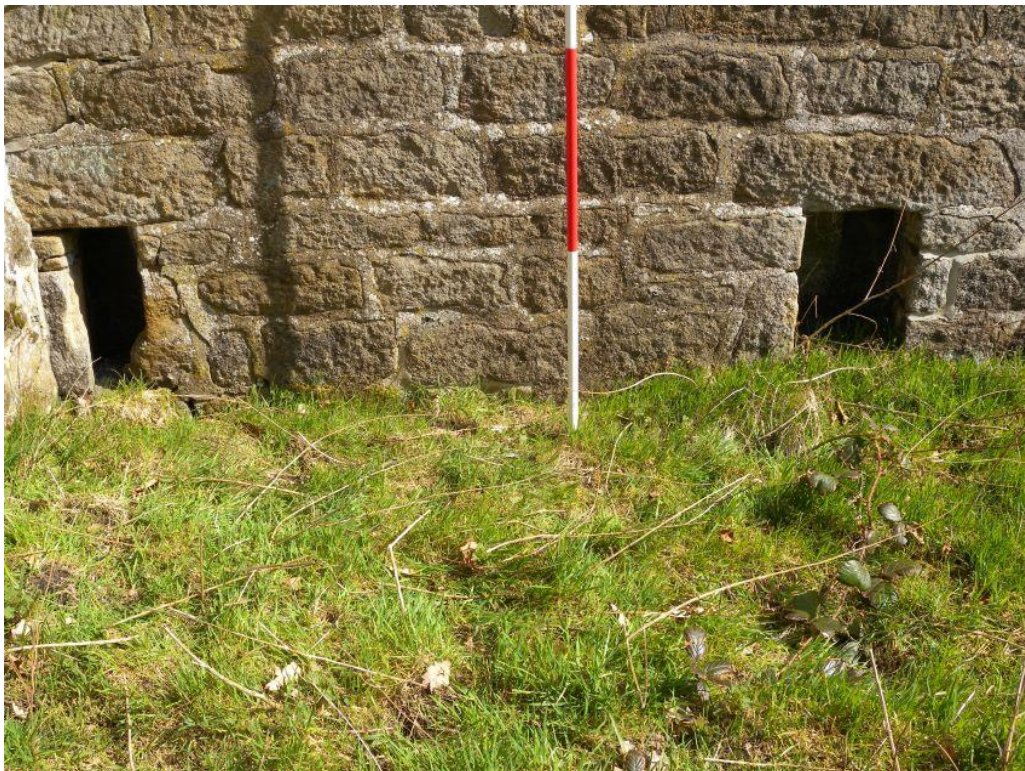
Pl. 8 External vents to east elevation; note ground level

shows evidence of similar phased construction with four vents at low level (Pl. 8). The masonry to the primary phase is formed of larger stone to that of the later phases and is of a higher quality.
