Wycolter Landscape Project

A Report on a Survey of Parson Lee Barn, Wycolter, Trawden

A Report on a Survey of Parson Lee Barn, Wycoller, Trawden

- Record No. AB.04
- Location Parson Lee Farm, Wycoller
- NGR SD 9420 3870
- Altitude 250m
- Orientation of barn doors east-west
- The barn and adjoining farmhouse are unlisted
- Date of Survey 18th June 2014

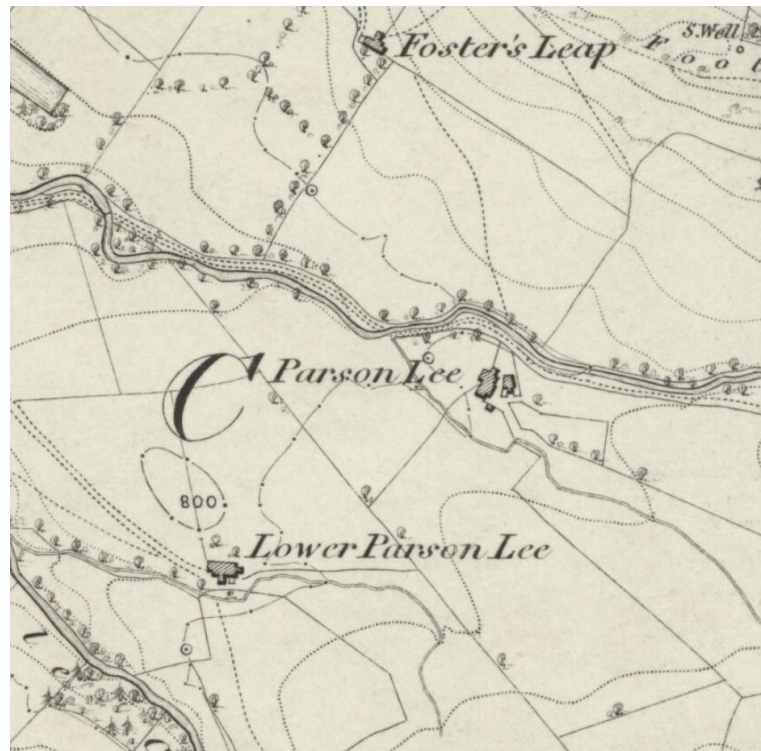
The first edition map of 1848 shows the barn and the farmhouse, together with a small building situated to the south east of the barn. A projection is shown to the west elevation which could indicate the barn doors, this is not shown on the east elevation. The road from Wycoller to Howarth is clearly shown.

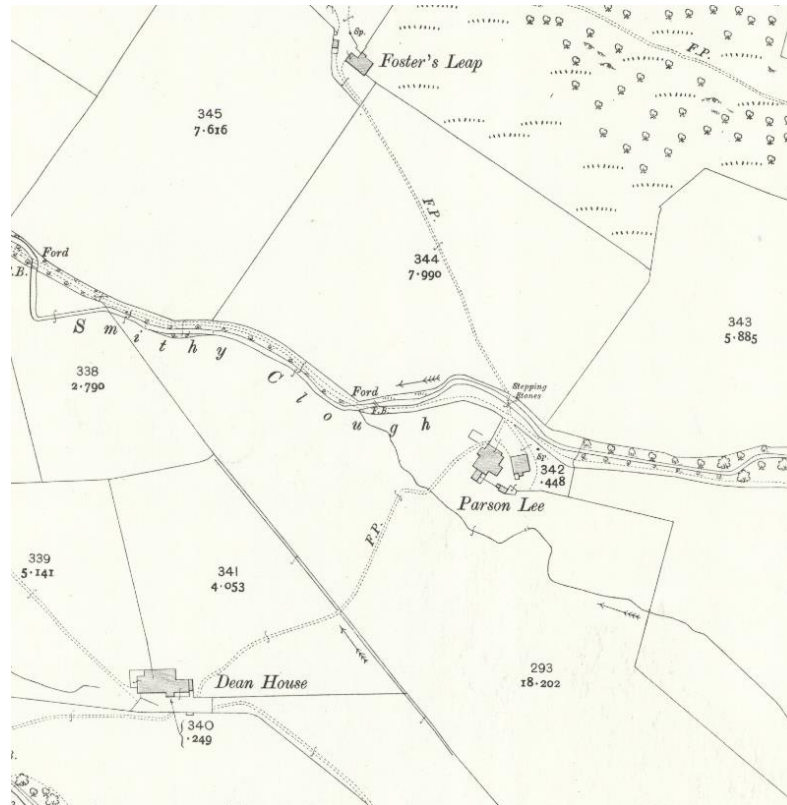
The map of 1910 25 inch map shows the barn, farmhouse and the small building to the south east. The west wall to the barn is shown as before. The barn door to the east is not shown as being central and it would appear that the two extensions to the east elevation had not been built, which are shown on Fig. 1. The modern extension to the east elevation is not shown. Doubt must be placed on the accuracy of this map.

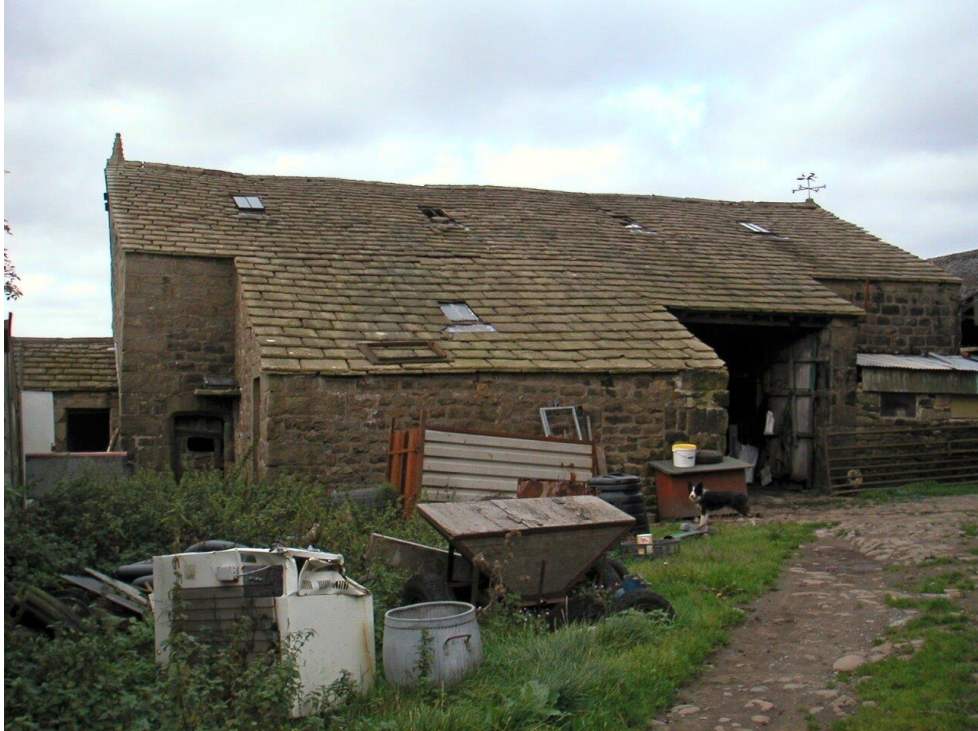
Pl.1 East elevation showing barn doors and later extension to south side.

Double projecting wagon entrances to the east and west are placed in the second bay measured from the north (pl. 1). The two projecting barn doors are set directly opposite each other and measure 3.350m (3.380m) in width. The amount of projection is 1.820m (1.860m). Across the width of the barn between the doors the floor is made up of large conjoining slabs of stone. A further door is formed in the west wall adjacent to the cattle stalls giving access into the central bays.

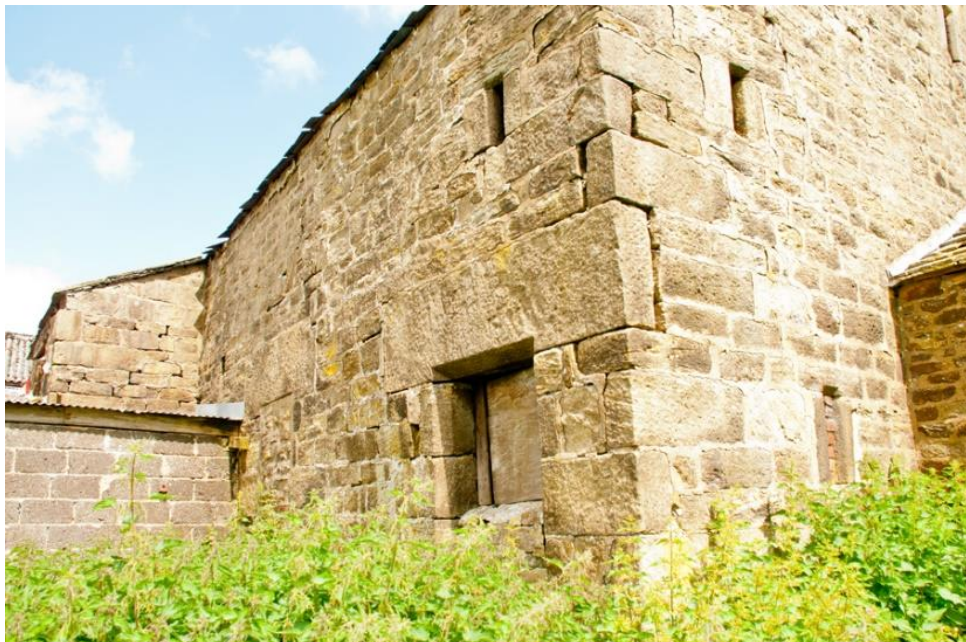
Pl. 2 Detail of large quoins and lintel to south-west corner.

The external walls are built of good squared coursed masonry and the internal face is similar. Large quoins with a punched finish are built into the external angles (pl. 2). The inner and outer leaves of stonework do not appear to have been adequately tied together and this is particularly evident to the south west corner where the two leaves appear to have separated. The top course and third course from the top to the south gable are made up of larger squared stones, which are not seen elsewhere in the building (pl. 3).

The two doors serving the cattle stalls to the east elevation are of higher quality than those set in the west wall having splayed jambs with stop ends and a chamfered lintel with rounded corners (pl. 4). The three door openings to the west have simple splayed jambs and heads. In all instances the lintels to the west are very large and are set as quoins to the south west and north west corners; the lintel over the south-west door measures 2.300m long by 600mm deep and 300mm thick (pl. 2 and 5). This is a similar detail to that seen at the barn at Bracken Hill, Wycoller.

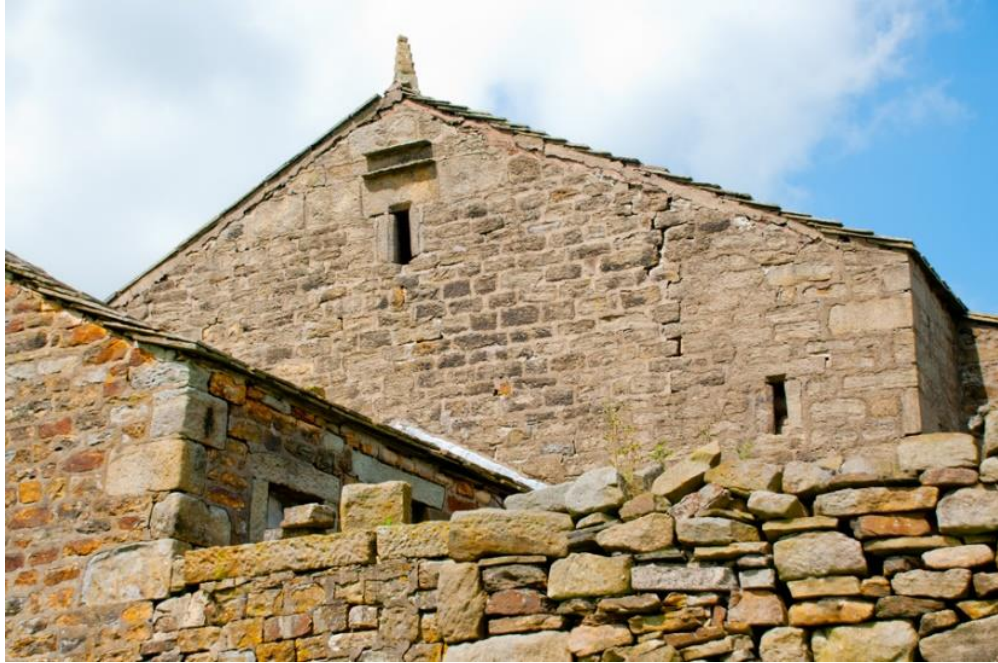
Pl. 3 Detail of south gable showing decorative finial and deeper courses to upper section of the gable wall.

The roof covering comprises blue slate to the western pitch with stone tabling over the gable walls and grey stone slate to the east. The change in the roof covering probably came about due to the failure of the roof covering to the western pitch as it was on the `weather` side of the building. The ridge is made up of cut stone ridge pieces. The end ridge piece to each gable has a four-sided base formed to receive a decorative finial (pl. 3).

It is strongly recommended that repairs are carried out in the short term to the south gable wall so as to stabilize the building. It is also our opinion that the building should be placed on the statutory list of Listed Buildings.

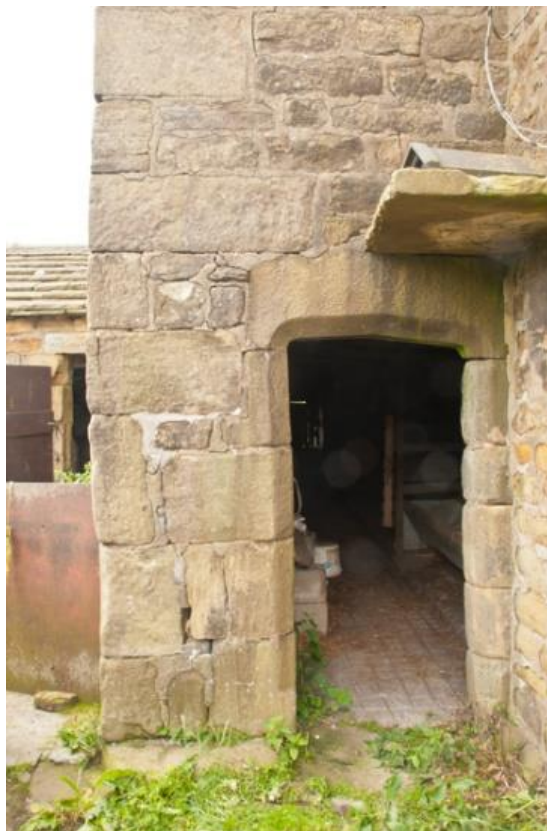
Pl. 4 Door to south southern corner of east elevation showing splayed jambs and rounded corners to the curved head.

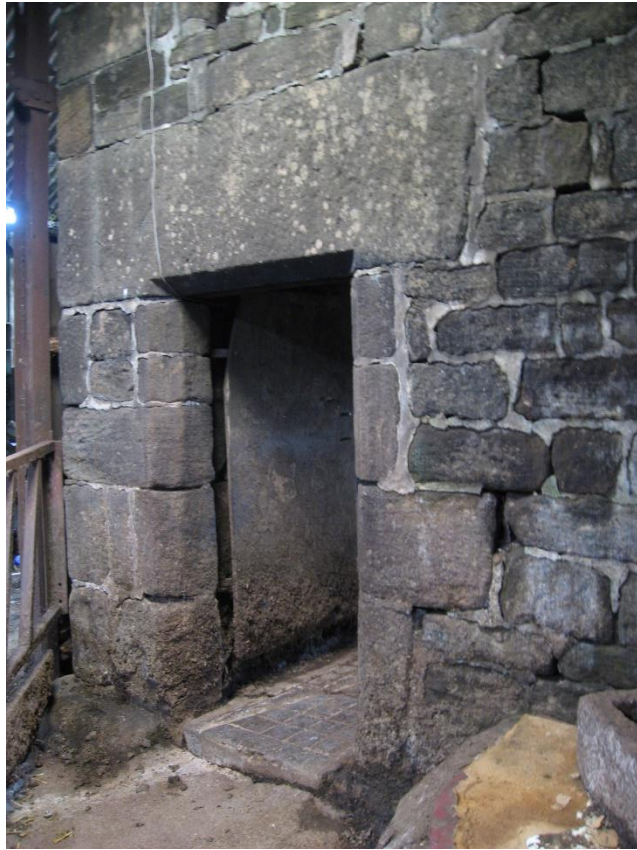
Pl. 5 Door to shippon at north end of west elevation with splayed head and jambs.

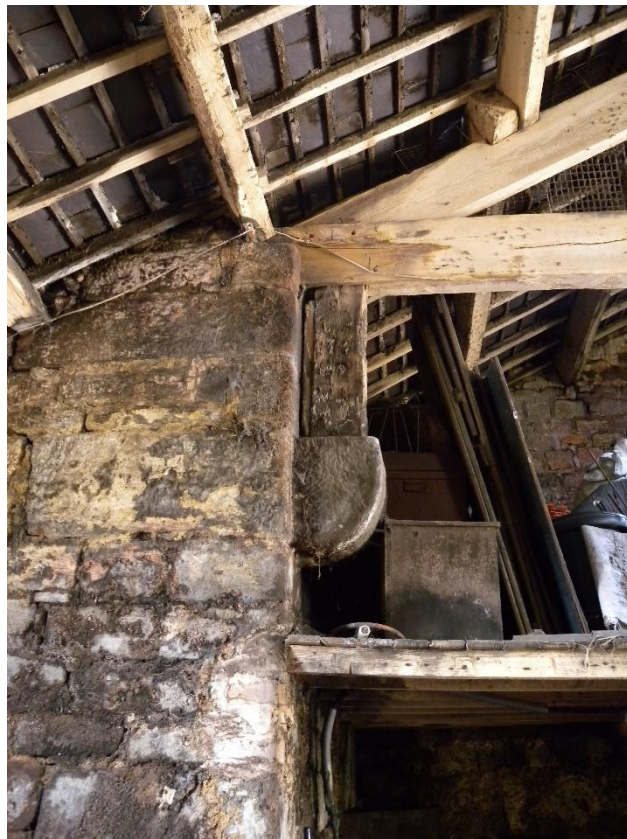
Pl. 6 Corbel and quoin to barn door cut from a single piece of stone.

Corbels are set approximately 500mm below the underside of the tie to the trusses. The four to either side of the two barn doors appear to have been cut out of a single piece of stone forming the internal quoin to the return of the projecting barn doors (Pl. 6). The quoins to the hayloft are of high quality.

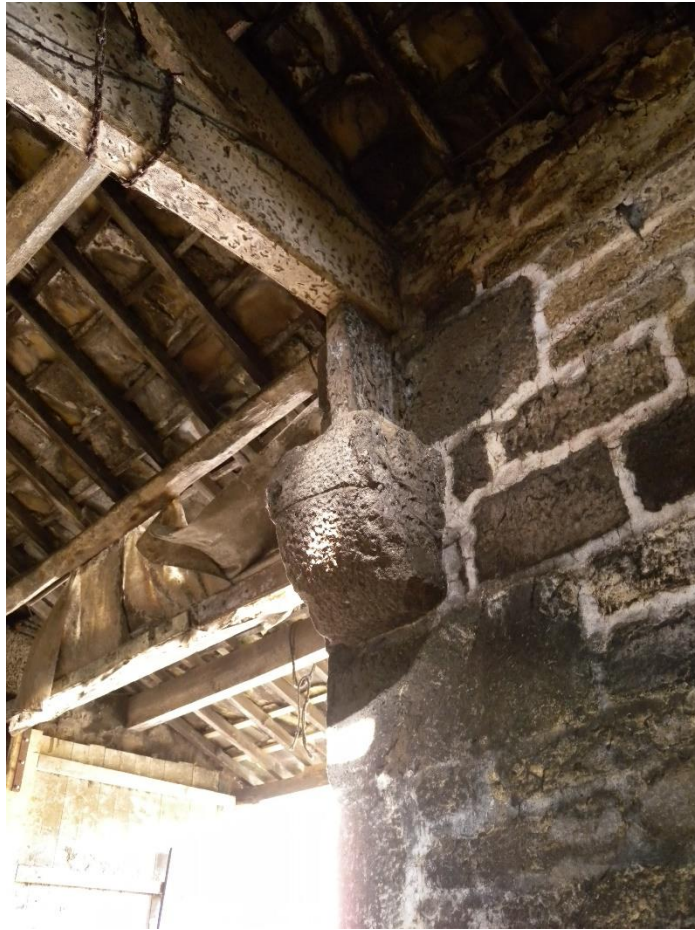
Pl. 7 Corbel and truss to east wall note raised external wall around truss foot.

The tops of the east and west walls appear to have been raised by approximately 300-400mm and this is almost certainly due to the placing of the present trusses and purlins and the need to raise the external wall due to a change in the design of the roof (pl. 7). The west truss foot to the bay to the south of the wagon door has been cut into large stone blocks forming the return angle to the door opening. This would seem to have been a later arrangement.

It would appear that when the roof was replaced with the present arrangement, the roof trusses were placed on the top of the existing walls (pl. 7). The external walls were then raised to cover the ends of the truss where they rested on the wall and to allow the spars to bear on the top of the external wall. These raised sections of walling can clearly be seen internally and externally at both barns. The primary roof form would appear not to have incorporated a tie beam placed at the bottom of the principal rafters with these rafters bearing on a shaped bottom member bearing on the corbels. This member could have been adjusted in height to take up any variation in levels. A tie would then have been placed at around first purlin height with a possible additional tie positioned higher up.

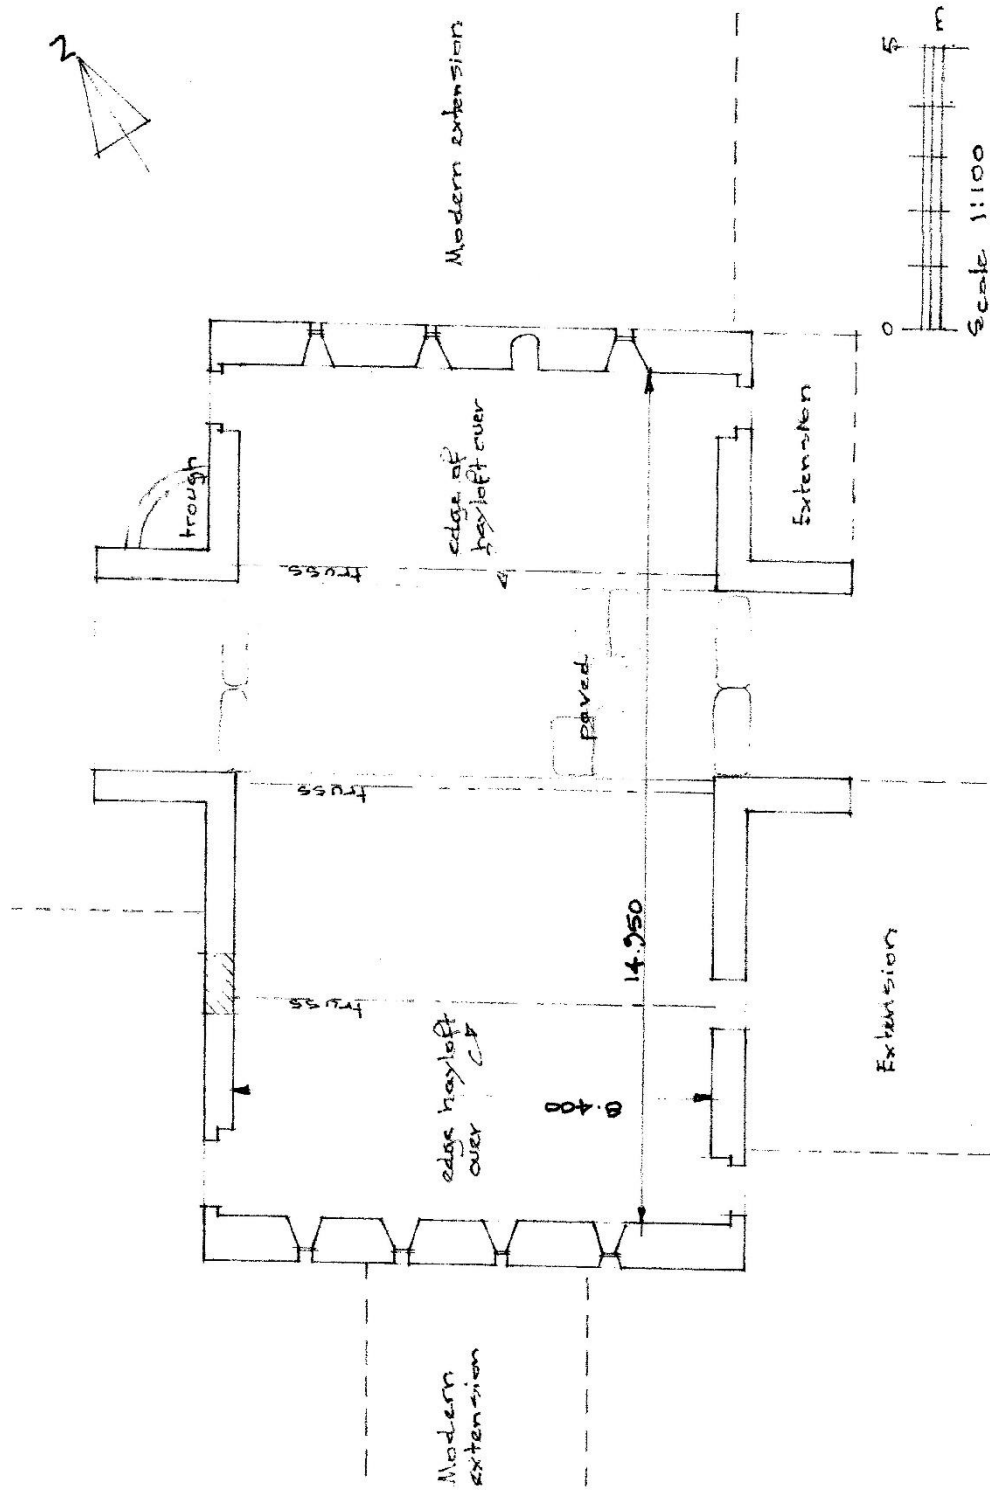
FIG 1 PARSON LEE BARN WYCOLLER

The barn measures internally 8.400m in width and 14.950m in length and is built to a high degree of accuracy, there being little variation on the opposing internal dimensions. The barn is divided into four bays of equal width.

Within the northern and southern end bays stalls were set out for cattle with a hayloft over. Door openings were formed in the east and west walls to each of these end bays. The original haylofts were supported on projecting corbels set into the two gable walls and projected 3.130m (south) and 3.90m (north) into the barn. There is no evidence of the original floor in these areas.

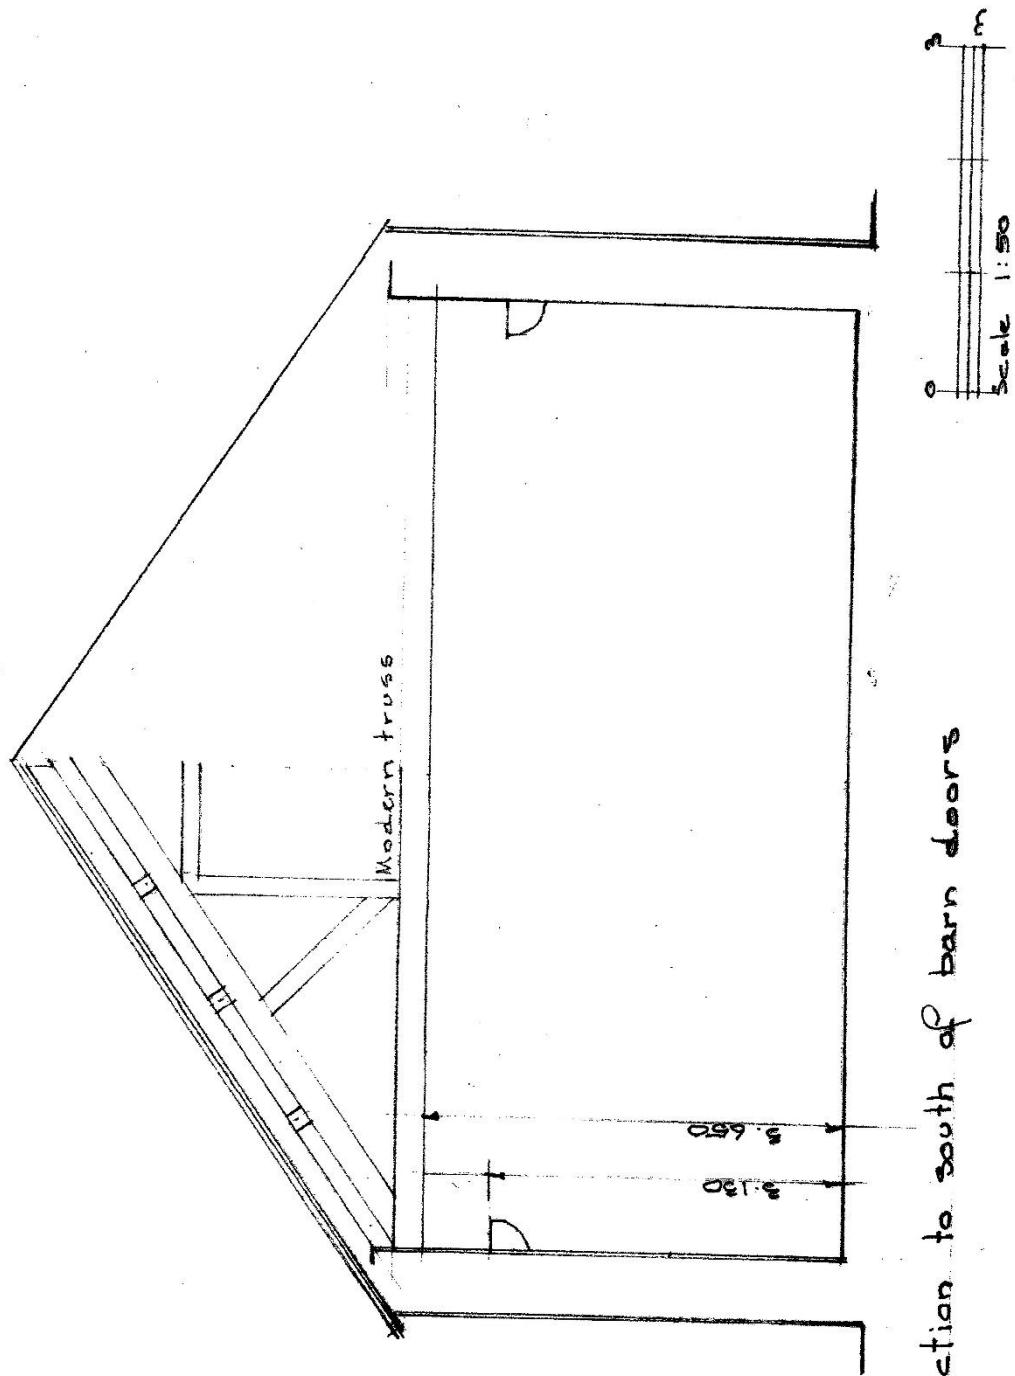
FIG. 2 PARSON LEE BARN WYCOLLER

The roof structure is made up of four equally spaced queen post trusses with a ridge piece and three purlins to each side with the exception of the wagon doors where there are five. All the timbers are modern and appear to be of pine.

The presence of projecting corbels approximately 500mm below the underside of the present tie beam to the trusses is unusual and suggests the original form of the roof. It is possible that the ends of each principal rafter were supported on an arched bracket which was supported on the corbel. The tie would have been placed at a higher level

Section to south of barn doors

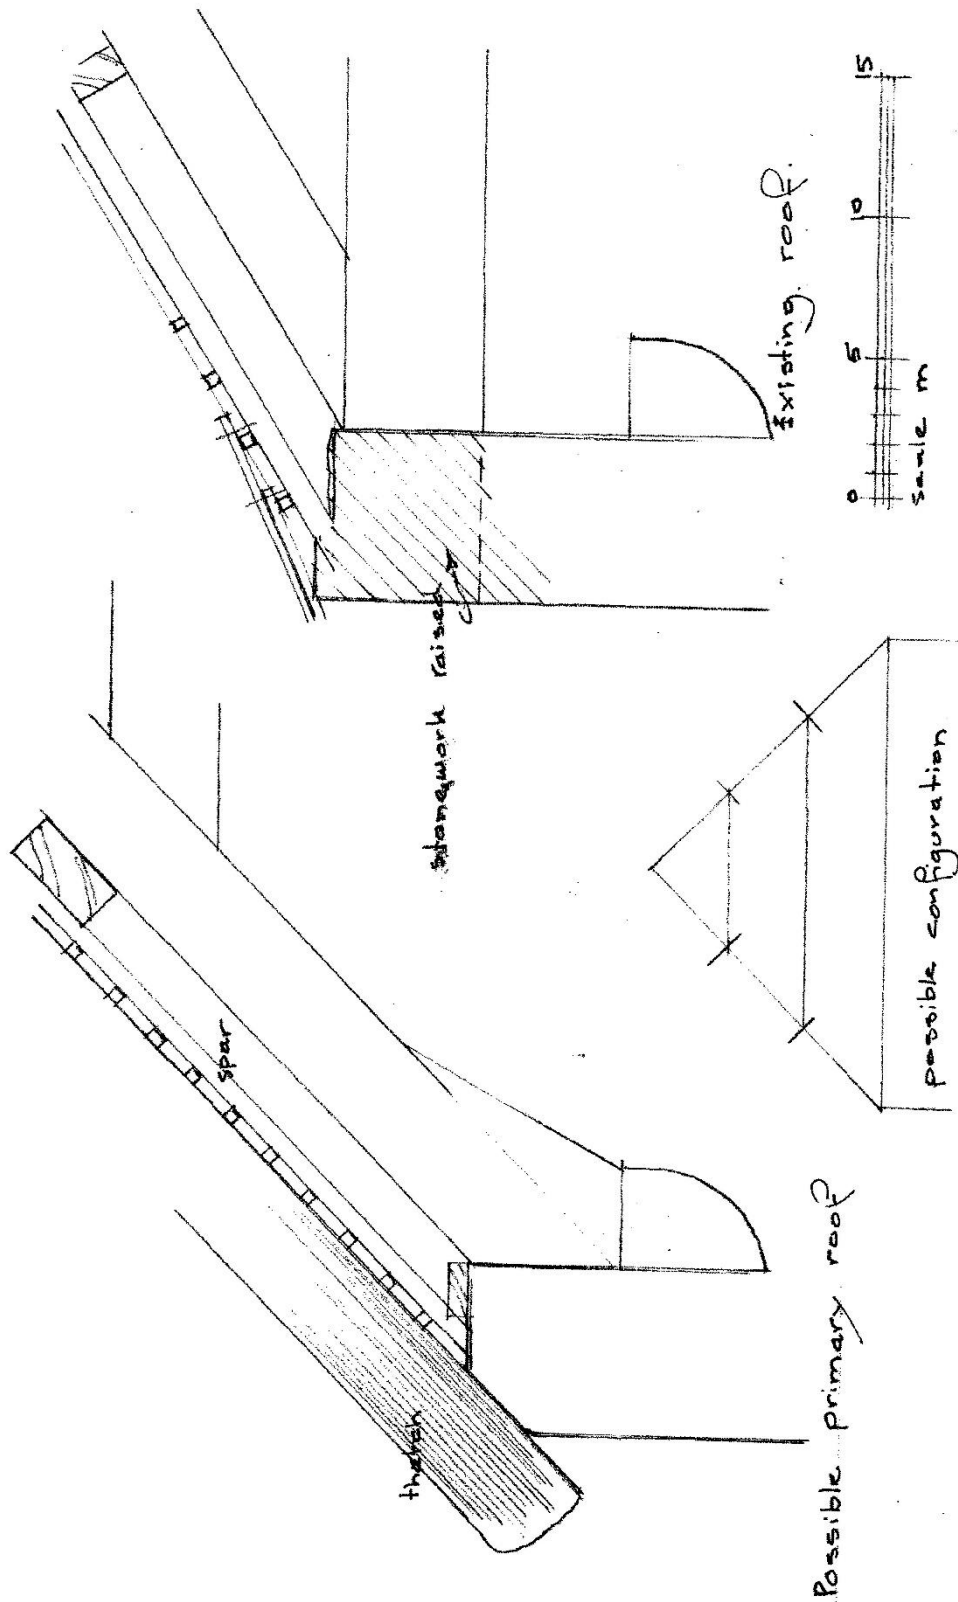
From the existing site evidence, both the barn at Parson Lee and that at Bracken Hill, Wycoller had the same primary roof configuration. This is shown in the presence of projecting stone corbels on the internal face of the external walls some short distance below the top course. The corbels of the barn at Parson Lee appear to be of similar heights, although the levels have not been checked. At Bracken Hill the present trusses rest on corbels made up of a series of projecting courses; the top of the corbels does not correspond in some cases to the original, whose position cannot be verified with certainty. The drawn reconstruction is based on evidence from Parson Lee Barn with a wall plate shown in the position as seen at Bracken Hill.

It is possible that the primary roof was covered in thatch rather than slate. The roof covering in the reconstruction is shown with this material; if it were incorrect and stone slate was used the pitch could have been less at around thirty five degrees and the slates laid as shown on the accompanying drawing. The pitch of any roof is determined by the roof covering and exposure. Generally speaking, the smaller the unit of roof cover then the greater the exposure, the steeper the pitch. Thatch requires a minimum pitch of 45 deg. In a sheltered position; this has been assumed in the reconstruction where there is evidence of a steeper primary pitch.

Fig.3 BRACKEN HILL BARN + PARSON LEE BARN WYCOLLER
EXISTING AND POSSIBLE PRIMARY ROOF ARRANGEMENTS.
