Wycoller Landscape Project

A Report on a Survey of Pepper Hill Barn, Wycoller

A report on survey of Pepper Hill Barn, Wycoller

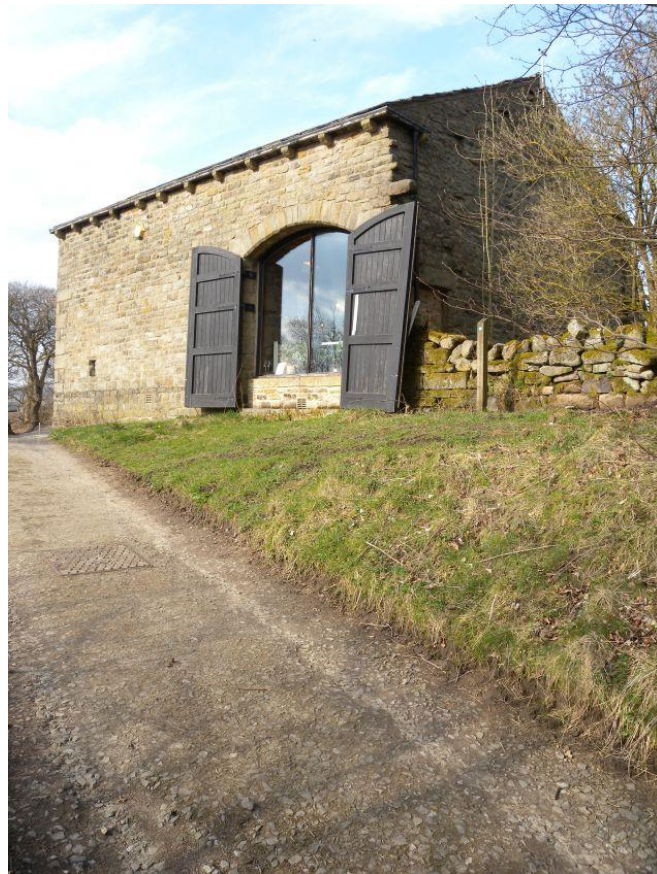
Pl. 1 West elevation

The barn is set at high level to the east of the hamlet. It overlooks the settlement and faces Nether Wycoller vaccary to the west. The present access road leading to the Study Centre from the unclassified road is modern and a new entry point has been created opposite the bridge into the village. The line of this road is in part on the course of the track running past the barn to the north leading to the former laithe farm and the adjoining fields and then on to Wycoller Hall. Historically the barn would almost certainly have had an access by means of a track running past the former large barn to the west leading to the road through the hamlet. A new dwelling has been built on the site of this barn. The barn is built into the hillside and wagon access is only likely to have been available from the west. At the present time there is a steep gradient between the postulated original floor level of the barn and the track. In view of this it is likely that the present levels of the track in front of the building have been adjusted.

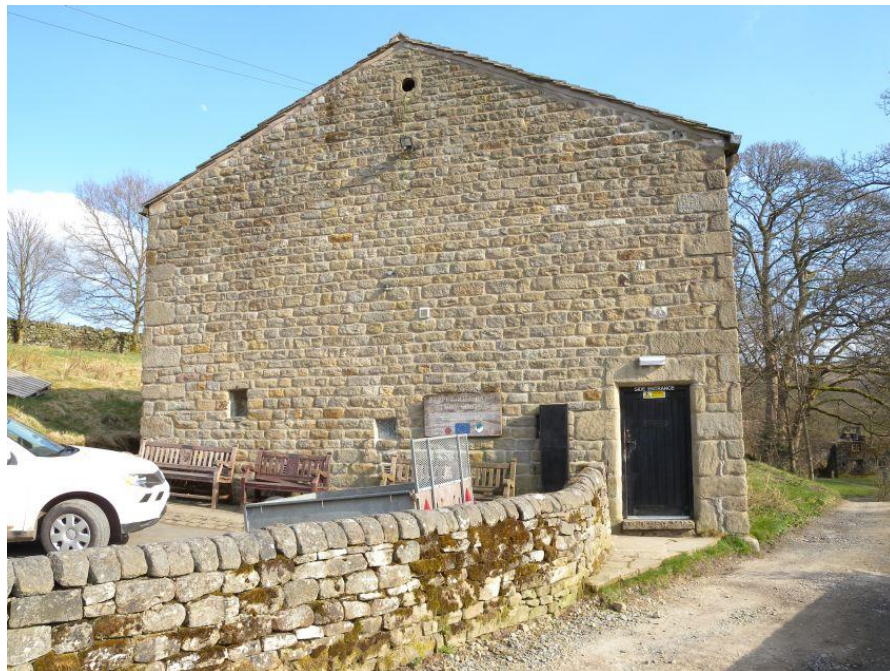
Pl. 2 North elevation

The external walls are built of stonework. The external leaf is of coursed watershot rubble and the inner leaf is of random rubble, both bedded in lime mortar. `Through` stones are evident which project into the building. The external doorway to the north has a splayed head and jambs as has the blocked door in the south wall (Pl. 2 and 6). The wagon door to the west is formed with voussoirs set form a shallow arch (Pl. 1). A flat head is formed over the internal opening with reused timber supporting the wall over. The narrower door to the east has a semi-circular head over the opening made up of voussoirs both internally and externally (Pl. 5). Single vents are extant in the east and south walls. It is likely that two further vents were present in the north wall but these have been enlarged to form windows. A single small window has been formed in the west wall. Two modern windows have been inserted at high level in the east elevation. Projecting small corbel blocks are set into the external walls at high level to support the gutter.

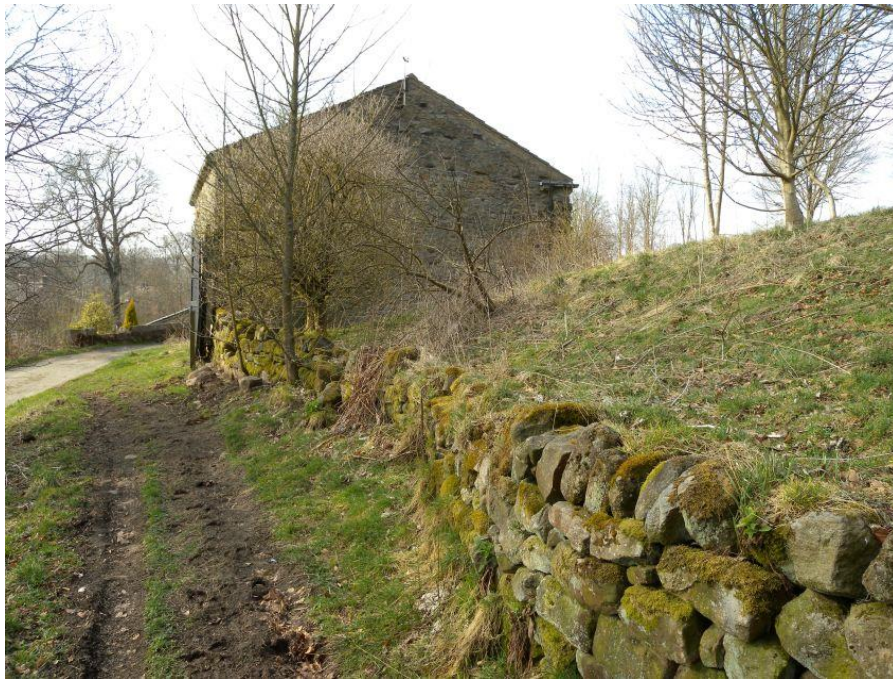
Pl. 3 South elevation showing boundary wall

The barn has been much altered and it is not possible to record much of the original detail such as the roof and floor finishes. From the extant structure it would appear that the southerly part has been demolished or probably not constructed as the present size of the barn is shown on the first edition of the OS map. This conclusion is reached as the external walls to either side of the gable wall project and are `toothed` reflecting an incomplete build of the masonry (Pl. 4). An examination of the boundary wall to the south of the building

exposed the foundation course of the barn. This showed that the original barn was intended to extend for some 7.400m to the south of the west facing barn door. The corresponding dimension to the north was 7.870m showing that the barn door was intended to be placed centrally.

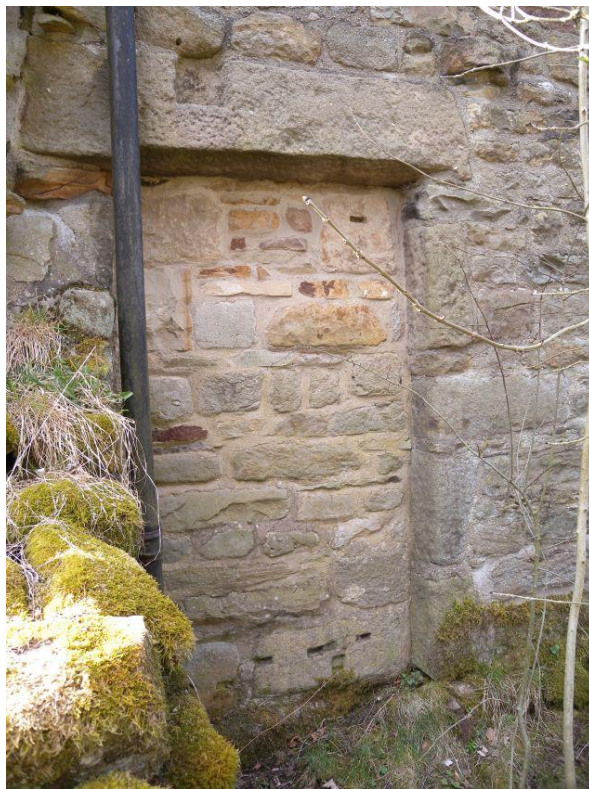
Pl. 6 Door in south wall

Adjacent to the stalls, accessed by doors in the east and west elevations, was a hay barn with storage provision over the cattle stalls to the north. The original difference in floor levels across the barn at the two large external doors was probably a little less than 700mm, leading to a considerable cross fall (Fig. 2). Evidence of the original floor level can be seen outside the west door in the form of pivot blocks. Due to the existing levels of the hillside, access to the barn door to the east would have been restricted. A blocked doorway with splayed head and jambs to both sides is positioned in the south gable wall towards its western end (Pl. 6). The clear internal span is 8.410m and the overall internal length is 6.730m.

The planning arrangements are unusual in that access to the eastern rear door to the barn is very restricted due to the slopping hillside close to the rear of the barn. The south wall appears to be original together with the doorway formed within it. It is probable that the intention was to build a barn symmetrical in plan with central barn doors. In the event this was not completed and a smaller asymmetrical barn completed with a `temporary` wall built to close off the barn to the south. It is significant that the clear span of the barn at 8.410m is almost identical to that of Bracken Hill Barn at 8.400m and Pepper Hill barn at 8.390m.
