A REPORT
on the
ARCHAEOLOGICAL RECORDING
of the
CORN MILL, BARNOLDSWICK

The text and plates

D J A Taylor Dip Arch PhD RIBA MIFA
2A Higham Road
Padiham
Burnley
BB12 9AP

May 2004

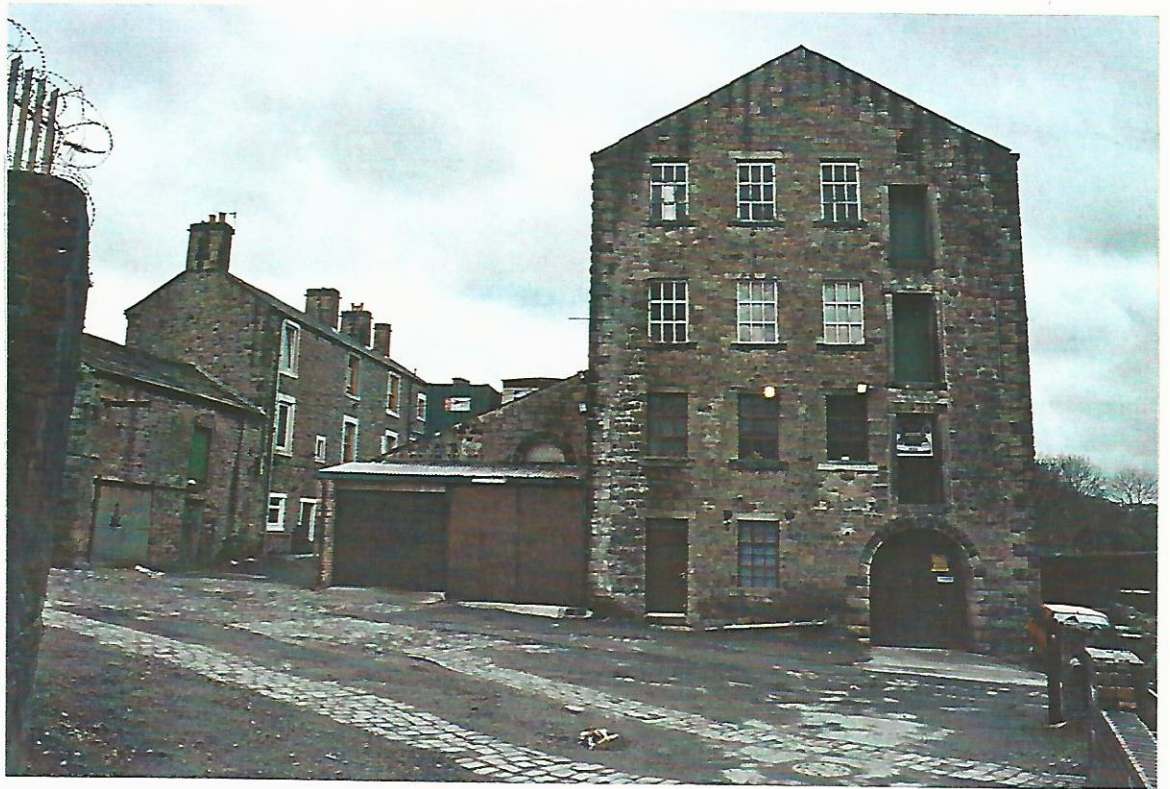
Pl. 1 North elevation of the Corn Mill with Corn Mill cottages on the left.

The four floors of the main building are expressed on the elevation by means of window and door openings below a single gable wall. At ground floor level the opening for arched loading doors measures 2.620m wide by 3.020m high with the springing for the arch set at 1.800m (pl. 3). The dressed voussoirs and quoins to the opening have chamfered edges. Two windows were formed to the east side of the doorway, each of six panes. The present easternmost window is now a modern doorway.

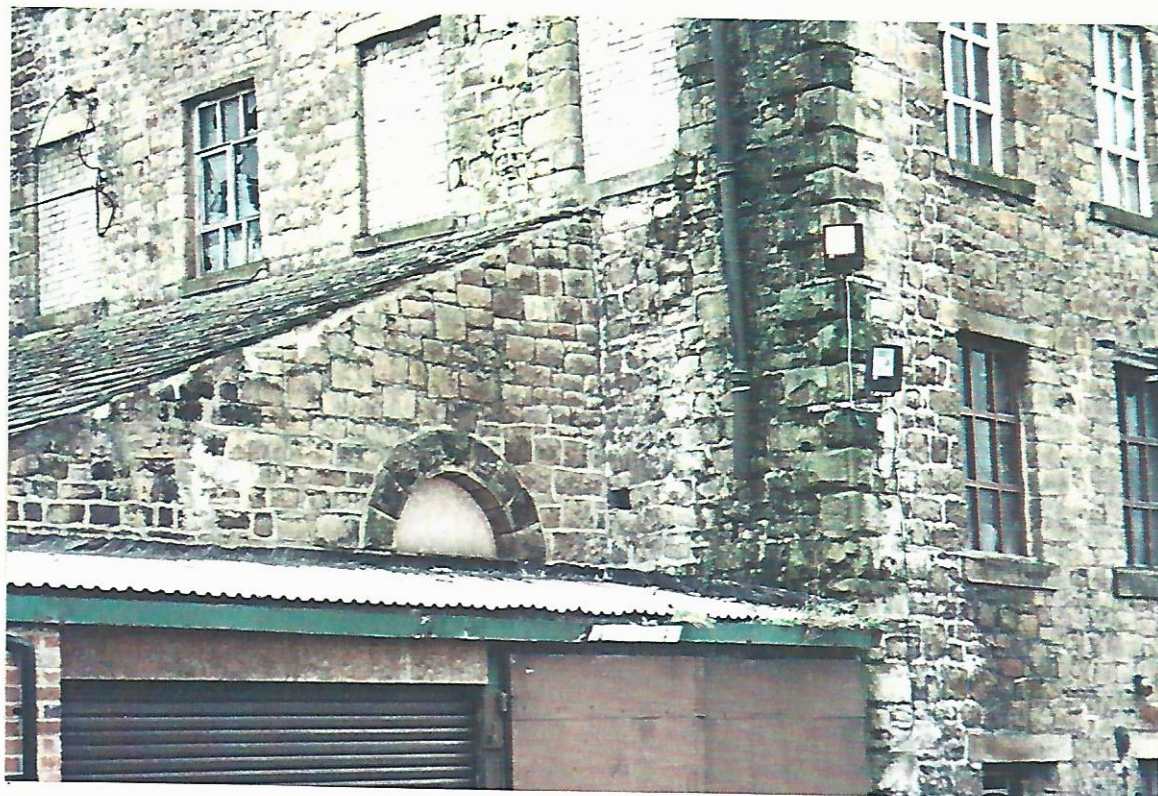
Pl. 4 The upper part of the single storey section to the east showing the top of an arched widow

The two single-storey bays to the east are later additions in coursed masonry, built when steam power was installed in the building. The bay nearest the four-storey block housed the steam engine and the adjacent bay housed the boiler. The fronts to the single-storey sections are later additions with metal shutter doors. These conceal the original frontage. The first bay was originally built with a full height narrow window running from close to ground level. The upper part of this window is still extant above the modern front and is reflected in the rear elevation by a matching window with a lower sill height (pl. 4). A modern concrete platform has been built up against the south elevation at some height above the original ground level.

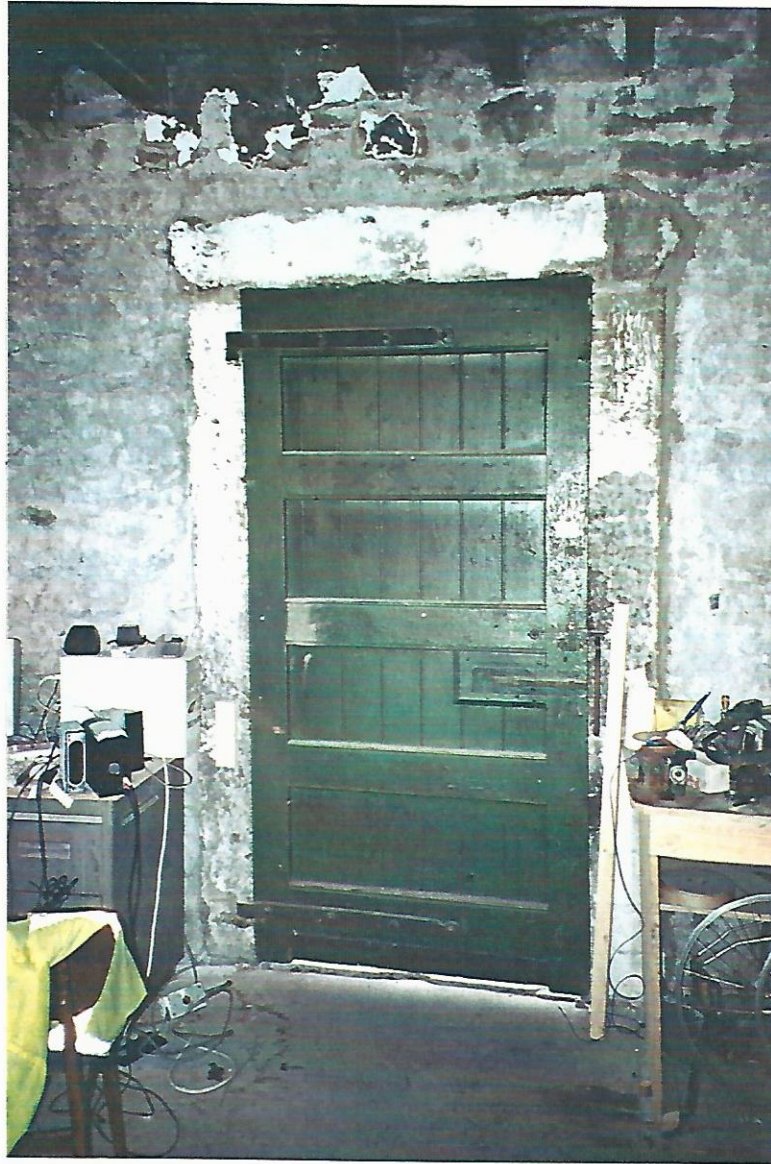
Pl. 5 North elevation, a typical loading door seen from the inside.

The upper floors are similar, with a loading door central above the ground floor arched loading door. To the east side of these openings are three six-pane windows to each floor. A further loading door was later cut on the first floor in the window opening adjacent to the loading door; this has now been closed up. It is probable that the timber doors to the loading doors are original as, being on the north elevation, they will have had least exposure to the elements (pl. 5).

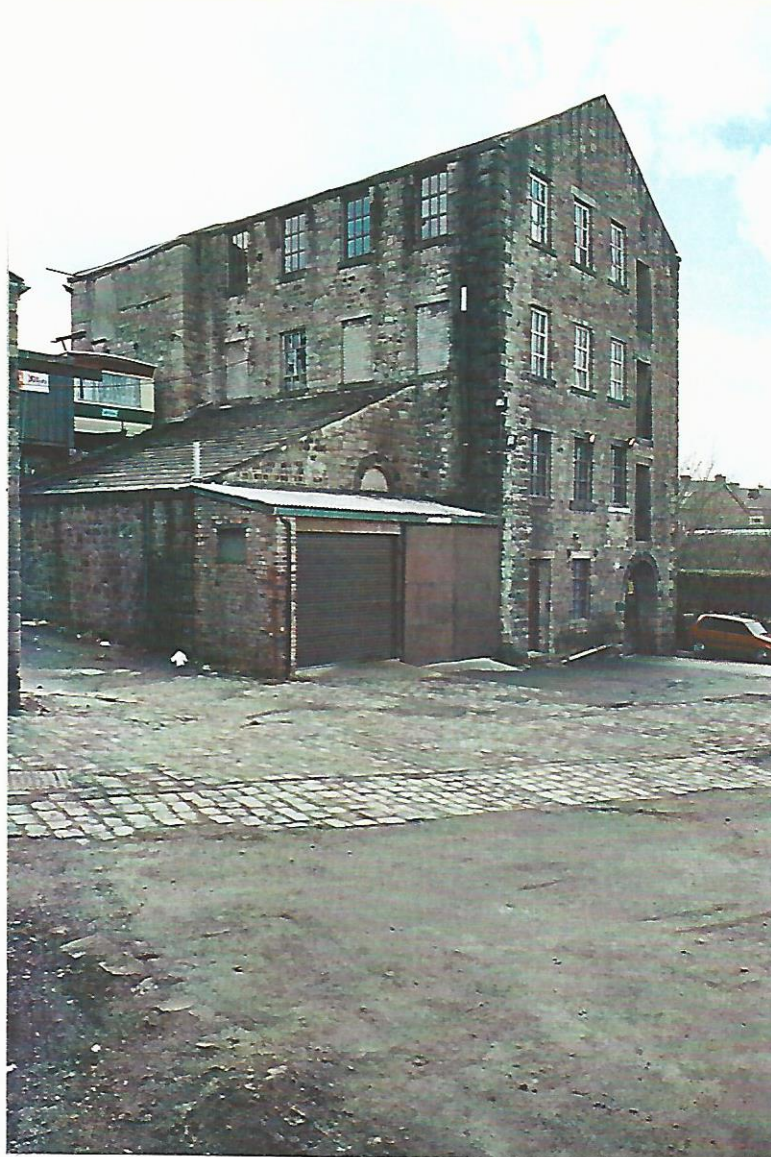
Pl. 6 East elevation.

The ground floor elevation to the single-storey bays is faced with coursed stonework; this formed an extension to the original four-storey building. There is a double break towards the top of the elevation, alongside the access road, presumably to support the concrete slab at loading bay level; this is a recent addition. To the south of this is the retaining wall to the access road to the loading bay. The coping to this wall includes much reused stonework. The line of this section of stone wall is modern as it now encloses an area used to house some outbuildings belonging to Corn Mill cottages.

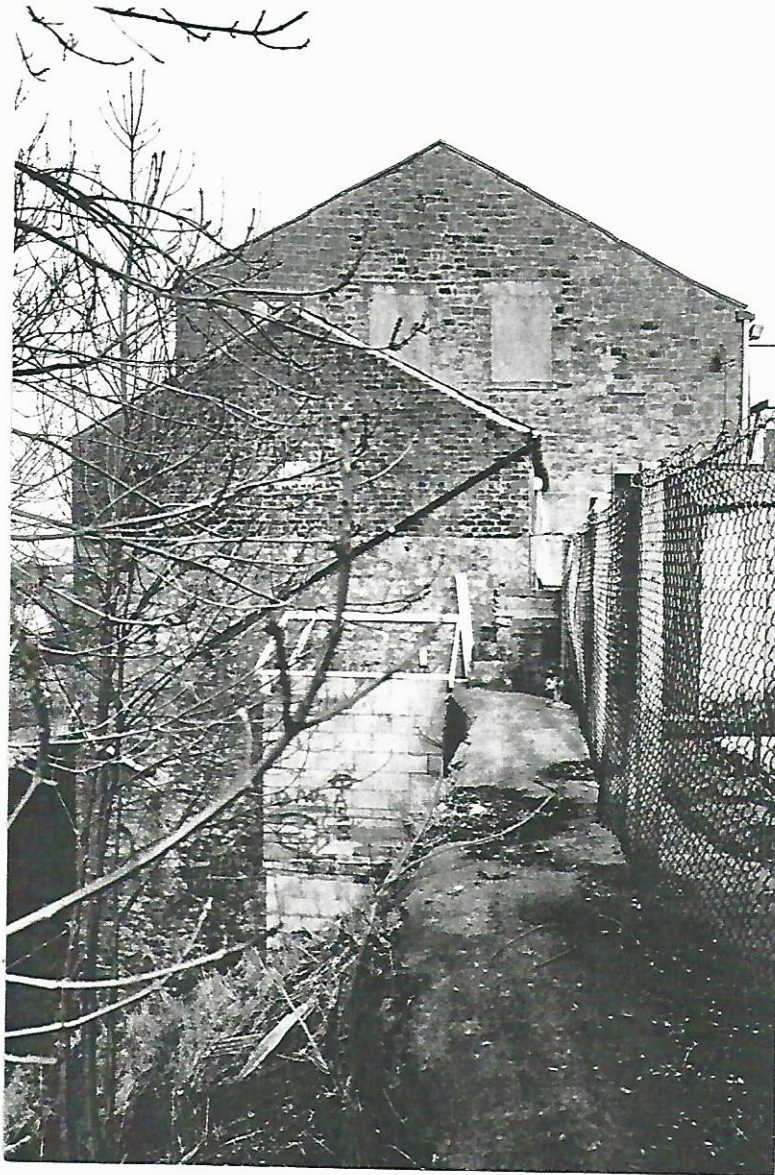
Pl. 8 South elevation. The edge of the dam wall to the mill lodge is shown in the foreground.

The gable wall is constructed of coursed stonework; this appears to have been built on earlier masonry at second floor level seen below an earlier window head to a blocked up window to the side of the loading door. The height to the underside of the lintel is 1.760m above ground level (pl. 9). The present loading doors have been widened, the extant threshold shows that the earlier width was 1.620m. One window and two blocked up openings are positioned at third floor level. In the southern retaining wall to the loading bay is part of a stone lintel 1.880m long by 450mm high by 280mm deep. The vertical face of the lintel had a curved surface over the opening (pl. 10). This lintel could have been built into the north wall of an early phase of the building. The present external loading area has been raised by approximately 1m in recent times.

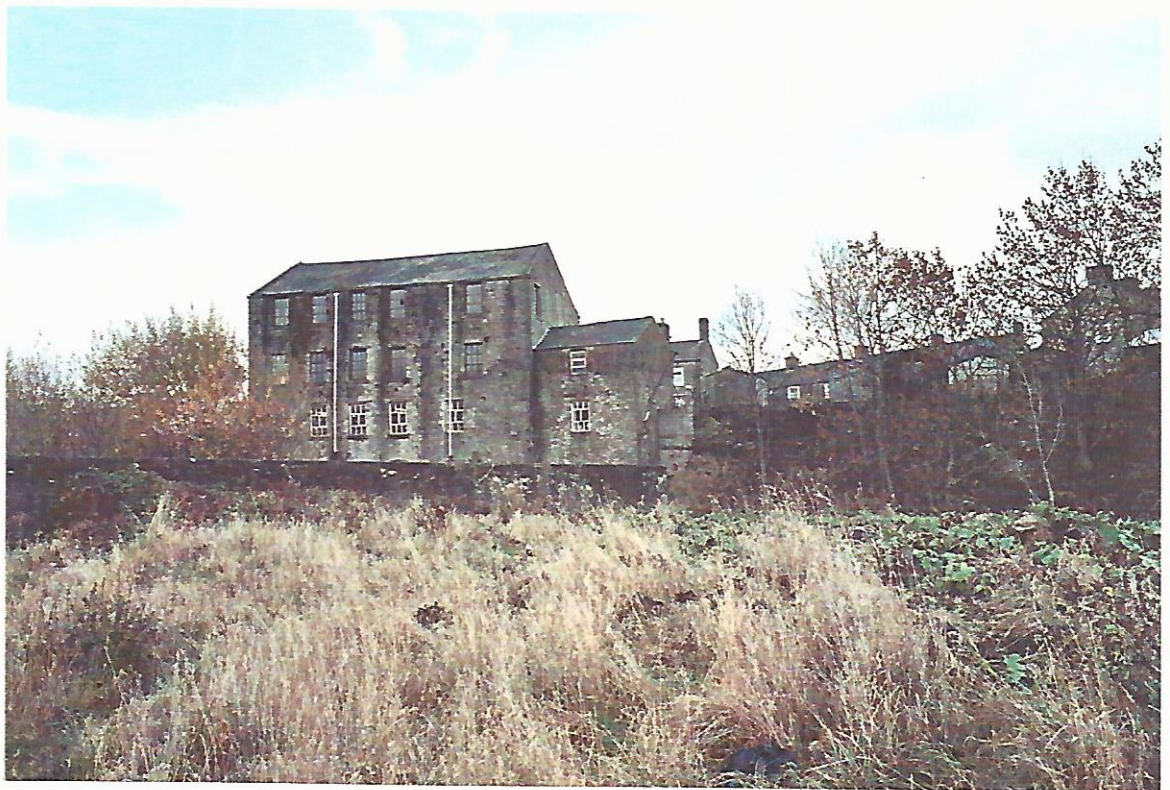
Pl. 11 West elevation

The west elevation runs alongside Butts Beck. The full height of the building can be seen and the fenestration to the four northerly bays is expressed in four six-pane

windows to each floor, with the exception of the ground floor where they have been blocked. A row of quoins can be seen between the fourth and fifth vertical rows of windows running from ground level to midway up the second floor line of windows (pl. 12). This break matched the break in the wall to east elevation represented as an offset. A stepped horizontal break in the masonry to the west elevation can be seen at this level, dropping to below the sill of the southernmost window on the second floor. This is matched by a slight offset in the return wall to the two-storey extension (pl. 13 & 14). The earlier masonry is of uncoursed rubble walling and differs from the later coursed masonry. The quoins to the south-west corner of the four storey block differ above and below this point, as does the masonry up to the line of quoins between the fourth and fifth windows indicating an earlier phase of the building.

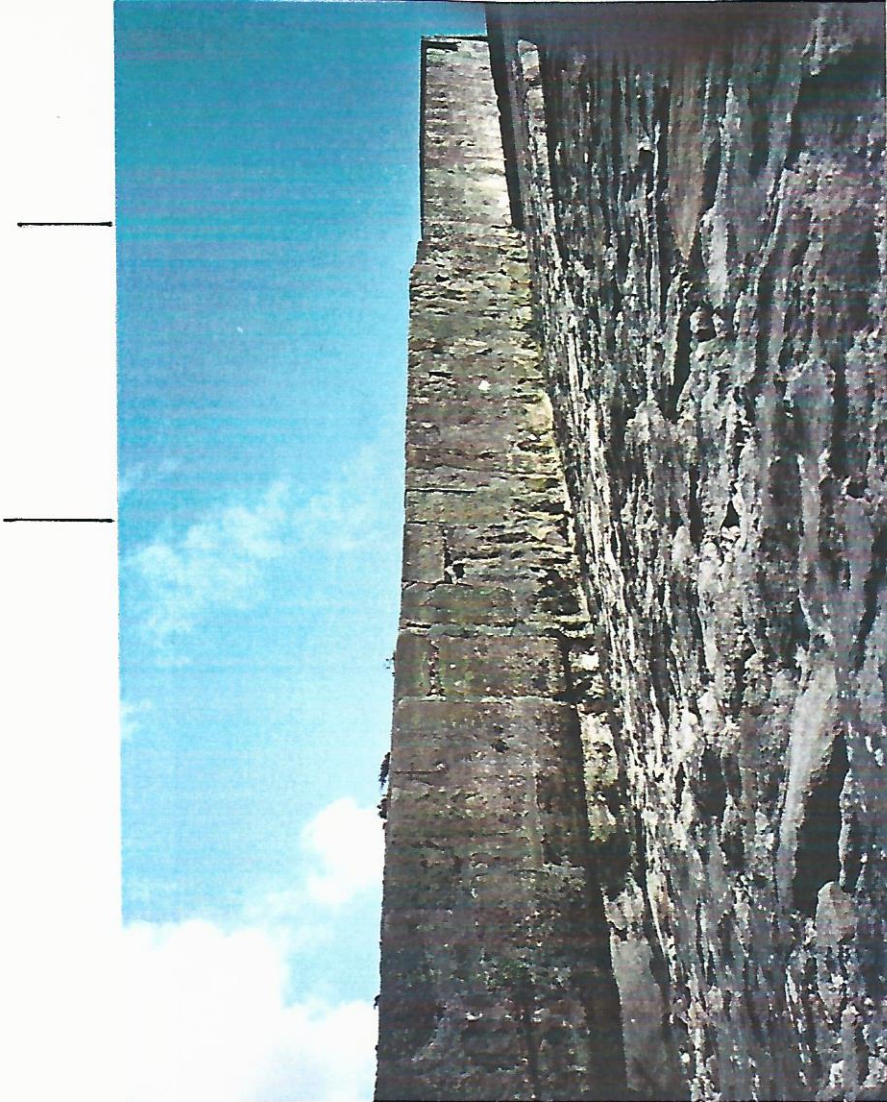
Pl. 14 West elevation showing position of offsets and edge of seventeenth century doorway.

At first floor level part of a small blocked up window is evident alongside the lower part of the southernmost window. This comprises sill, head and single piece jamb. At the break between the main block and the southernmost block, the left-hand chamfered jamb of a doorway is evident. The right hand jamb of this doorway in the former external wall can be seen internally at first floor level. A further phase in the building can be identified as there is another slight offset seen just above the door jamb (pl. 14). The quoins at this point differ from those below the offset suggesting that the building was raised in height.

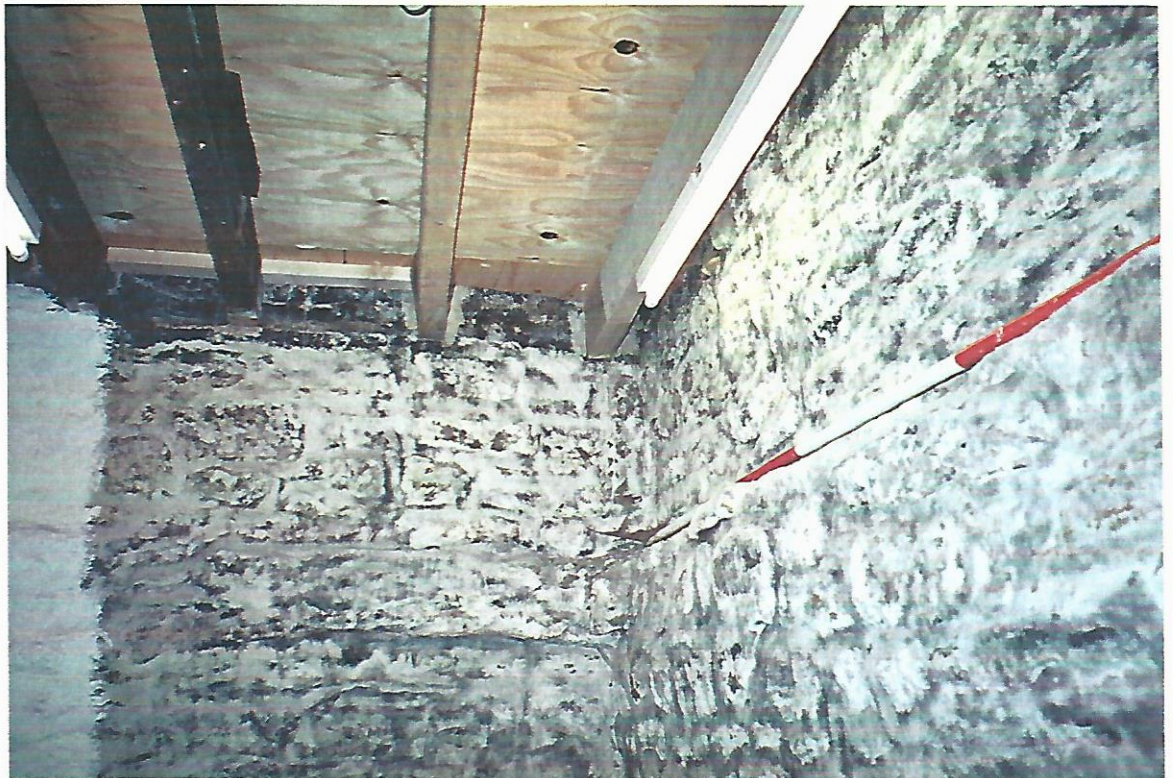
Pl. 15 Ground floor workshop with threshold of seventeenth century doorway at high level in end wall, and offset showing earlier floor level.

Evidence of an earlier first floor level can be seen in the south-west corner of the present main workshop area. At high level the threshold of a door opening can be seen 2.230m above the present floor level (pl. 15; fig. 9). The right hand side of this doorway can be seen on the first floor, with the left-hand jamb being seen externally. The first floor level has been raised by some 880mm, above the earlier first floor level. The bearing for this earlier first floor can be seen as an offset in the west external wall. Evidence of the line of a former external wall butting into the present external west wall can be seen at the fourth column line from the south and is represented by uneven masonry (fig. 3, 5). The line of this wall coincides with a break in the eastern workshop wall, and quoins for a return can be seen in the roof space of an internal stone (pl. 16). This wall line represented the external north wall of an earlier phase. A small opening 700mm high at low level in the southernmost bay could be a former window opening, with sill level 700mm above present floor level.

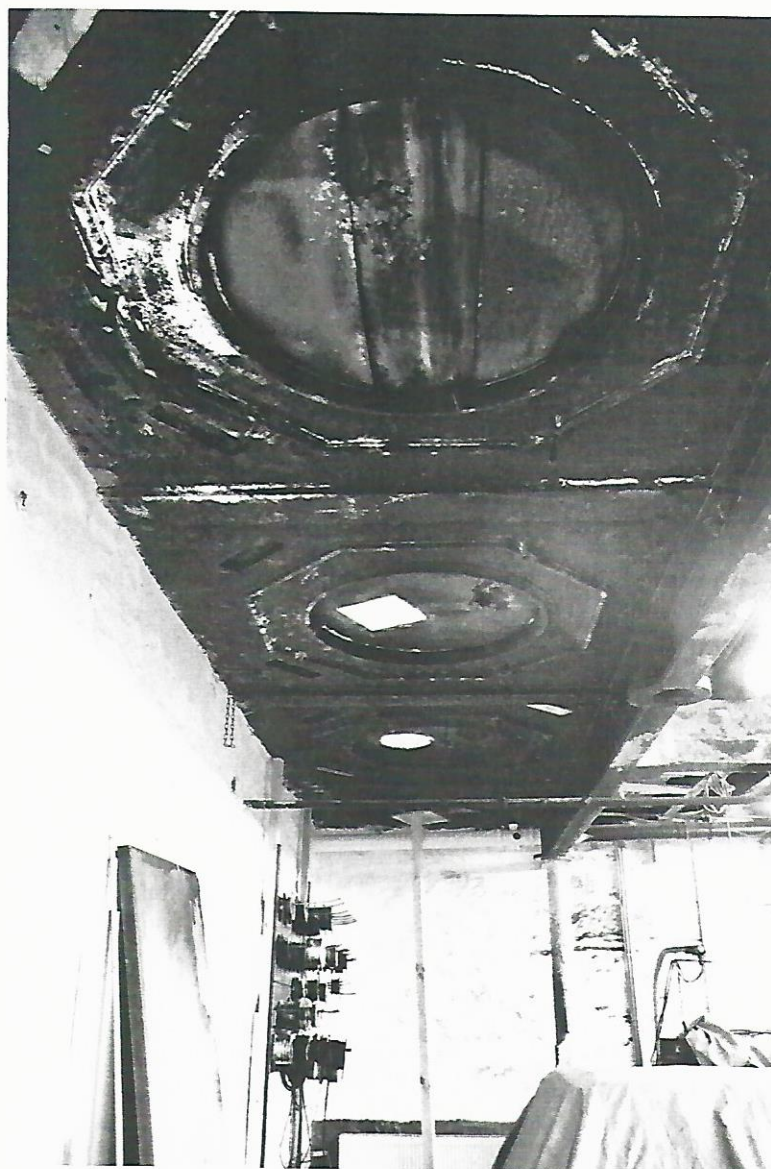
Pl. 17 Ground floor workshop, cast iron millstone frame.

The cast iron mill frames run north-south and number eight (pl. 17; fig. 4, 11). Each millstone housing was supported mid-way by a cast iron column. There is no evidence of any drive shafts to the millstones. It is significant that the stone floor directly under the millstone is slightly raised and more uneven than elsewhere (pl. 18). Several of the millstones are still in position. Many of the columns supporting the frame have been removed, and only the fourth and eighth columns are now extant. Remains of a cast flange is evident to the northernmost column.
