# **Pendle Heritage Archaeology Group**

## **Report of an Excavation at Wycoller Hall, Wycoller**

**2007-2009**

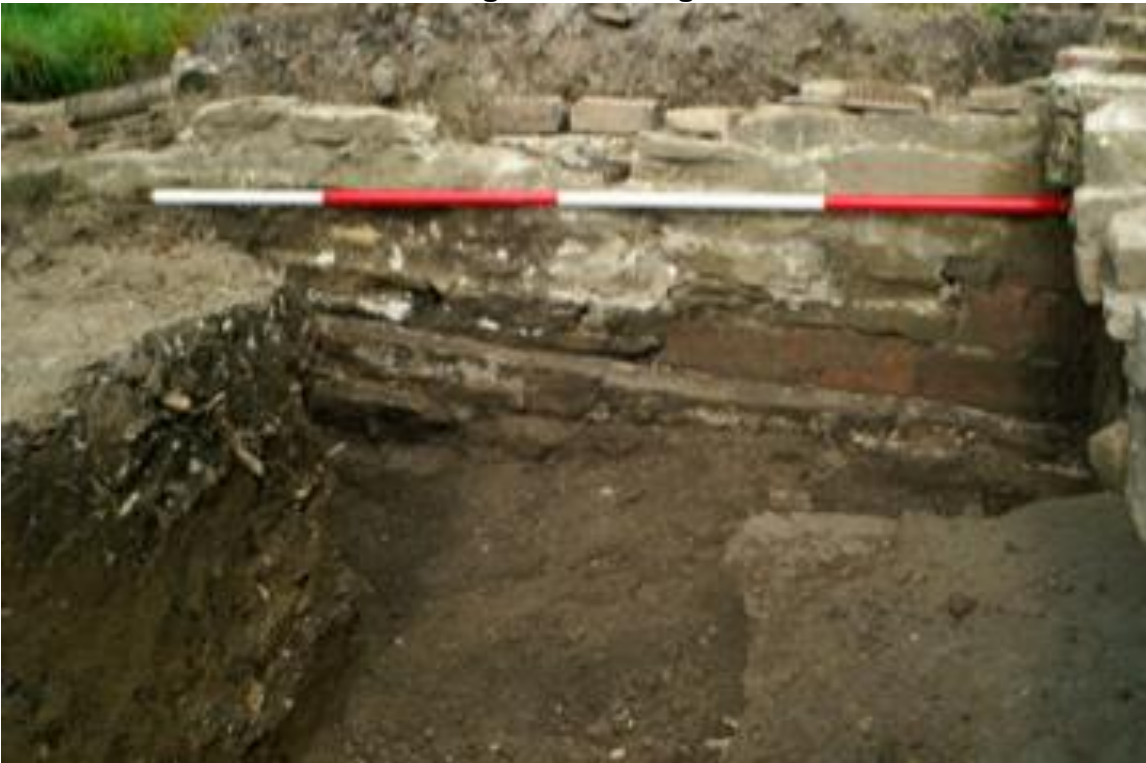
**Plate 2** Northern wall showing inclined flag course on internal face.

The north-western wall was seen to be 400mm thick with a 225mm (9") brick outer leaf set on stonework. An inclined flag course was seen on the internal face falling approximately 100mm from the west to the east. (plate 2) The lime mortar below the flag course was harder than that above. The south-eastern wall was seen to be similar. None of the walls were tied in to each other.

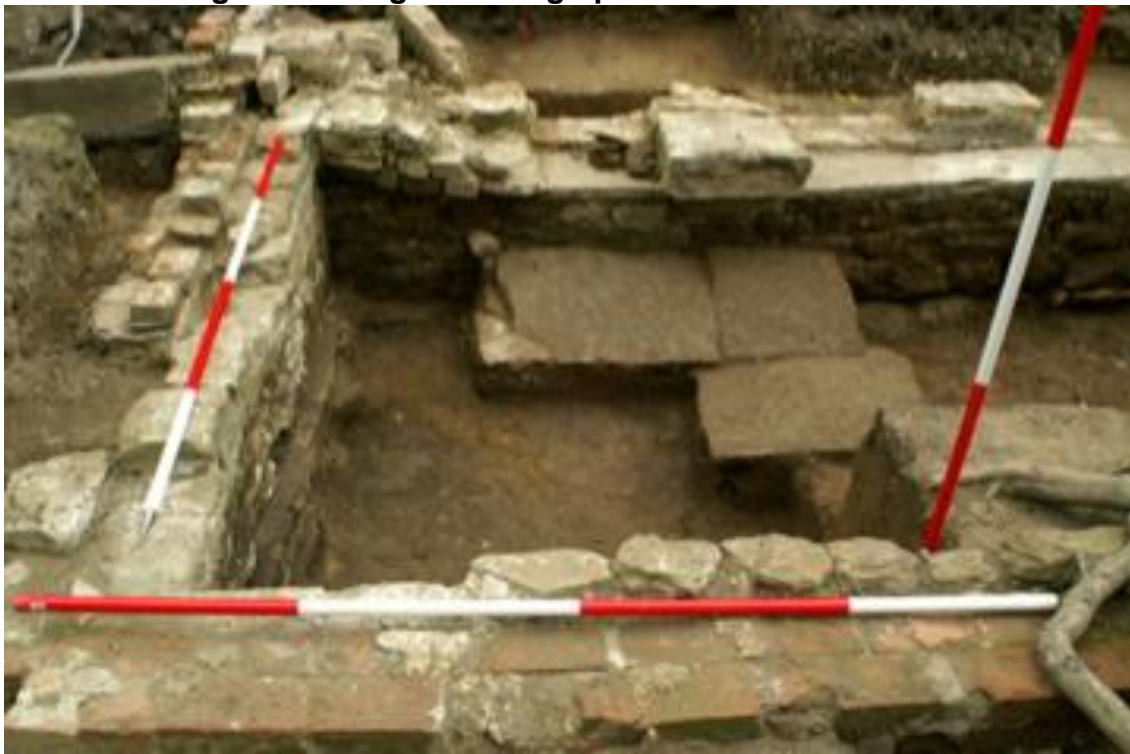
**Plate 3** Large stone flags inclining up to north east wall.

At the north-west end of the building, the interior infill deposits were removed down to the natural sandy deposits to reveal a stone foundation course in the walls and also a possible floor level above this. Also in this part of the structure were three large stone flags sitting on the primary fill above the natural and two of these were either purposely set or abandoned at an angle, inclining up to the north-east wall. (plates 3 - 5)

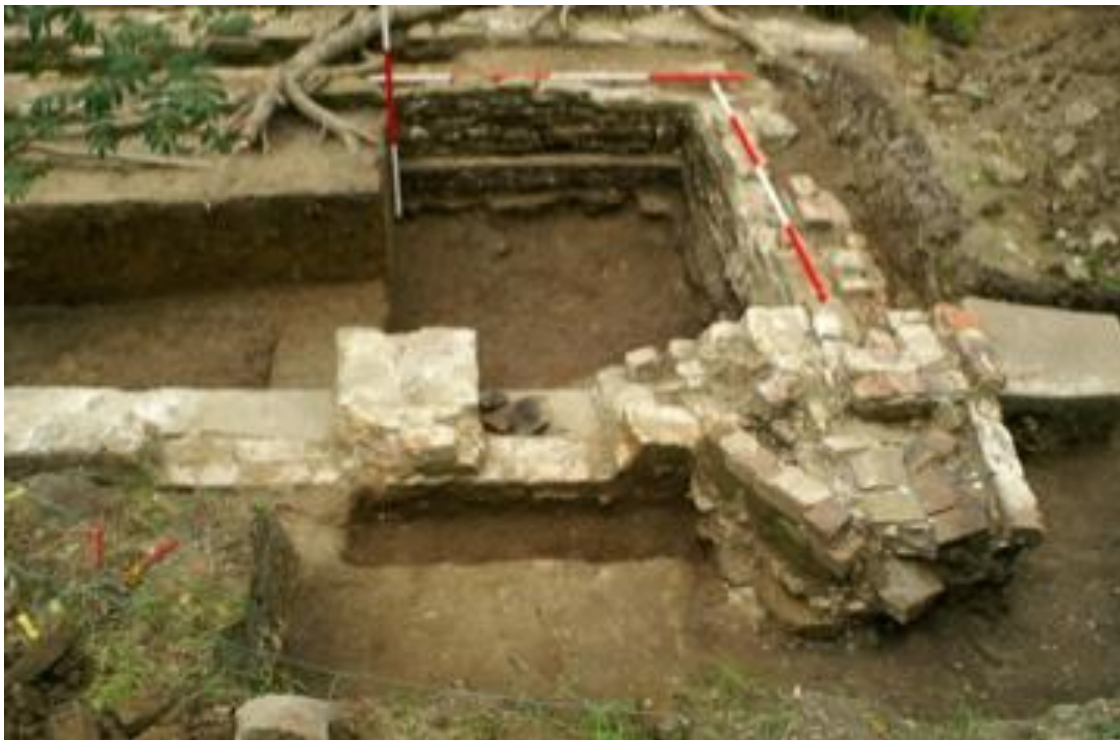
**Plate 6** Succession of walls on west of site.

At a distance of c. 300mm to the south-west was seen a stone wall c. 700mm thick with a stone facing to each side and a rubble core. This wall was well constructed with lime mortar. A further 400mm to the south-west a fourth wall was seen made up of two leaves of brickwork 275mm thick. This was of poor workmanship. (plate 6)

The substantial stone wall just to the south-west of the structure is 600mm wide and well built and in view of this, it is probable that it once formed part of the building. However, this feature was not fully investigated and no return ends seen nor any occupational level determined. No explanation is offered for the poorly built brick wall positioned slightly to the west of this.

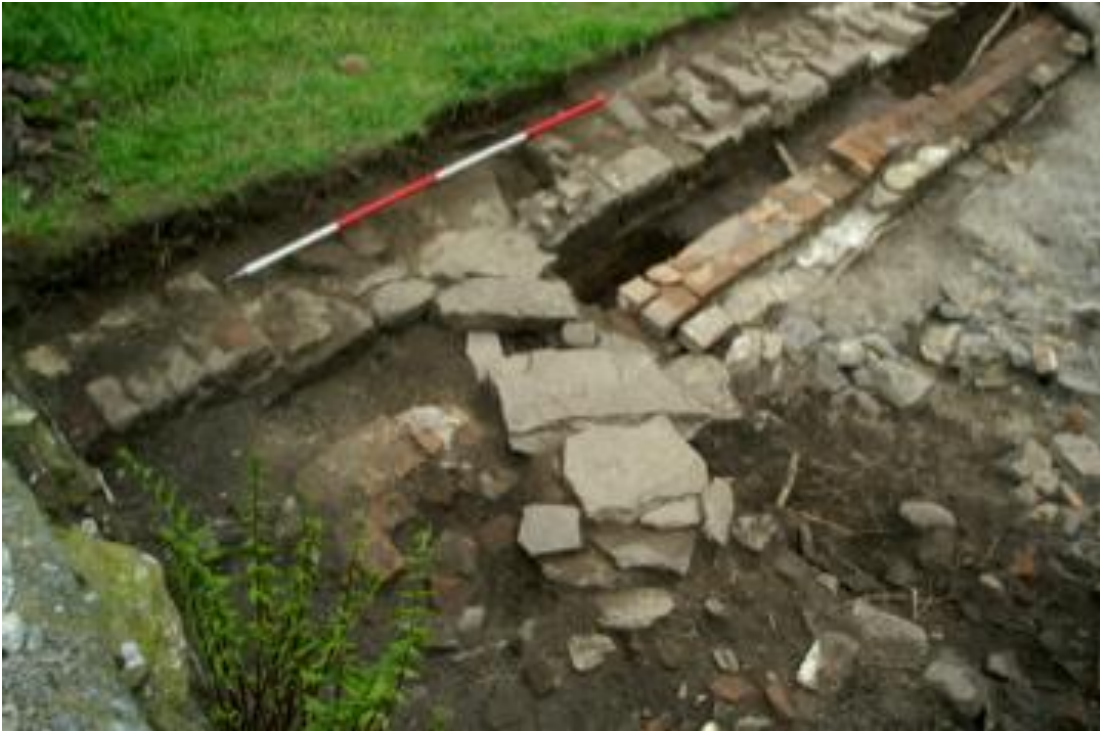
**Plate 7 Culvert.**

Near to the field wall, a culvert cut across the south-east end of the building. This secondary feature was constructed of stone blocks, clay-lined, with a flat but irregular stone slab capping, and overlay the south-west external wall of the building. The exposed northern side was seen to comprise two courses of brickwork over some of its length. (plates 9 - 10). It appears to come from the pond in the adjacent field, entering the site in the north-east and bisects all three south-west walls, continuing down to the river. On excavation, the culvert was found to be almost full of fine sandy silt, with occasional brick fragments especially towards the bottom, and a fine, light - coloured sandy lens at about half depth. (context sheet 129). A coin was found just below the surface of the fill. Small fragments of window glass and a substantial amount of terracotta sherds were also found throughout the site.

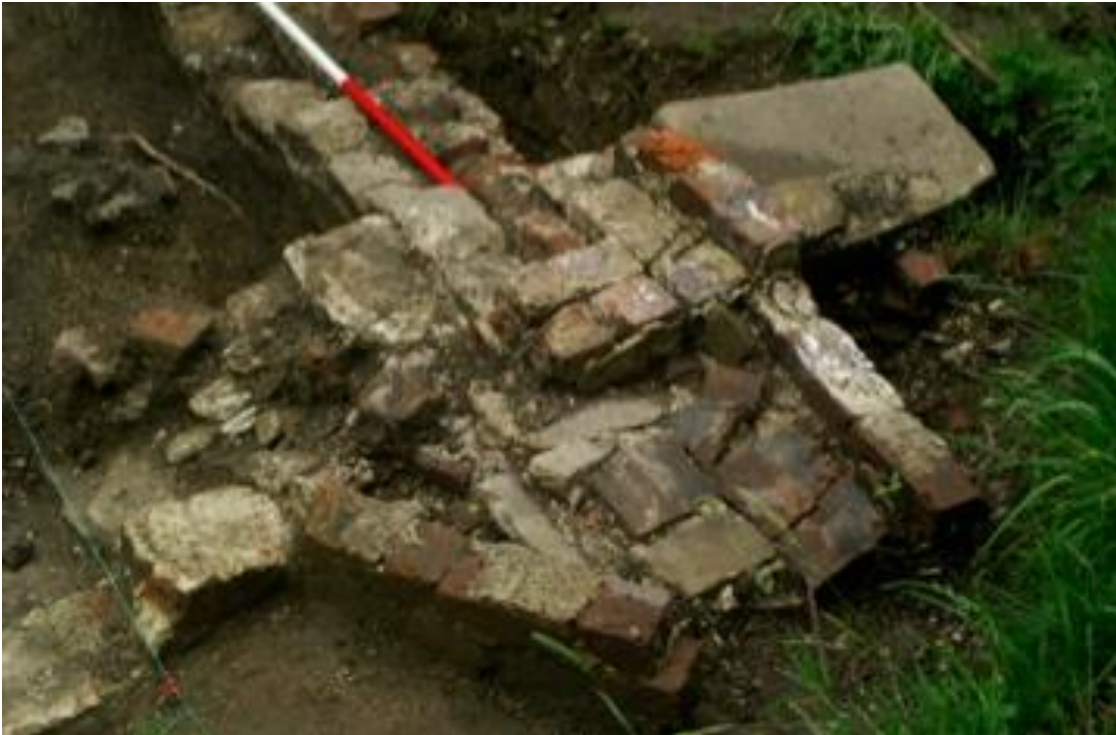
**Plate 8 Base of brick flue.**

A poorly constructed brick flue was built outside the external wall to the northern corner of the building. (plates 7 - 8). Many particles of coal were spread throughout the excavated deposits and this probably represents the fuel source for the heating grate. The ashes from the fire appear to have been raked out from outside the building, although whether the fire was fed from within the building and whether it heated some type of water cauldron or boiler are questions which remain unanswered.
