Jewel Mill Area Visited 24th April 2020

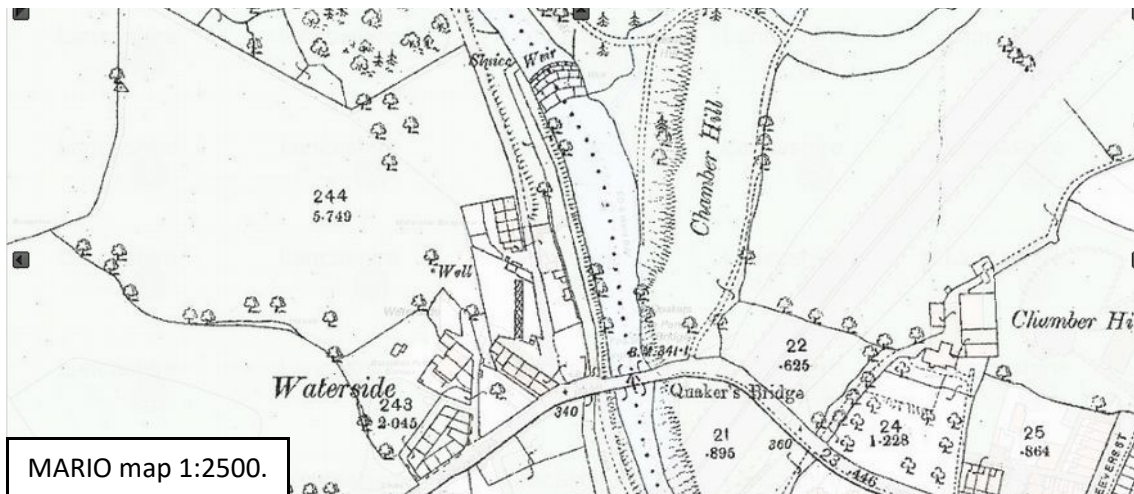
The MARIO map shows that as well as the factory there was what looks like a terrace of workers' houses. The site today is occupied by a short terrace and some agricultural buildings where most of the factory stood. There was a mill race and mill pond (an impressive 3.5 acres) just north of the factory complex. Water was diverted from Pendle Water about 150 m north of the Quakers' Bridge, Brierfield.

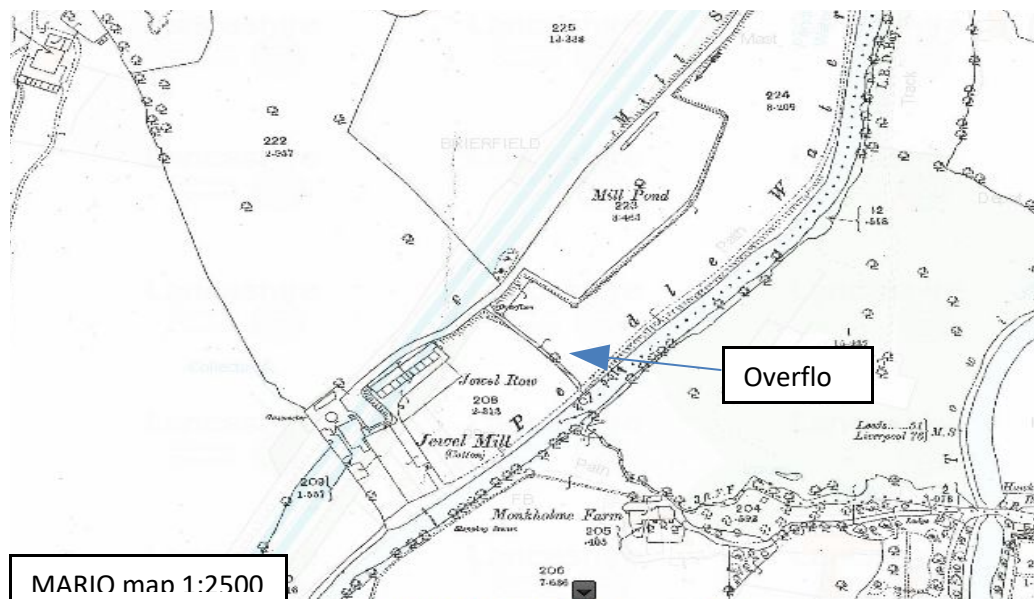
The diverted water became the mill race and supplied the mill pond. The pond has been filled in and all that remains is a depression in the field. There is an overflow shown on both MARIO maps; presumably this was an open stream. What happened to the water used in the factory is not indicated on the maps – assumed returned to Pendle Water via an underground drain.

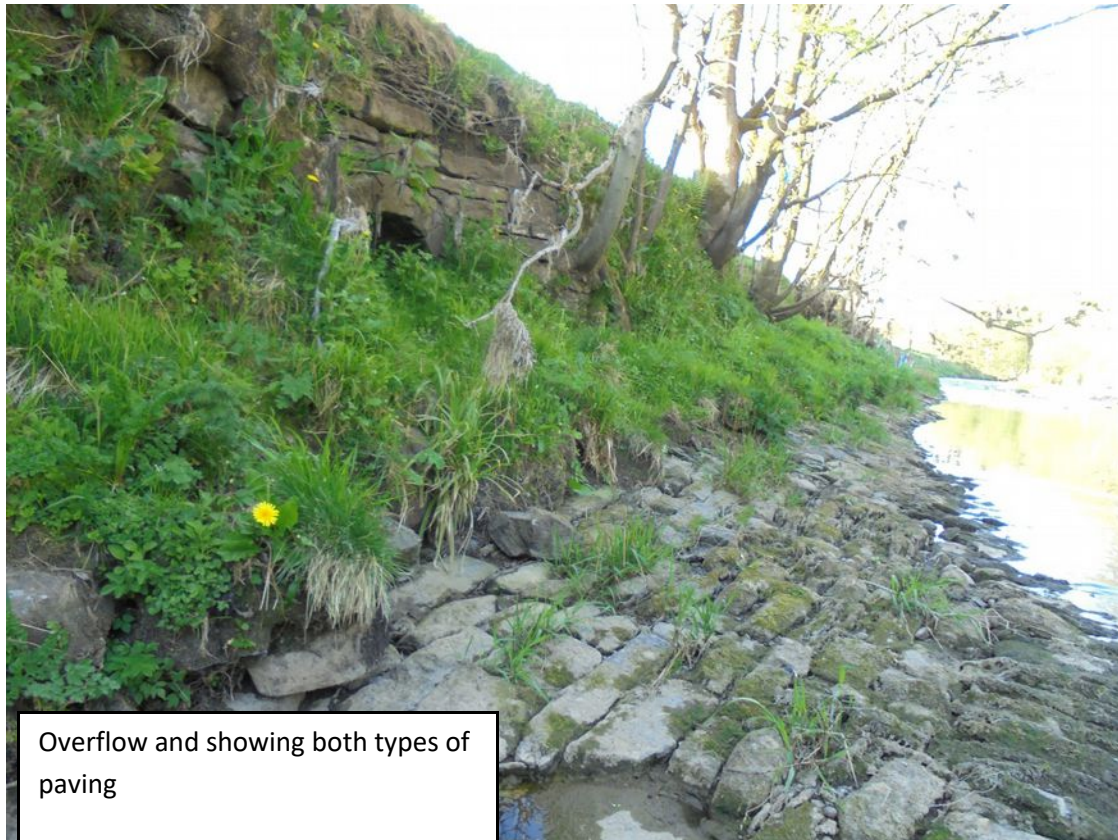
The overflow emerging from under the track, diameter around 0.8m.

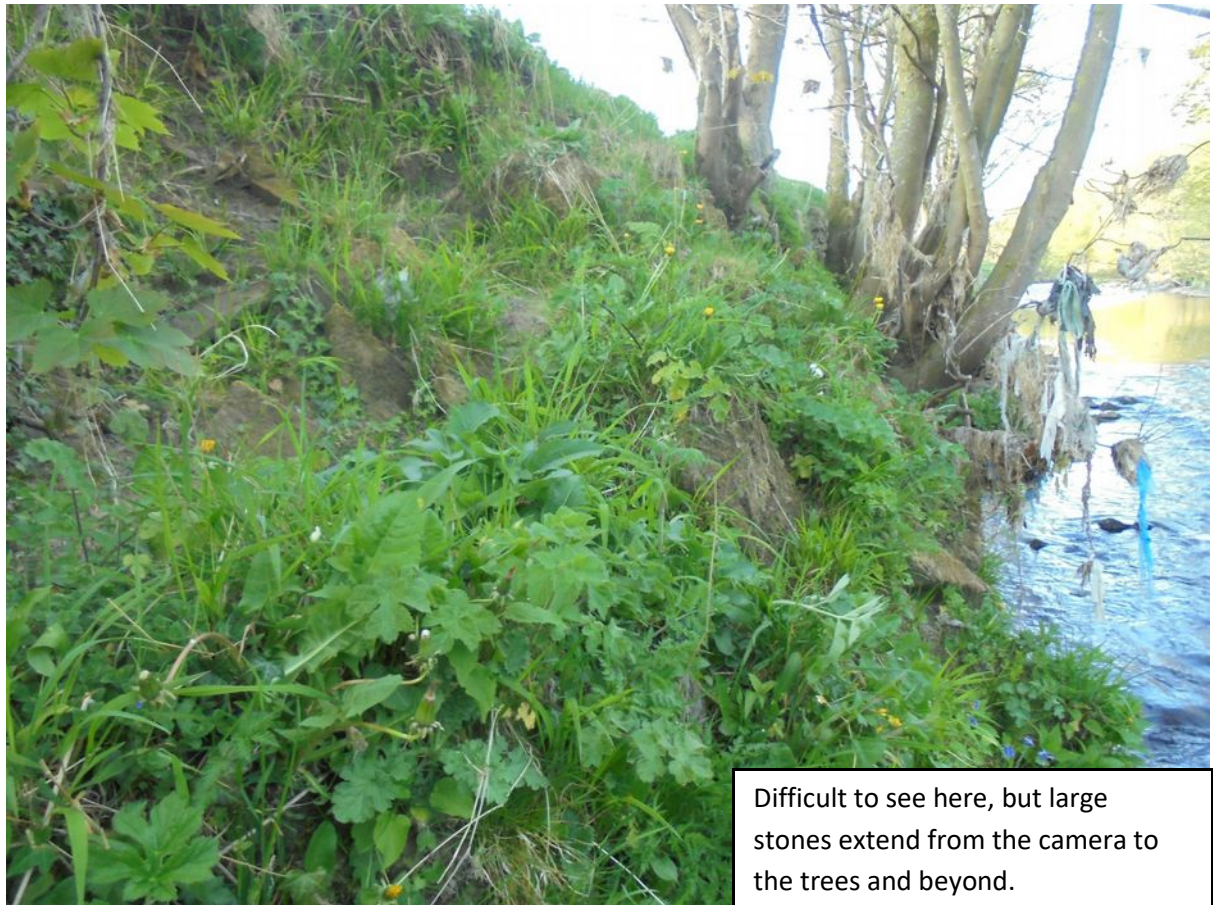
Modern repair to the bank?
